**Re: 49 CFR Part 573 Defect and Noncompliance Report**  
Bestop, Inc. Rear Shell Roof Rack - Bestop Part # 41400-01

Generic name of the item: Roof rack

Make: Bestop Model: Rear Shell Roof Rack

Part Number: 41400-01 Size: Not applicable

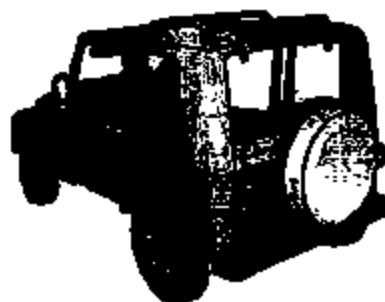
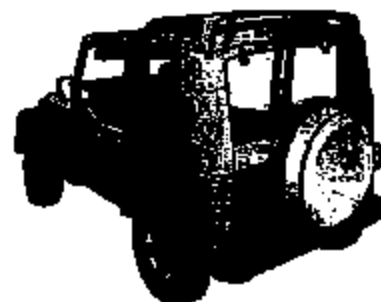
The cockpit cover may not stay latched to the roof rack because the latch bracket mispositions the rotary latch to the cockpit cover. (Attached is the cover page from the Rear Shell Roof Rack Installation Instructions that shows the cockpit cover in place in one drawing and stored on the roof rack in the second drawing. Also attached is the Parts List and Hardware Identification page from the Installation Instructions. The affected latch bracket and striker plates are circled on the parts list.)

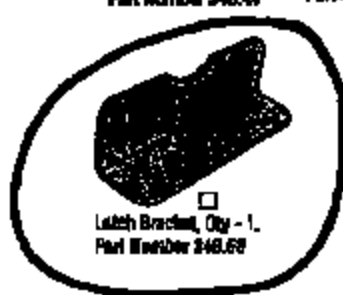
Latch Bracket, Qty - 1,  
Part Number 348.69

The mounting holes for the screws that fasten the latch bracket to the cockpit cover are in the wrong location. This allows the rotary latch that mounts to the other side of the latch bracket to be mispositioned on the cockpit cover.

The mispositioning of the rotary latch on the cockpit cover prevents the striker plates from fully engaging the receiver brackets that secure the cockpit cover to the front cross rail. As a result, the cockpit cover may not stay latched to roof rack and could come off the roof rack.

Bestop will provide replacement parts consisting of an updated latch bracket and updated striker plates to all customers who purchased the Rear Shell Roof Rack. The updated latch bracket and updated striker plates will enable the striker plates to fully engage the receiver brackets that secure the cockpit cover to the front cross rail.

The replacement latch bracket will have mounting holes located closer to the edge of the bracket that is fastened to the cockpit cover than the recalled component to ensure that the rotary latch is correctly positioned on the cockpit cover. The replacement striker plates will have mounting holes that have a longer slot than the recalled component to allow for greater adjustment of the striker plates on the cockpit cover.

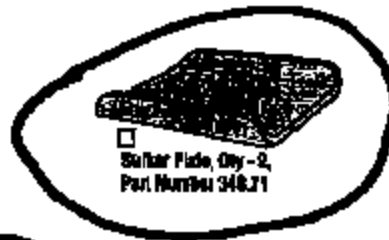
Strike Plate, Qty - 2,  
Part Number 348.71

Although Bestop has not received any reports of unintentional separation of the cockpit cover from the roof rack, rattling caused by the movement of the striker plates in the receiver tracks could occur before the cockpit cover separates from the roof rack.
