04V-038 ① of ②

**VEHICLE SAFETY DEFECT SERVICE BULLETIN**

**Monaco File # R03024**

**Re: Safety Recall- I-Beams and Panard Bar Bracket**

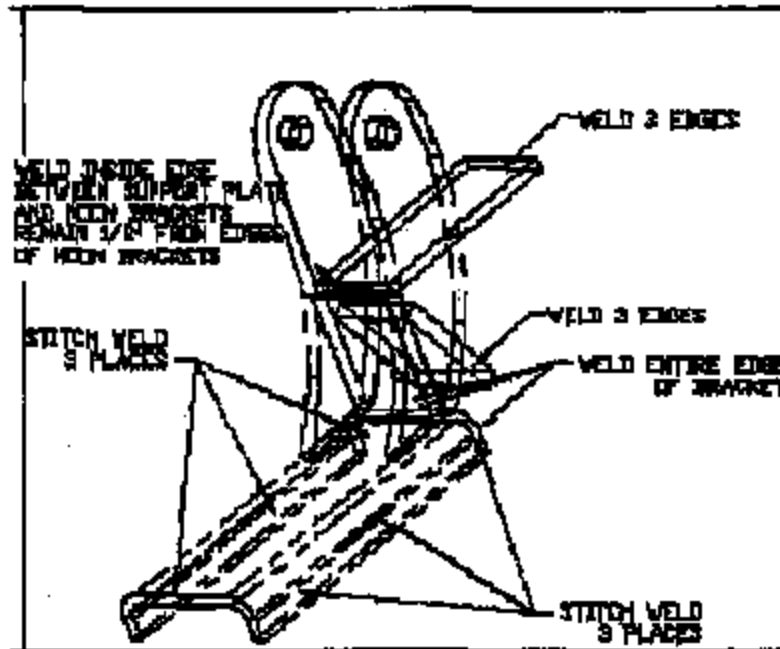
The defect relates to the I-beam leaf imitator in the front axle suspension (the "I-beam") and the rear axle panard bar bracket that is welded to the curbside top of the rear axle housing (the "panard bracket"). The I-beam has the potential to crack and break due to an inadequate welding process. The panard bracket has the potential to crack and break due to an inadequate welding process and a design deficiency.

1. Weld in a 4" x 3" x .375 steel plate from the upright support plate between the 'half moon' plates. This plate should be oriented from the rear side of the upright plate to the square axle housing on a 45° angle.
2. Weld in a 7 3/8" x 3" x .375 steel plate from the top of the previous plate added and support plate to the rounded portion of the axle gear housing. This should be on a parallel plane to axle housing.
