**TO:****FROM:****DATE:****SUBJECT: Campaign # 03E-061**

REASON FOR THIS CAMPAIGN

AFFECTED MODELS

2004 Essex Class A Motor Homes built between April 20, 2003 and November 26, 2003

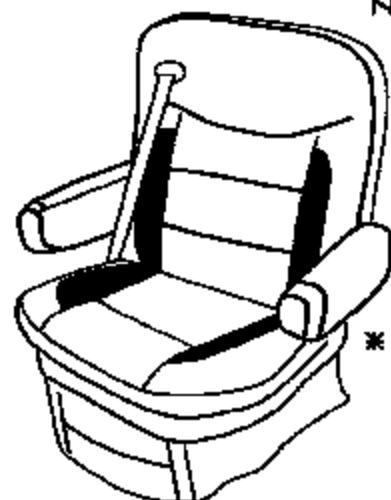
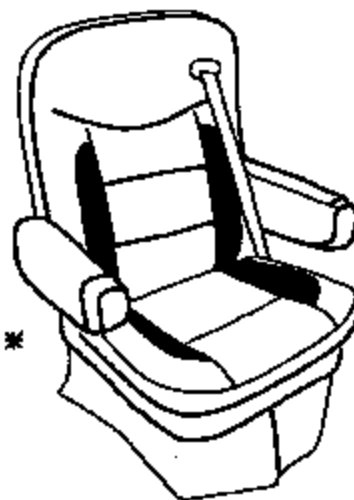
* BELT BUCKLE *

The seat belt latch where bolted on the seat frame may fail in the unlikely event of an accident.

Due to a hollow space in the location of the buckle attachment, the bolt may not be supported and may shear.

1. LOCATE BELT BUCKLE, I.E., AISLE SIDE OF THE VEHICLE. SEE ABOVE FIGURES. BELT BUCKLE LOCATION INDICATED BY AN ASTERISK (*).
2. TAKE OUT THE CAP AND LOOSEN EXISTING BOLT TO REMOVE BELT BUCKLE. SEE FIG. 1.
3. INSERT 7/8 ID x 3/8 ID x 3/4 SPACER INTO 1" DIA. TUBE. SEE FIG. 2.
4. RE-INSTALL BELT BUCKLE WITH 3/8 USS FLAT WASHER ZINC & 3/8-16 x 2 GRADE 5 HEX BOLT. SEE FIG. 2.
5. TIGHTEN BOLT TO 30 FT. LBS. PUT CAP BACK ON.
