## Safety Defect and Noncompliance Report Guide for Vehicles

**PART 573 Defect and Noncompliance Report<sup>(1)</sup>**

Charlot Eagle West, Inc.  
8100 West Buckeye Road  
Phoenix, Arizona 85043

## **PROCEDURE FOR CONVERTING A VENTED FURNACE DOOR TO NON-VENTED DOOR**

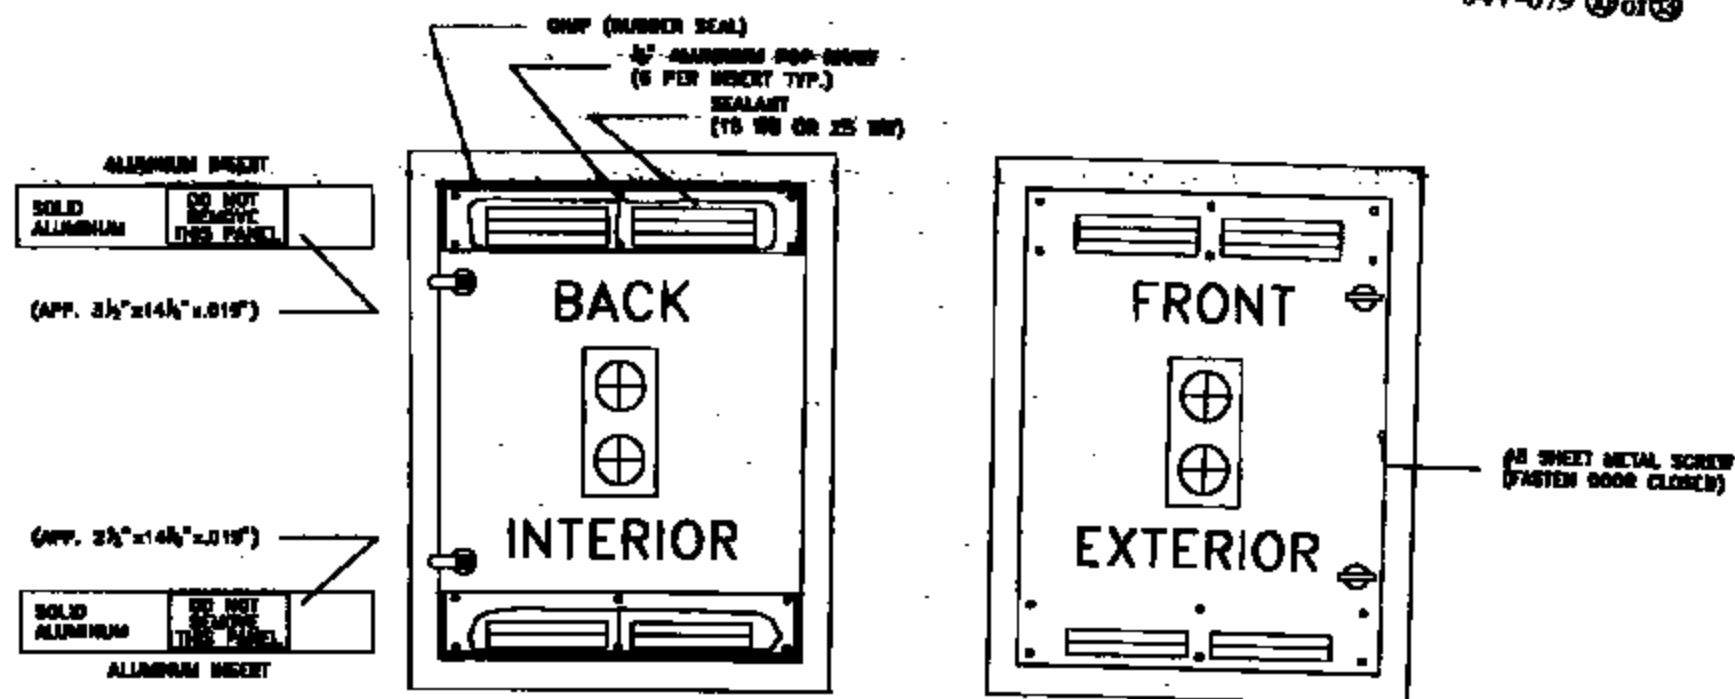
## FURNACE DOOR

Exterior furnace door with unnecessary air vents.

Exhaust fumes could re-enter trailer through air vents.

5. With flat aluminum not installed in door, apply bead of sealant around louvers and through center of louvers on the inside of the door.
  6. Insert flat aluminum over louvers and re-install gimp on edges.

7. Install six (6) pop-rivets per each aluminum insert, as shown in the drawing.
  8. Apply a bead of sealant to the edge of the aluminum insert that is not under gimp.

9. Apply "DO NOT REMOVE" labels to both aluminum inserts.
  10. Close the door and re-install the exterior vent.
  11. On the latch side of the door (in center of edge frame) drill a 1/8" pilot hole and install #8 sheet metal screw (this will prevent accidental opening of the door).
