Re: Four Winds International Corporation Recall
Defect and Non-Compliance Report

VEHICLE SAFETY DEFECT SERVICE BULLETIN

Recall Campaign No: TBD
Four Winds International Corporation File Number: R030009
Bolting the Seat Belt Harness

Regarding: Recall 04V-127 – Amended Scope of Affected Units/Instructions

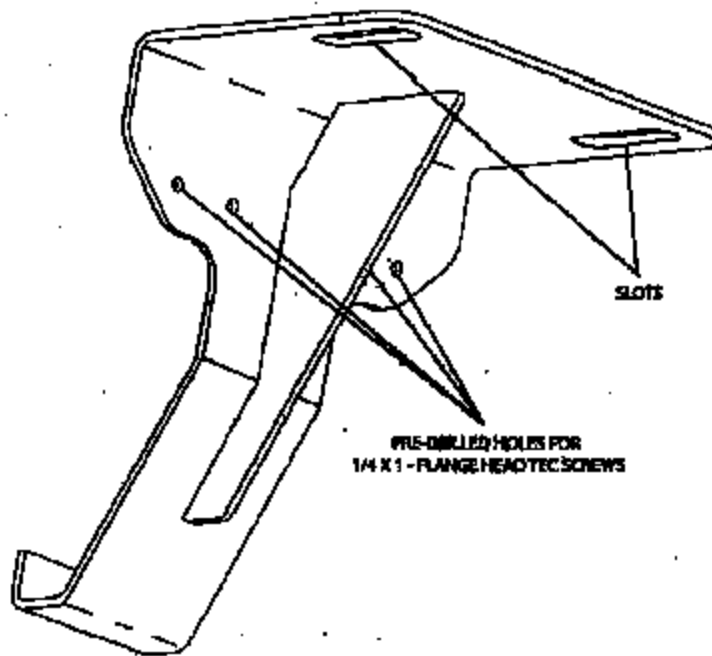
**DIAGRAM 1-1**

Identify the brace, and inspect, insuring that there are 4 (four) 1/4 X 1 - Flange Head Tec Screws securing the brace to the motor home chassis frame. If there are less than 4 (four) screws, proceed to secure the brace using 1/4 X 1 Flange Head Tec Screws (refer to diagram 1-1). If upon inspection a seat pedestal brace is not present refer to diagram 1- 2 of this installation guide.

Using the 1/2 X 1 Flange Head Tec Screws, fasten the brace to the front truss (refer to diagram 1-1).

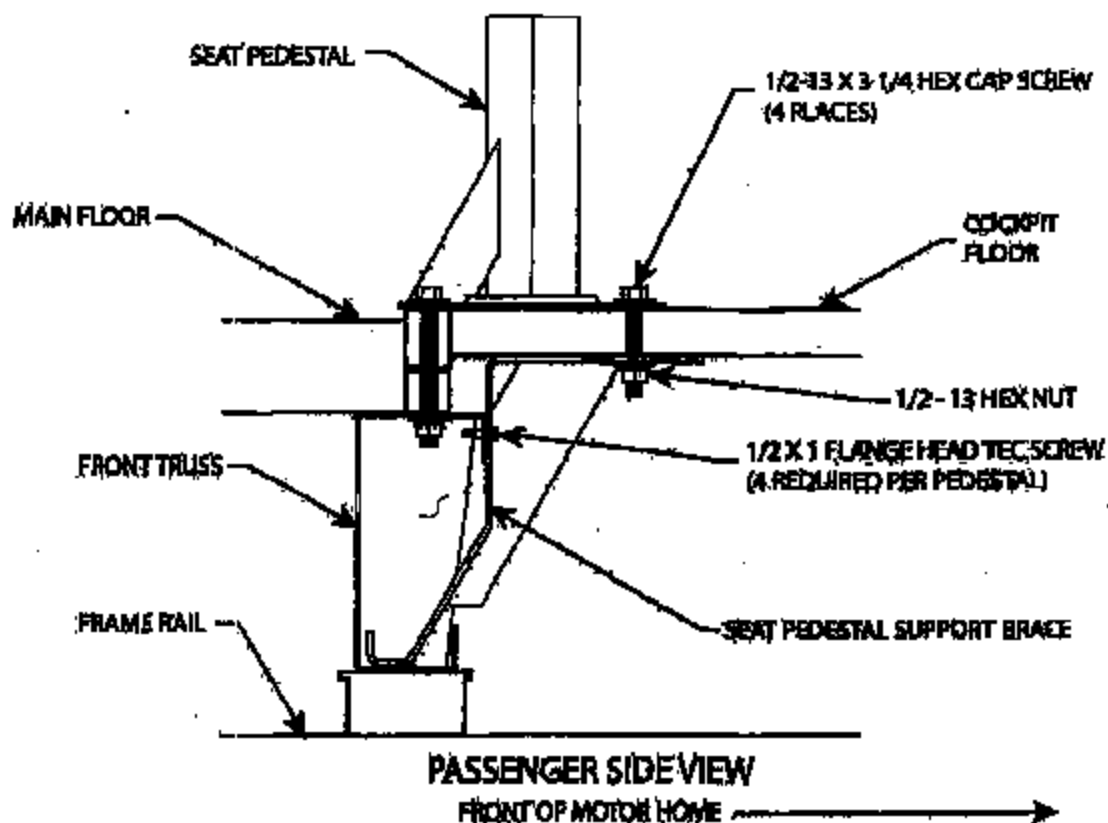
DIAGRAM 1-2

Upon inspection, if a seat pedestal brace is not present, installation of the brace is required immediately.

To proceed with installation, remove the seat pedestal's front 1/2 -13 Hex Nuts from the 1/2 -13 Hex Cap Screws, as well as the 1/2 Lock Washers and the 1/2 Flat Washers, which secure the seat pedestal to the doghouse frame.

Place the brace slots over the Hex Cap Screws. Replace the Flat Washer, followed by the Lock Washer and then the Hex Nut. Hand tighten the Hex Nut. Insure the back of the brace is flush with the front truss of the chassis frame.

Torque the hex screw and nut to 65 lb.ft. Repeat procedure for the opposite seat pedestal.

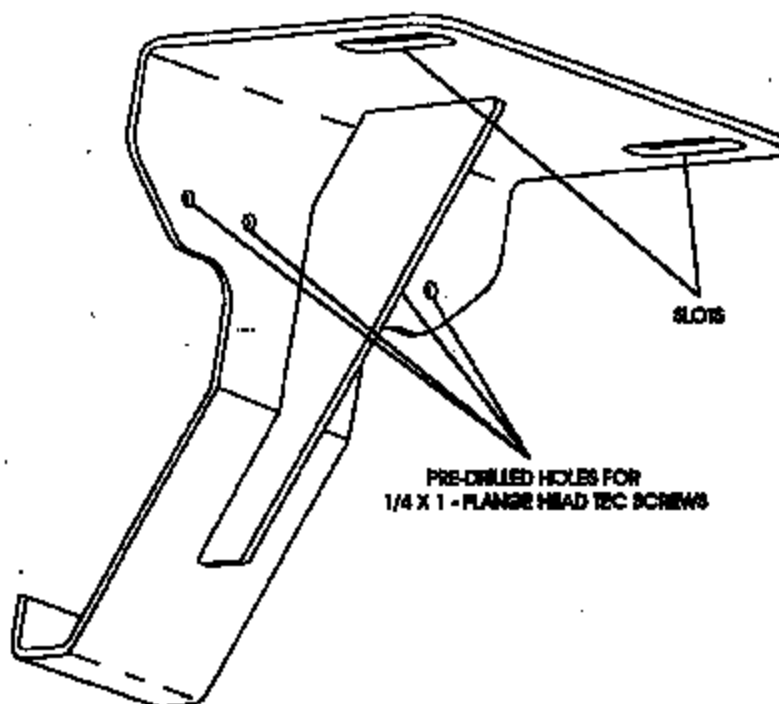
DIAGRAM 1-1

Identify the brace, and inspect, insuring that there are 4 (four) 1/4 X 1 - Flange Head Tec Screws securing the brace to the motor home chassis frame. If there are less than 4 (four) screws, proceed to secure the brace using 1/4 X 1 Flange Head Tec Screws (refer to diagram 1-1). If upon inspection a seat pedestal brace is not present refer to diagram 1-2 of this installation guide.

Using the $\frac{1}{4}$ X 1 Flange Head Tec Screws, fasten the brace to the front truss (refer to diagram 1-1).

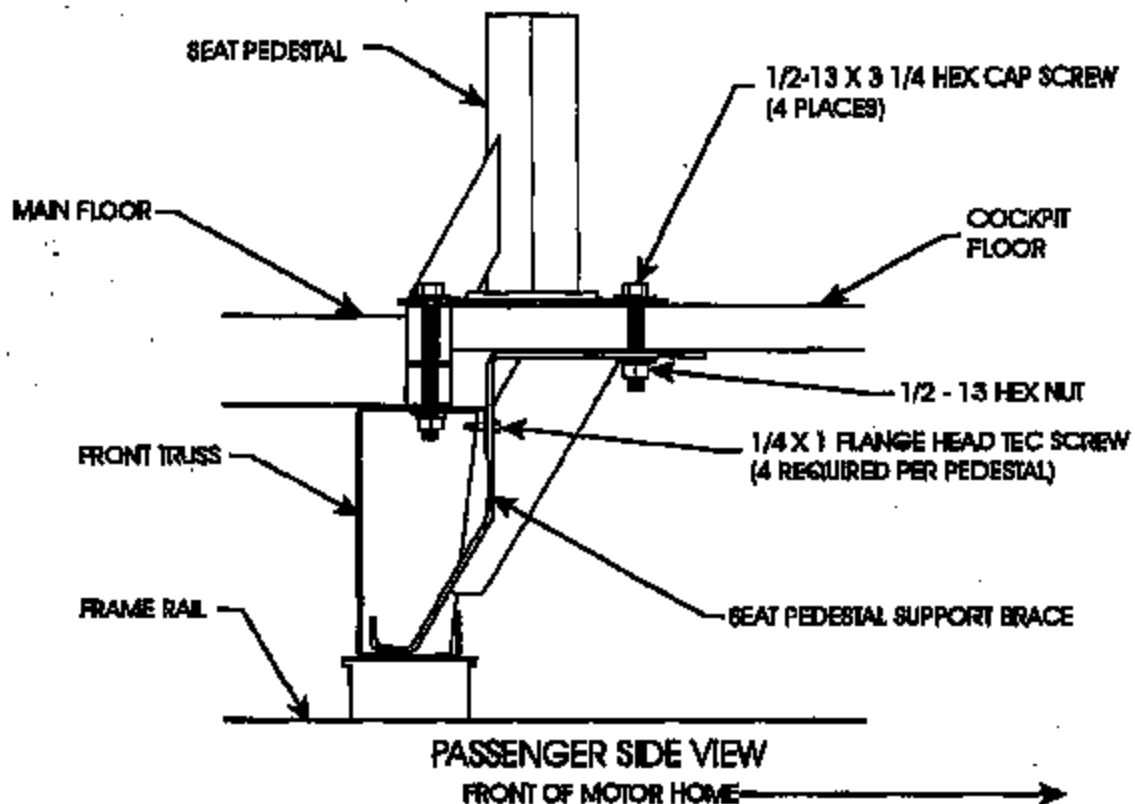
DIAGRAM 1-2

Upon inspection, if a seat pedestal brace is not present and the vehicle is equipped with a 3-point harness, installation of the brace is required immediately.

To proceed with installation, remove the seat pedestal's front $\frac{1}{2}$ -13 Hex Nuts from the $\frac{1}{2}$ -13 Hex Cap Screws, as well as the $\frac{1}{4}$ Lock Washers and the $\frac{1}{2}$ Flat Washers, which secure the seat pedestal to the doghouse frame.

Place the brace slots over the Hex Cap Screws. Replace the Flat Washer, followed by the Lock Washer and then the Hex Nut. Hand tighten the Hex Nut. Insure the back of the brace is flush with the front truss of the chassis frame.

Torque the hex screw and nut to 85 lb.ft. Repeat procedure for the opposite seat pedestal.

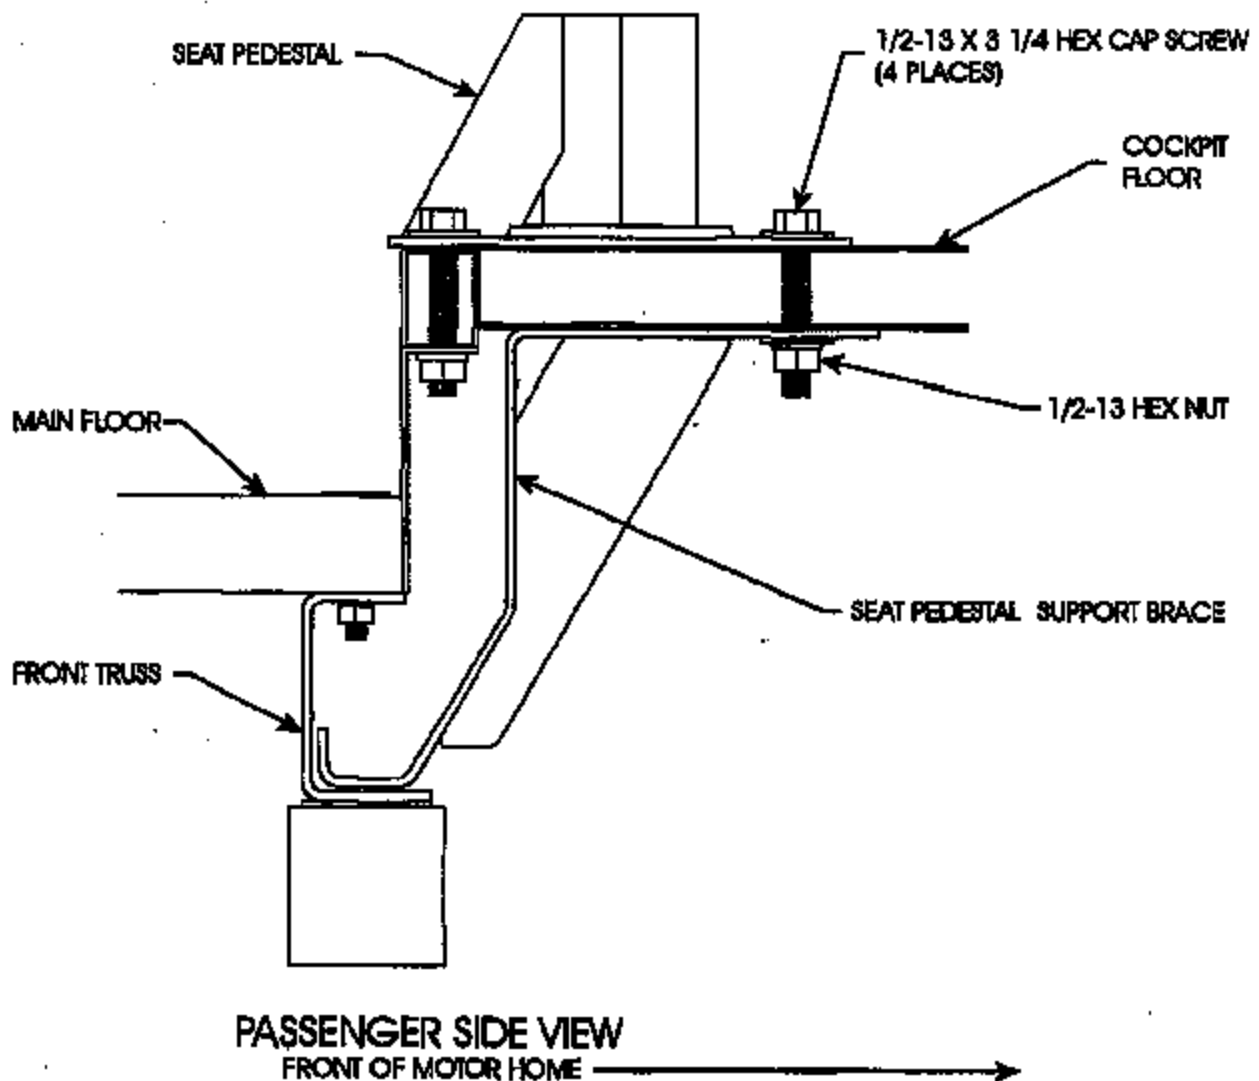
DIAGRAM 1-5

Upon inspection, if a seat pedestal brace is not present and the vehicle is equipped with a 3-point harness, installation of the brace is required immediately (refer to diagram 1-5).
