04V-135 ① of ⑮

IMPORTANT MOTORCYCLE SAFETY RECALL

**Service Bulletin 327
Recall Action
Confidential**

Affected Models Daytona 600, Speed Four
VIN Range See attached appendix
Markets France, Italy, Netherlands, Sweden, USA
Subject Fuel pump plate seal.

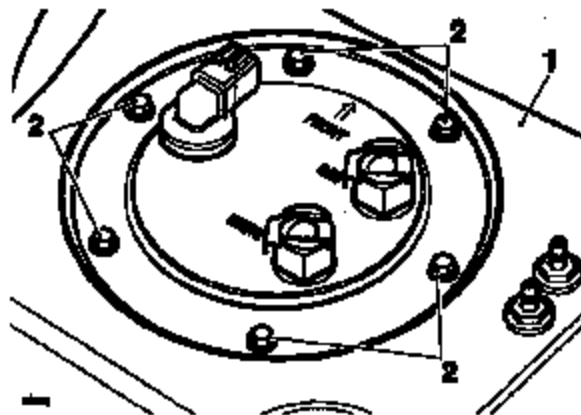
1. Fuel tank
2. Fuel pump mounting plate fittings

4. Invert the fuel tank and place on a protective surface to prevent paint damage.
5. Remove the lock nuts and washers securing the fuel pump mounting plate to the tank.

6. Lift the fuel pump assembly and manoeuvre it from the tank aperture.
7. Remove the seal from the tank aperture.
8. Ensure that the tank aperture and fuel pump plate are clean.
9. Position the new seal on the tank aperture and ensure that it is correctly seated.

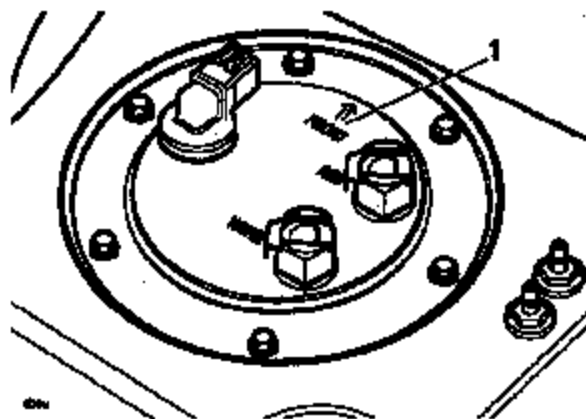
1. FRONT marking

10. Carefully manoeuvre the fuel pump assembly into the tank aperture and ensure that the 'FRONT' arrow is facing towards the front of the tank.

11. Locate the washers and lock nuts to the studs and tighten sequentially to 5 Nm.
12. Recheck the torque on each nut.
13. Refit the fuel tank.
14. Reconnect the battery positive (red) lead first.
15. Check integrity of all fuel system pipes and connections.
16. Refit the seats.
