Safety Defect and Noncompliance Report Guide for Vehicles
PART 573 Defect and Noncompliance Responsibility and Reports¹

04V-154 (D of 8)

Re: Part 573 Report to NHTSA

Parker Hannifin Corporation - Mobile Cylinder Division has decided to conduct a safety recall campaign with respect to fourth stage packing nut retention on large, five-stage, telescopic, single acting dump cylinders used on large framed and frameless end dump trailers manufactured by Commercial Intertech/Parker Hannifin Corporation - Mobile Cylinder Division.

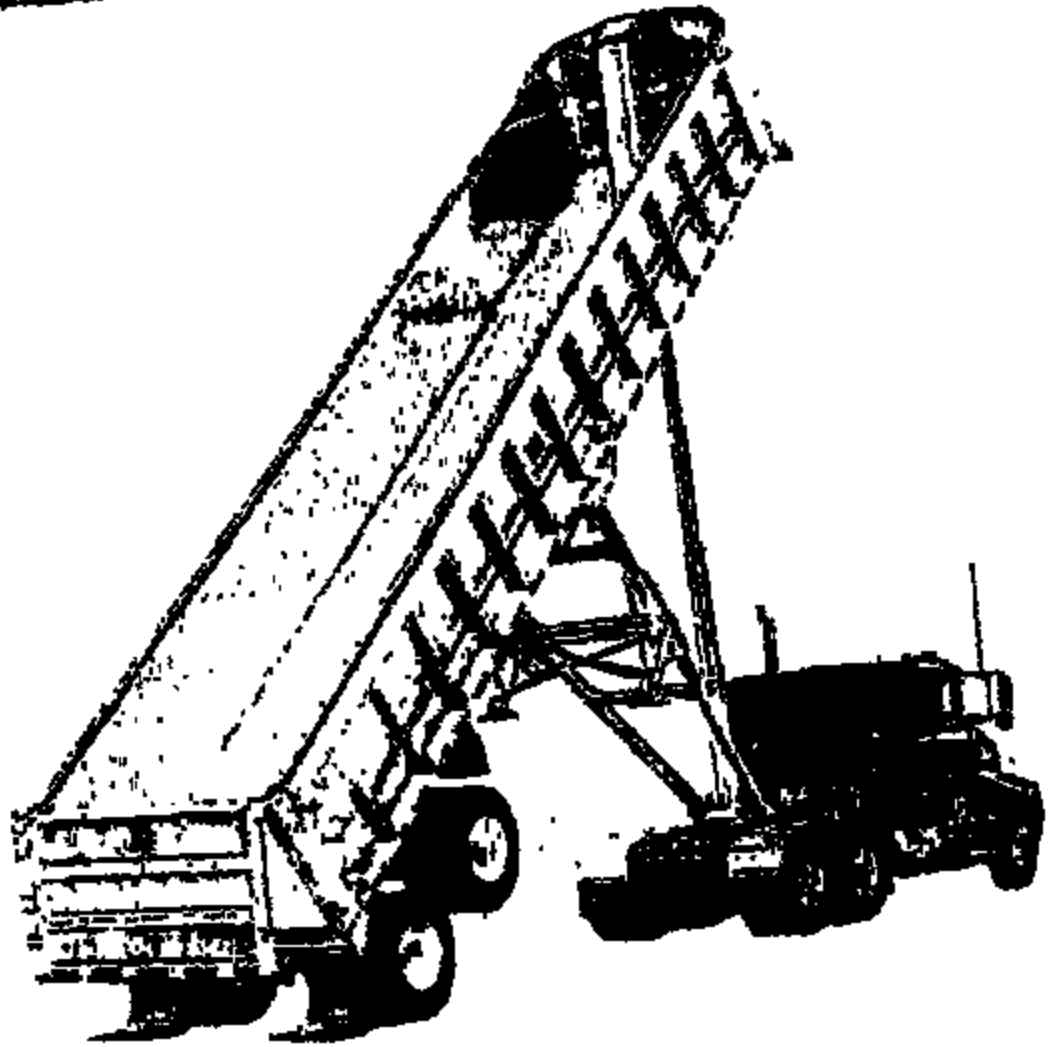
**TYPICAL SUPER DUMP TELESCOPIC CYLINDER APPLICATION
FRAMELESS TRAILER**

The telescopic cylinder models that are affected have been commonly referred to as a "Super Dump." The cylinder can be easily identified by a quick visual inspection of the cylinder as it is pinned in the doghouse of the dump trailer. This is done with the trailer completely lowered. Lifting a flexible flap or removing an access panel, can our view the top pin area and the cylinder packing nuts. See Attachment A, captioned "Typical Super Dump Telescopic Cylinder Application Frameless Trailer."

With use, the packing nut on the fourth stage retaining the plunger can loosen, backing off the fourth stage. This condition, if not remedied, can continue until the nut backs completely off the stage. If this occurs, there is nothing to retain the fifth stage or plunger in the assembly. When the cylinder is then extended to its maximum stroke the fifth stage separates from the cylinder assembly causing loss of control over the trailer. The trailer will free fall until it hits the trailer frame and/or fifth wheel.

A field modification kit (273 1805 206) to secure the packing nut in position on models 885DC-55/56-XXXX will be provided to customers/owners without charge. The kit provides a drill bit to drill through the packing nut and into fourth stage tube and a tap to thread the hole. Loctite, Allen wrench and (2) sockets will be included with a written procedure. After drilling and threading, one socket is inserted into the packing nut and tightened in the fourth stage tube at a specified torque, thus locking the packing nut in place. The socket is sealed with Loctite and then staked.
