**STRICK CORPORATION**

04V-260  
(33 pages)

**Re: NOTICE OF DEFECT**

## **SERVICE BULLETIN**

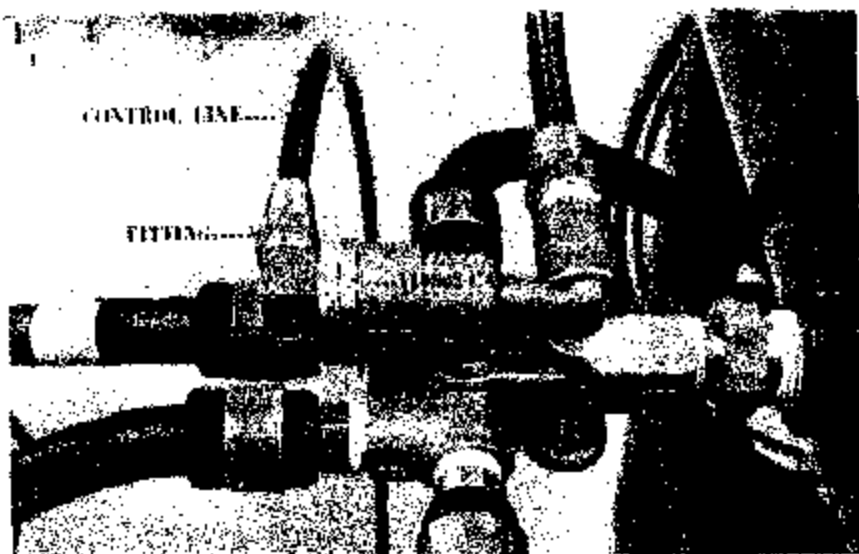
Step 1 – Remove the blue control line from it's fitting (Picture 1)

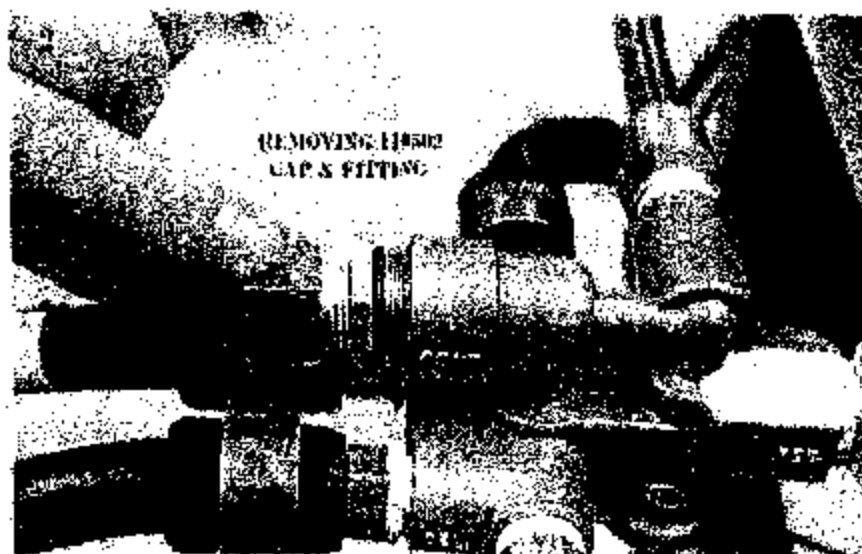
Step 2 – Remove 110502 Brass Cap & fitting from Control Port of valve (Picture 2)

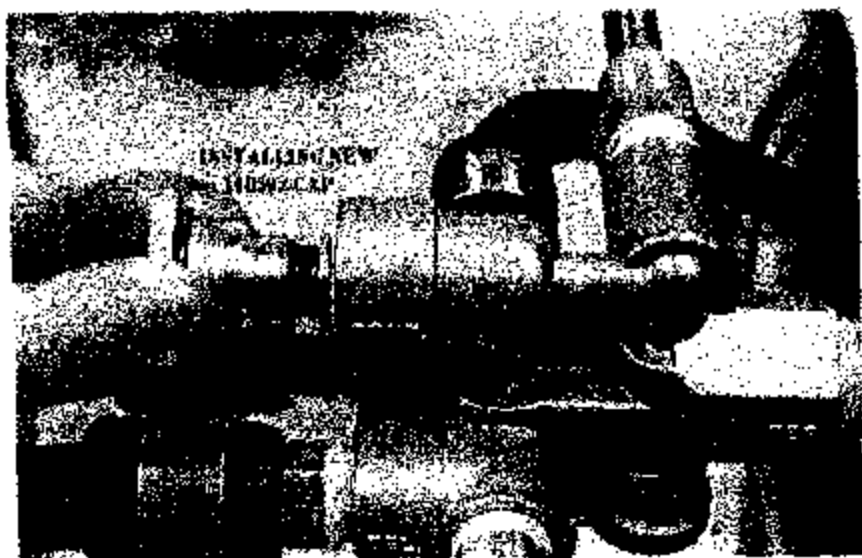
Step 4 – Install new 110502 Brass Cap Assembly with torque of 6-8 ft. lbs. (Picture 3)

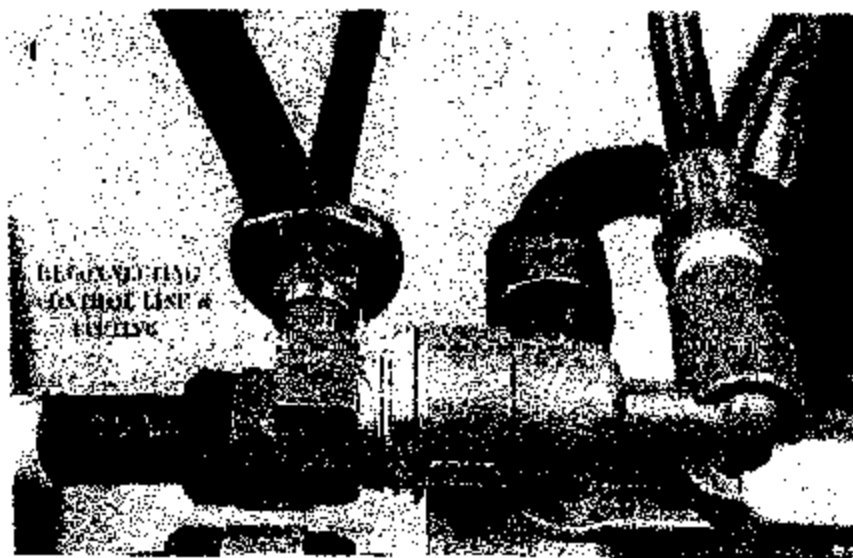
Step 6 – Connect the blue control line back into the fitting (Picture 4)
