**Safety Defect and Noncompliance Report Guide for Vehicles**  
**PART 573 Defect and Noncompliance Report<sup>1</sup>**

04V-277  
(13 pages)

Sutphen Corporation  
7000 Columbus-Marysville Rd  
Amlin OH, 43002

Model(s): All Single and Tandem Axle Chassis

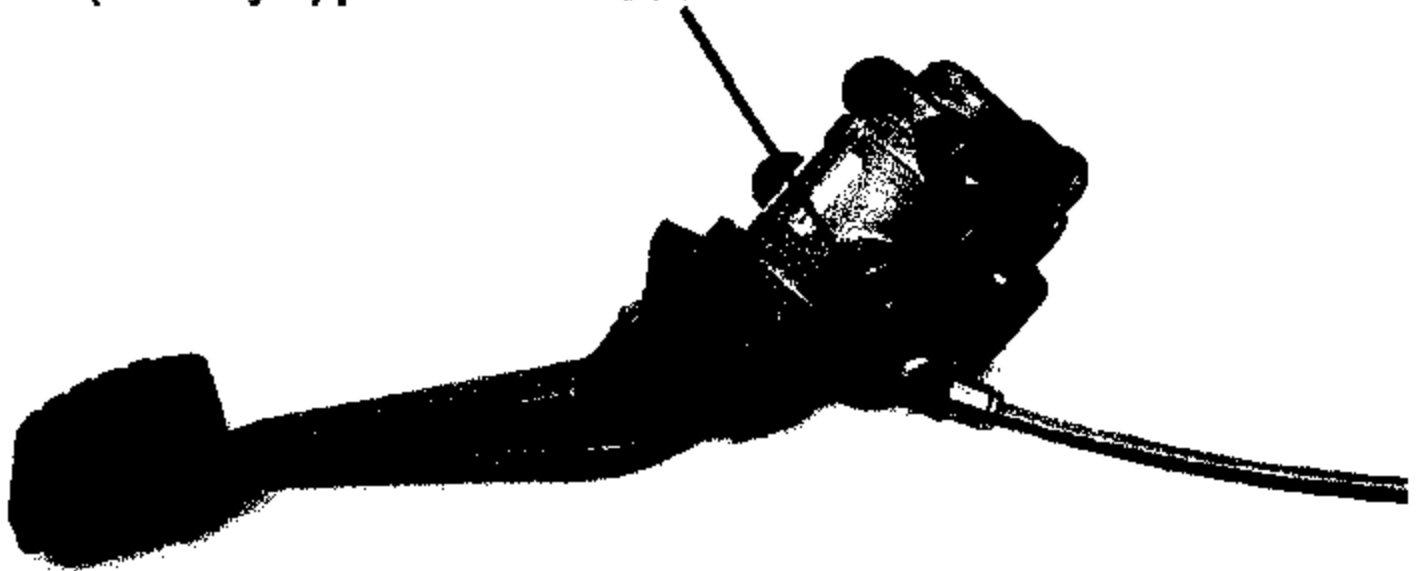
PIC1

**INCORRECT** location of the green control line plumbed into the D-1 (Delivery 1) port on a Tilt Cab.

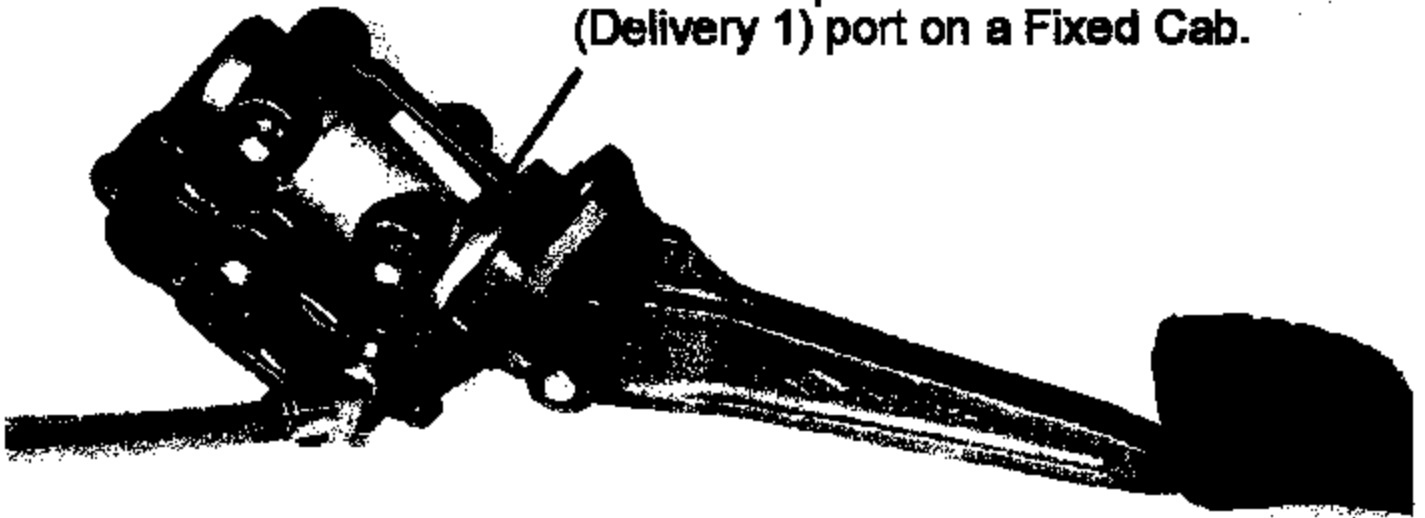
PIC2

**INCORRECT** location of the green control line plumbed into the D-1 (Delivery 1) port on a Fixed Cab.

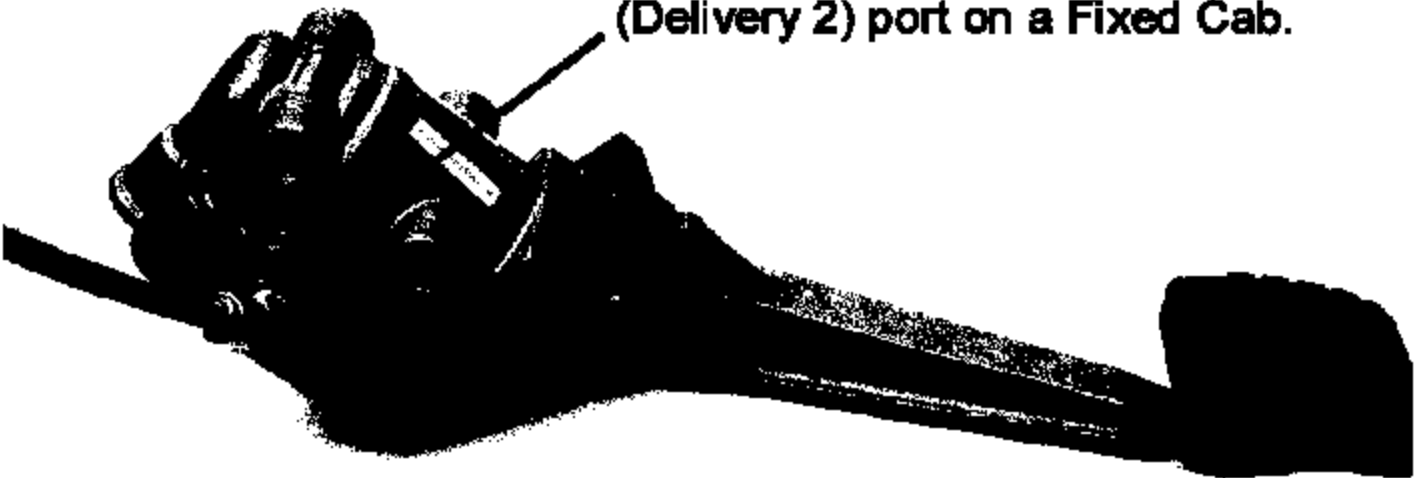
PIC3

**CORRECT** location of the green control line plumbed into the D-2 (Delivery 2) port on a Fixed Cab.

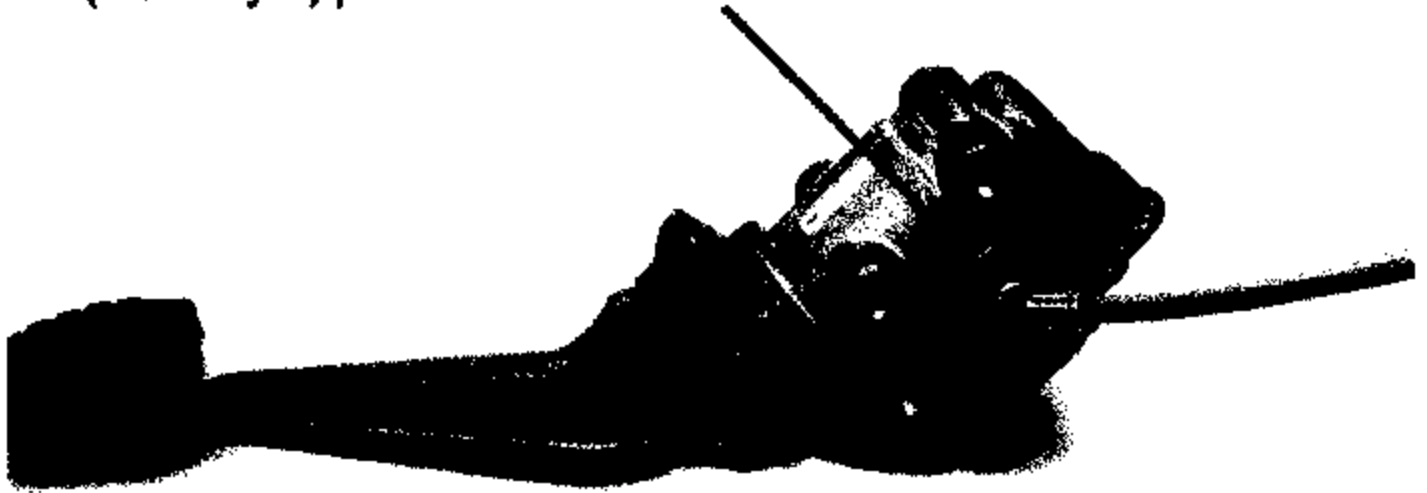
PIC4

**CORRECT** location of the green control line plumbed into the D-2 (Delivery 2) port on a Tilt Cab.

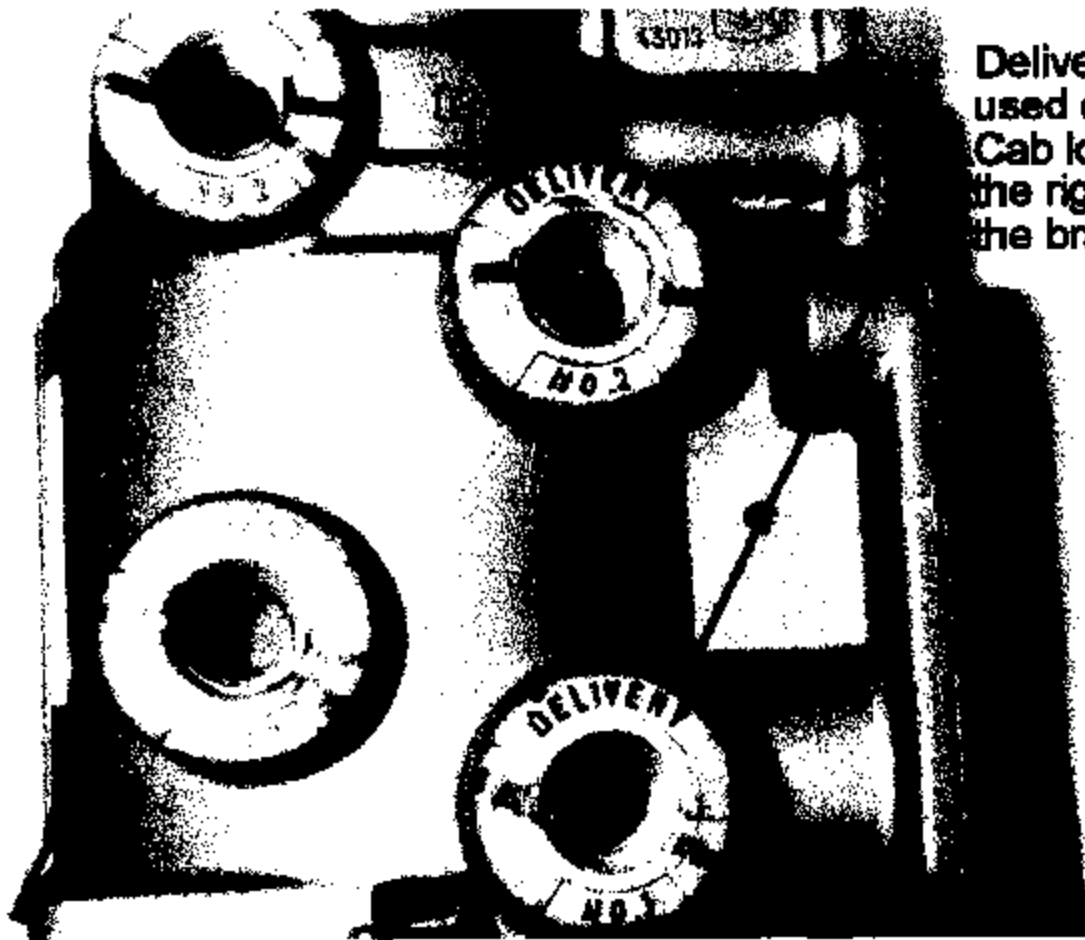
PIC6

Delivery ports  
used on a Tilt  
Cab located on  
the right side of  
the brake valve.

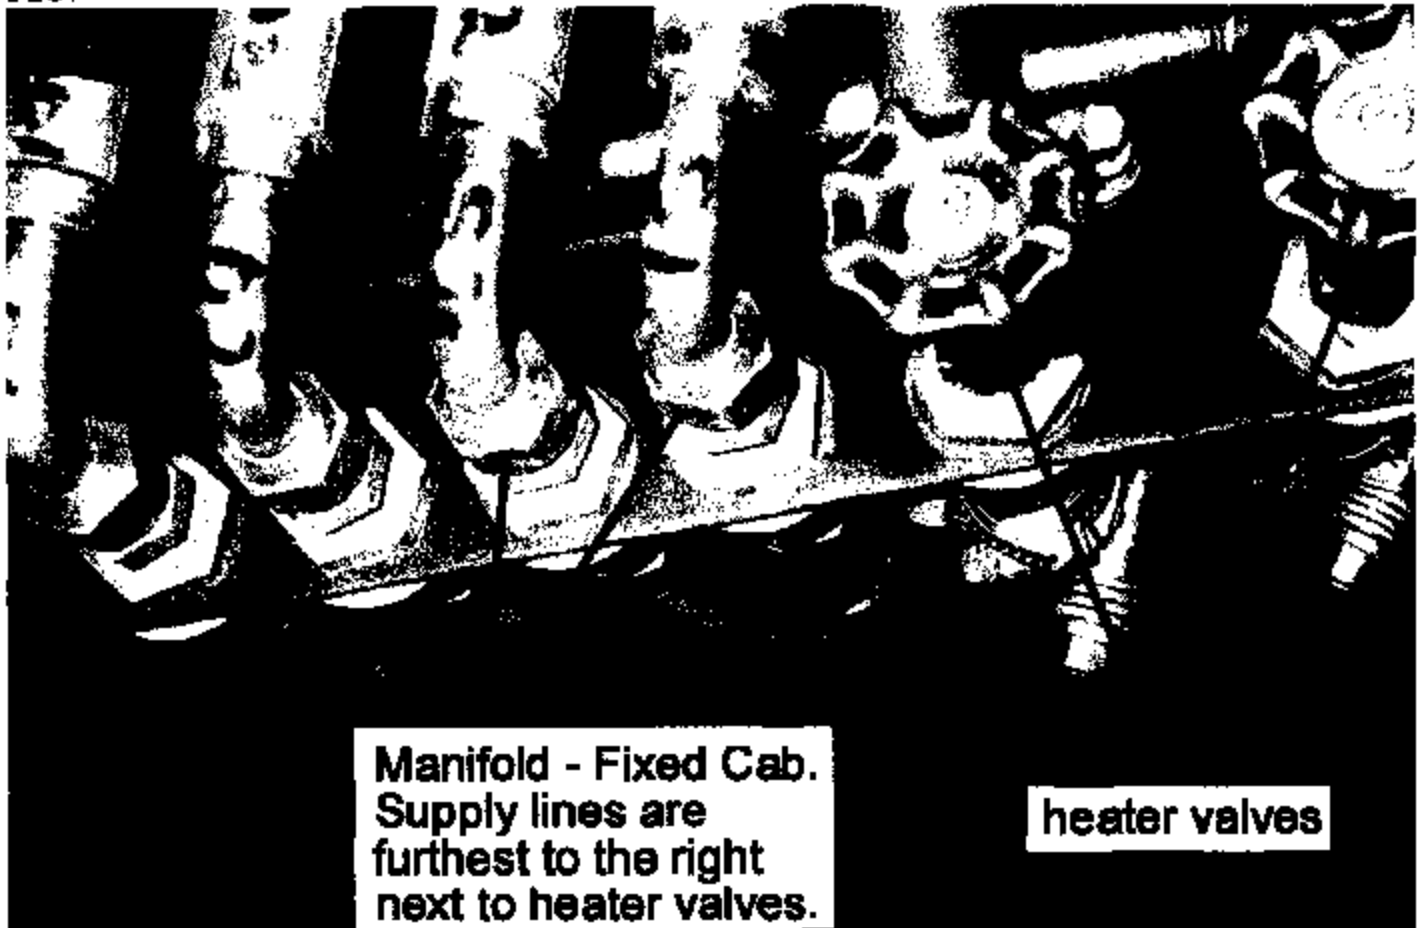
PIC7

Manifold - Fixed Cab.  
Supply lines are  
furthest to the right  
next to heater valves.

1. At the brake manifold at the front of the skid plate located under the front of the truck, locate the two supply lines
2. When facing the manifold, the two supply lines are the ones farthest to the right, next to the frame rails. Exchange the location of these supply lines.  
NOTE: On the newer trucks these lines are color-coded. To prevent someone from switching them back, color-code the lines on the other side of the bulkheads using yellow and blue tape. This is extremely important, because if the lines were to be switched back with the control line in the secondary port of the brake treadle valve, the secondary braking would be disabled.
3. Perform steps 1 through 5 of the following re-test procedure.

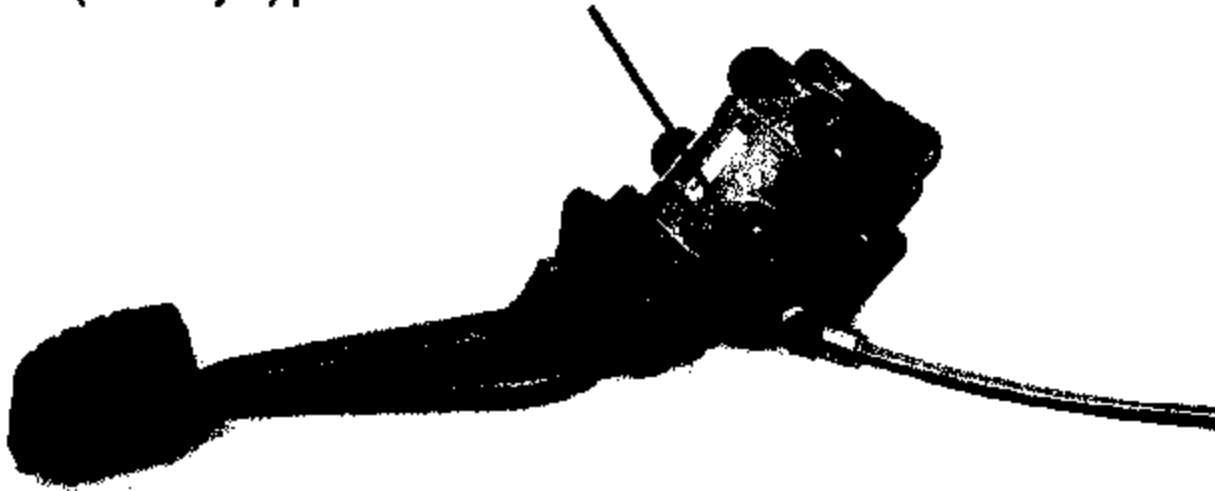
A corrected E-7 Valve control line will be connected to the D2 port whereas a non corrected E-7 would have the control line connected to the D1 port. Reference PIC1 through PIC4 below.

**INCORRECT** location of the green control line plumbed into the D-1 (Delivery 1) port on a Tilt Cab.

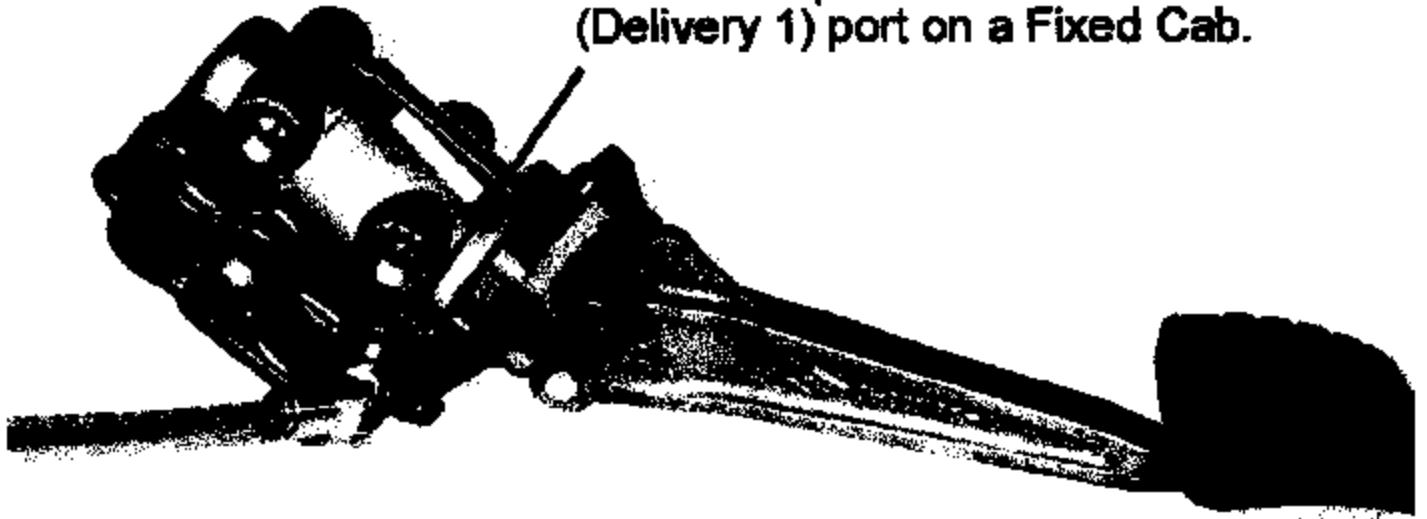
PIC2

**INCORRECT** location of the green control line plumbed into the D-1 (Delivery 1) port on a Fixed Cab.

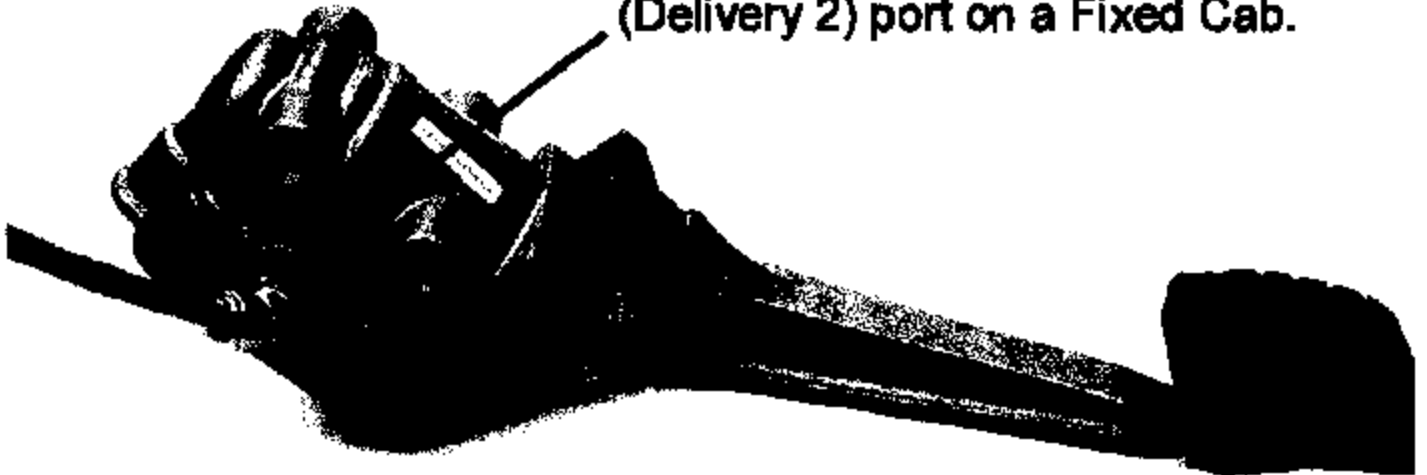
PIC3

**CORRECT** location of the green control line plumbed into the D-2 (Delivery 2) port on a Fixed Cab.

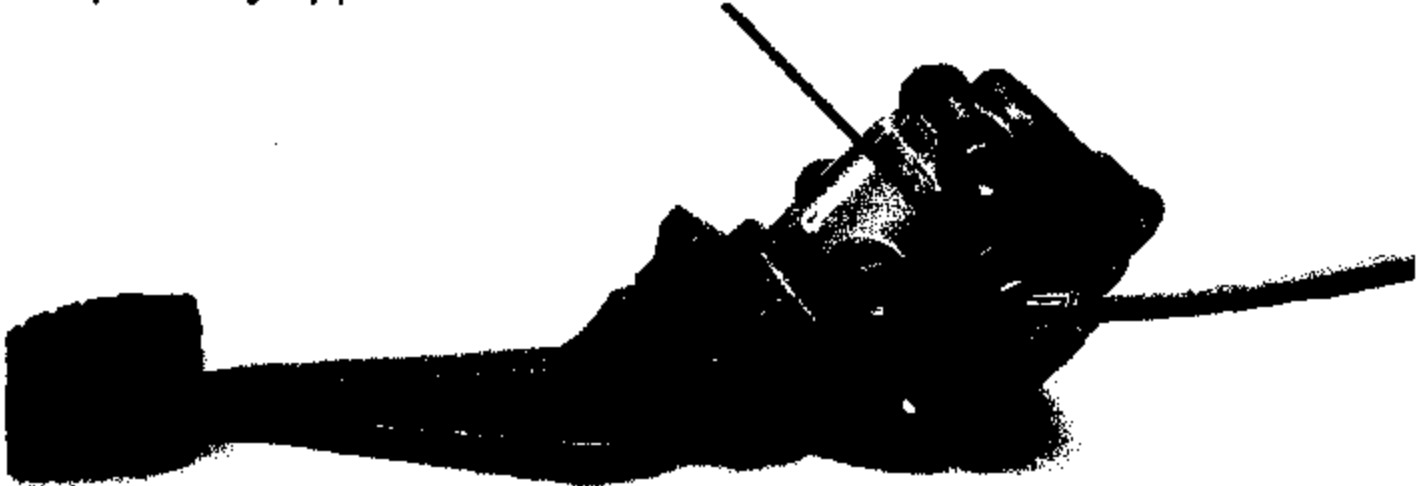
**CORRECT location of the green control line plumbed into the D-2 (Delivery 2) port on a Tilt Cab.**
