04V-287
(10 pages)

Recall Bulletin

SUBJECT: FRONT BRAKE CALIPER BOLT TORQUE

**MODELS: 2004 CHEVROLET IMPALA, MONTE CARLO
 2004 PONTIAC GRAND PRIX**

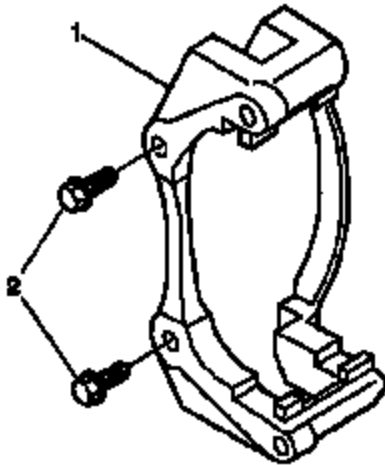
788076

General Motors has decided that a defect, which relates to motor vehicle safety, exists in certain 2004 model year Chevrolet Impala and Monte Carlo, and Pontiac Grand Prix vehicles. Some of these vehicles may have left and right front wheel assemblies in which the two bolts that attach the front brake caliper to the steering knuckle were not tightened adequately. If too much movement occurs between the caliper bracket and knuckle, the bolt(s) may back out or fracture. Depending on whether one or both bolts back out or fracture, the result can be 1) locking of the affected wheel during braking and an abrupt steering input in the direction of the locked wheel, 2) reduced braking and noise from the affected wheel, or 3) severing of a brake hose, increased brake pedal travel, and reduced steering control. If this were to occur, it could result in a vehicle crash without prior warning.

3. Remove the two bolts (2) attaching the left front caliper mounting bracket (1) to the knuckle. Do not remove the bracket and caliper from the knuckle.
4. Using a wire brush, clean any threadlocker from the threads on the two bolts.
5. Apply adhesive (threadlocker), GM P/N 89021297 (Canadian P/N 10953488) or equivalent, to the threads of both bolts.
6. Reinstall the two bolts into the bracket. **Tighten**

Tighten the bolts to 170 N·m (125 ft lb).

7. Repeat the procedure on the right side front caliper mounting bracket bolts.
8. Install both front tire and wheel assemblies. **Tighten**
