June 22, 2004

The following information is submitted pursuant to the requirements of 49 CFR 573.6 as it applies to a determination by General Motors of a safety defect involving certain 2004 Pontiac Grand Prix model vehicles.

SUBJECT: FRONT FRAME REAR BODY MOUNT BRACKET FRACTURE

MODELS: 2004 PONTIAC GRAND PRIX

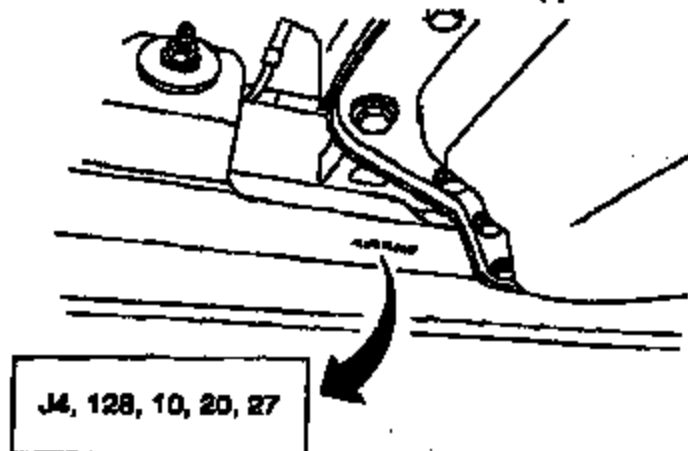
1629588

2. Locate the data code stamped on the frame assembly near the transmission pan as shown. For this inspection we are looking for frames made during a certain timeframe on one particular day this year.

The data codes involved are J4, 128, 10, 20, 27 to J4, 128, 13, 25, 54.

- "DAY" Begin with the Day number. If the "day" number in the date code is not 128, the frame does NOT need to be replaced. If the "day" number is 128, proceed to the next step and inspect the "hour".
- "HOUR" If the "hour" number in the date code is 9 or less, or 14 or higher, the frame does NOT need to be replaced. If the number on the frame is 11 or 12, the frame must be replaced. If the number is 10 or 13, proceed to the next step and inspect the "minute".
- "MINUTE" If the "hour" number is 10 and the "minute" number in the date code is 19 or less, then the frame does NOT need to be replaced. If the "minute" number on the frame is 21 or higher the frame must be replaced. If the "minute" number is 20, then continue and inspect the "second".
