The following information is submitted pursuant to the requirements of 49 CFR 573.6 as it applies to a determination by General Motors of a safety defect involving certain 2004 Chevrolet Classic and Pontiac Grand Am model vehicles.

Recall Bulletin

File In Section: Product Recalls
Bulletin No.: 04068
Date: June 2004

SUBJECT: FUEL TANK WELD

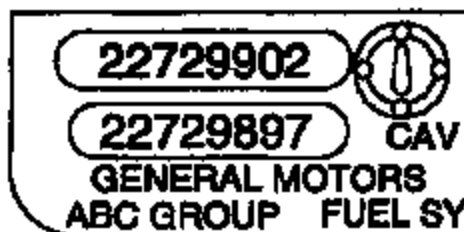
1530064

2. Inspect the bottom side of the fuel tank to determine if the tank requires replacement.
 - o If the fuel tank has the name "ABC GROUP" as shown above, then proceed to the next step and continue the inspection.
 - o If the fuel tank does NOT have the name "ABC GROUP", then the fuel tank does NOT need to be replaced and no further action is required.
3. Lower the vehicle.
4. Open the hood.
5. Remove the cover from the underhood electrical center and remove the fuel pump relay.
6. Start the engine on the remaining fuel system pressure and allow it to run until stall.

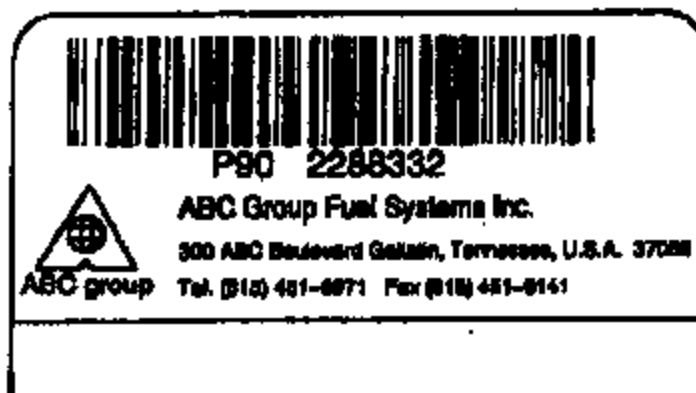
1630081

24. Inspect the label as shown above, located on the top of the fuel tank.
 - o If the bar code number on the label matches one of those listed at the end of this service procedure, then the fuel tank must be replaced. Proceed to the FUEL TANK REPLACEMENT procedure.
 - o If the bar code number on the label does NOT match any of those listed at the end of this service procedure, then the fuel tank does NOT need to be replaced. Proceed to Step 13 in the FUEL TANK REPLACEMENT procedure to reinstall the tank.
