04V-320  
(15 pages)

# Recall Bulletin

**SUBJECT: TRANSMISSION SHIFT CABLE SEPARATION**

**MODELS: 2004 CHEVROLET EXPRESS  
2004 GMC SAVANA**

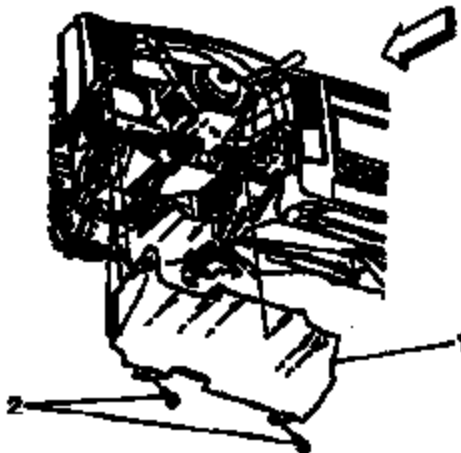
836467

4. Locate the date code (1) printed on the shift cable as shown. The code follows a part number also printed on the cable.
  - o If the cable has a date code that is 4129 through 4139, the cable **MUST** be replaced. Proceed to the section title, "Shift Cable Replacement."
  - o If the cable has a date code before 4129 or after 4139, the cable does **NOT** need to be replaced and no further action is required. Reinstall the carpet and hinge pillar trim panel.

1. Remove the AIR BAG fuse from the fuse block.
