**RE: NOTIFICATION OF DEFECT**

MCI 2001 through 2003 model G4500 motor coaches manufactured at Motor Coach Industries Mexico's Sahagun facility prior to unit 80518.

# Service Bulletin No. 227

MODEL G4100/G4500 Series Coaches	TYPE Field Change Program	SECTION/GROUP 12-Suspension	DATE
SUBJECT <b>RADIUS ROD BRACKETS ON FRONT AXLE LEG ASSEMBLY</b>			
CONDITIONS

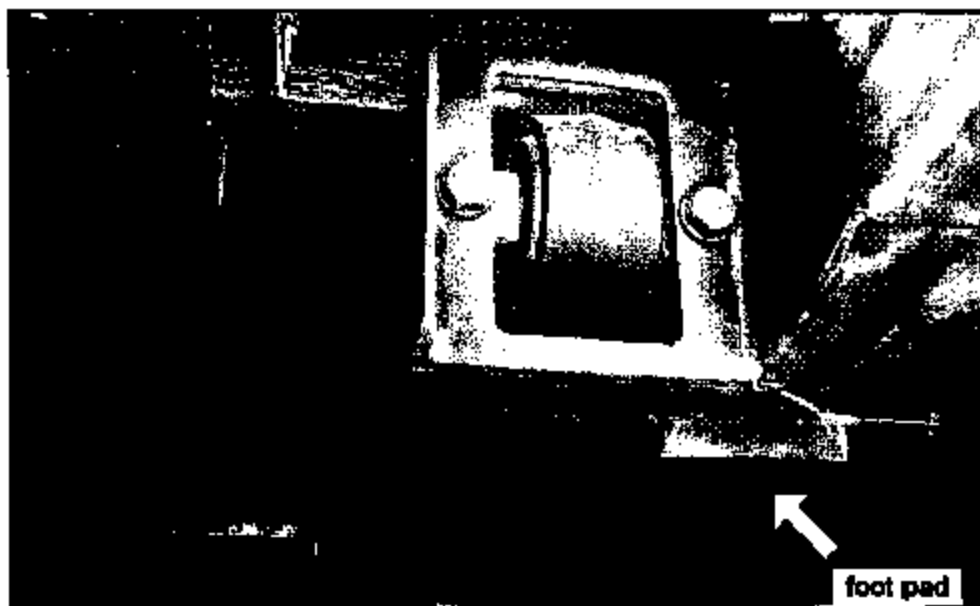
Figure 4. Reference photo only, radius rod removal is required to perform retrofit steps.

- Preheat the foot pad to 400 degrees F ( Figure 4 ). Use a temperature stick to verify that proper preheat temperature has been achieved.

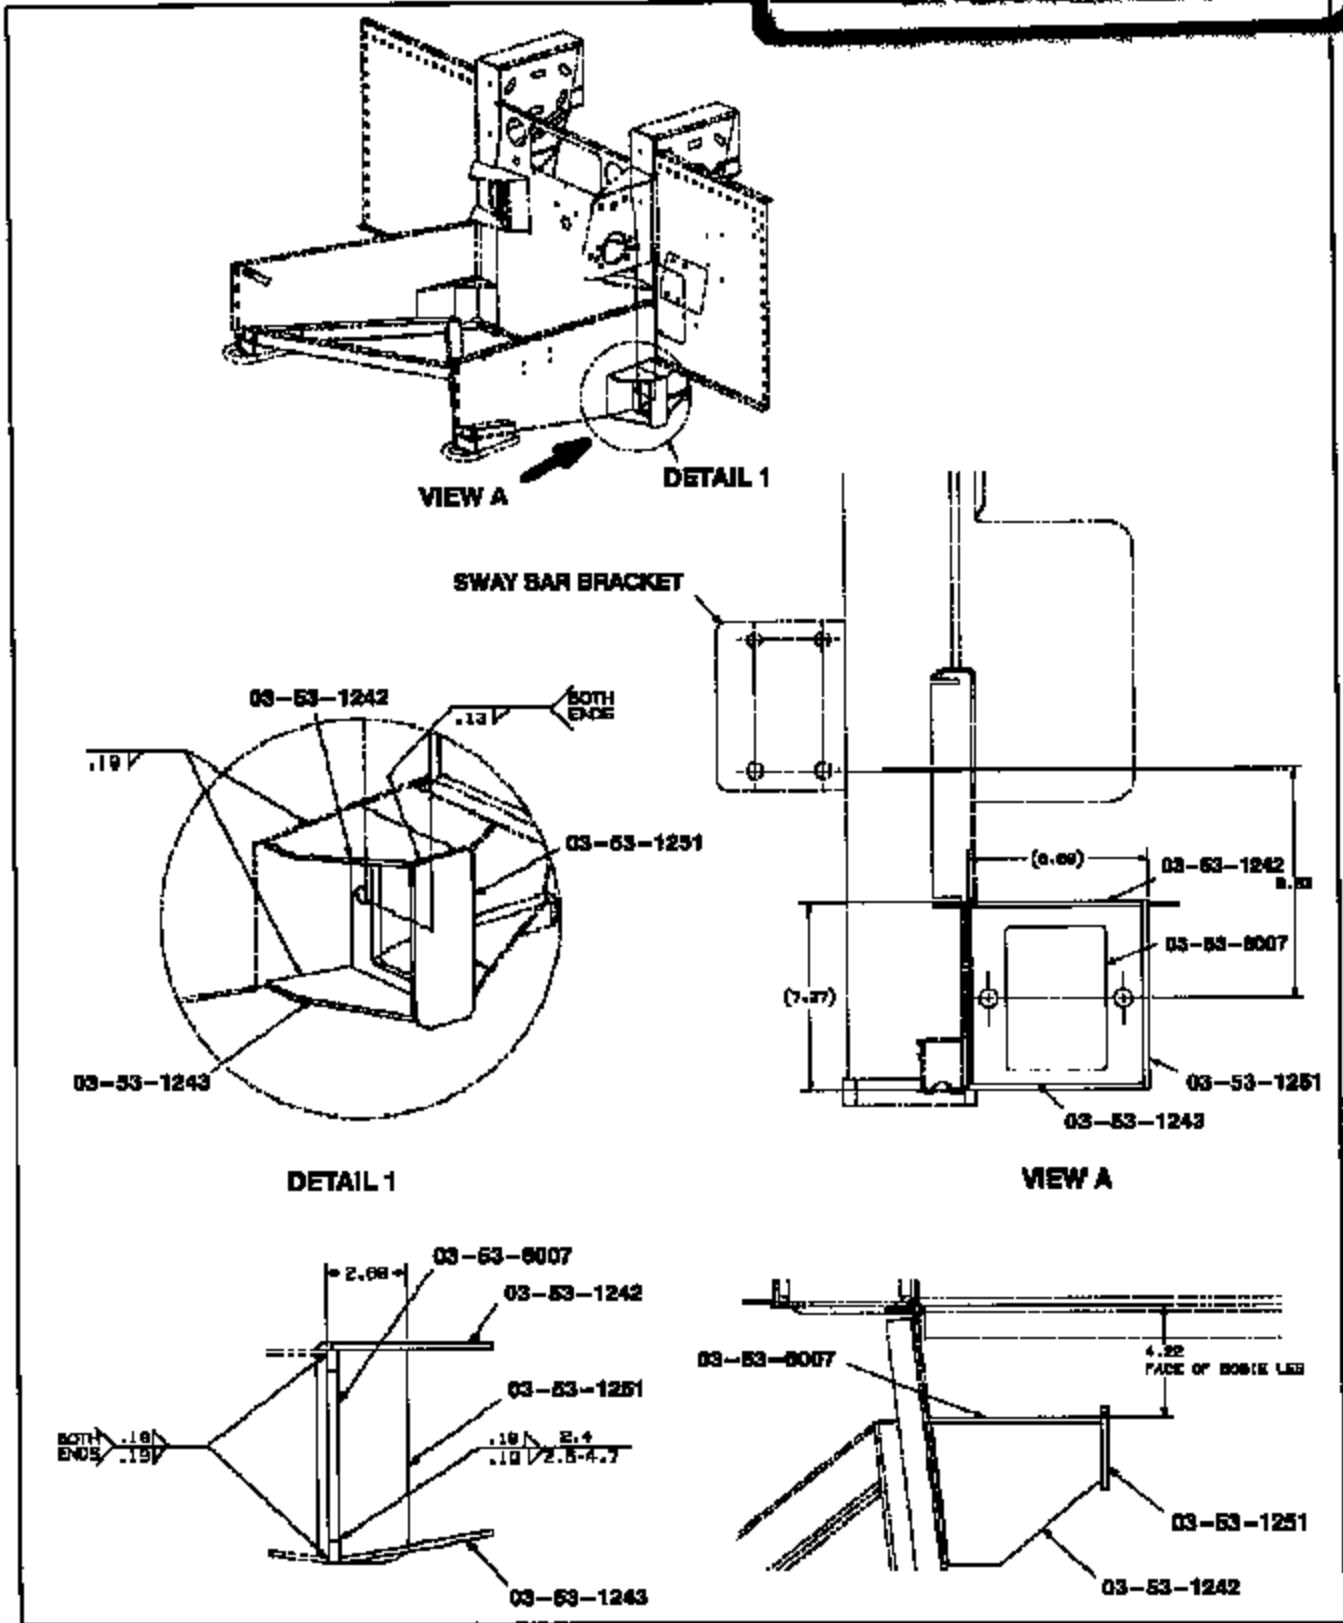
The front lower radius rod mounting bracket components may not have received sufficient weld penetration at time of manufacture. As a result and over time, these welds may begin to crack, allowing movement and potential separation of the radius rod mounting bracket. MCI has been made aware of at least one field failure involving an MCI vehicle experiencing this anomaly.

7. Visually inspect the lower radius rod bracket assembly.
8. If no cracks are present at the radius rod mounting holes and no damage to the assembly has occurred, reweld all joints according to Figure 5. Upon completion of rewelding all joints, proceed to Step 14.

- Tack weld the new support brackets and plates ( part numbers 03-53-1242, 03-53-1249, 03-53-6007 and 03-53-1251 ) into position, according to Figure 5.
- Weld the new bracket assembly to the front leg, using the weld sizes and locations in Figure 5.
