04V-333
(17 pages)

DEFECT INFORMATION REPORT FOR DAIMLERCHRYSLER RECALL D21

Safety Recall B21 **Rear Floorpan Reinforcement Spot Welds**

2005 (LX) Chrysler 300 and Dodge Magnum

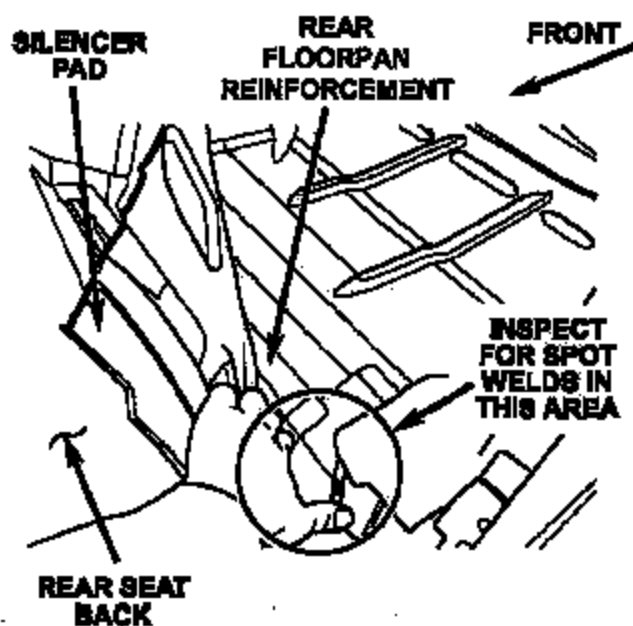
Figure 1

1. Open the trunk.
2. Lift the rear of the trunk floor cover and then pull the floor cover rearward.
3. Open the rear driver side door.
4. Fold the rear seat back forward to expose the cargo/trunk area.
5. Remove the seat back carpet push pin retainer on each side of the vehicle and then pull the carpet back.
6. Pull the floor silencer pad forward to expose the rear floorpan reinforcement (Figure 1).
7. Inspect the floorpan reinforcement for the presence of the two spot welds shown in Figure 2.

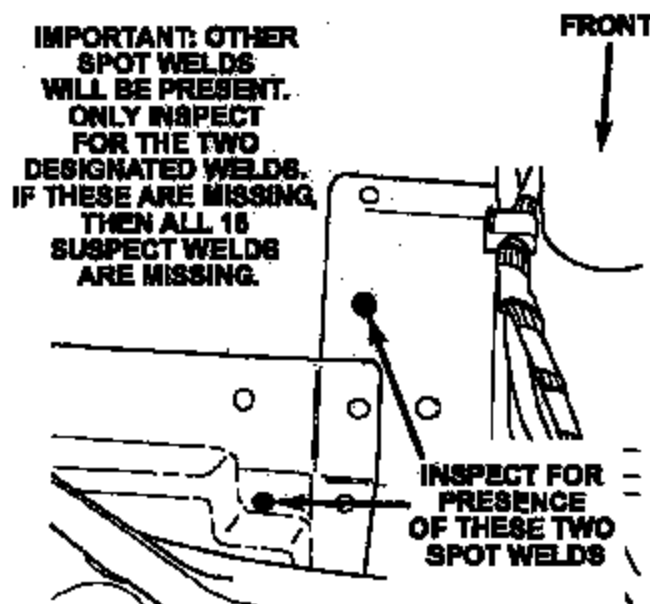
Figure 2 – Driver's Side Shown

Welds that secure a rear floor pan reinforcement bracket to the floor pan may be missing. This may result in reduced structural support for the rear seat belts and rear seat LATCH system lower anchorages during a severe frontal impact.

8.
 - If spot welds are present, no further action is necessary. Continue with Step 9.
 - If spot welds are missing, continue with Section B – Install Structural Rivets.
9. Return the floor silencer pad to its original position.
10. Return the seat back carpet to its original position and install the push pins.
11. Return the seat back to its upright position.
12. Close the door.
13. Return the trunk floor cover to its original position.
14. Close the trunk lid.
15. Return the vehicle to the customer.
