**DEFECT INFORMATION REPORT FOR DAIMLERCHRYSLER RECALL D28**

## **Safety Recall D28**

### **Battery Cable Bulkhead Stud Fasteners**

**2005 (LX) Chrysler 300 and Dodge Magnum**

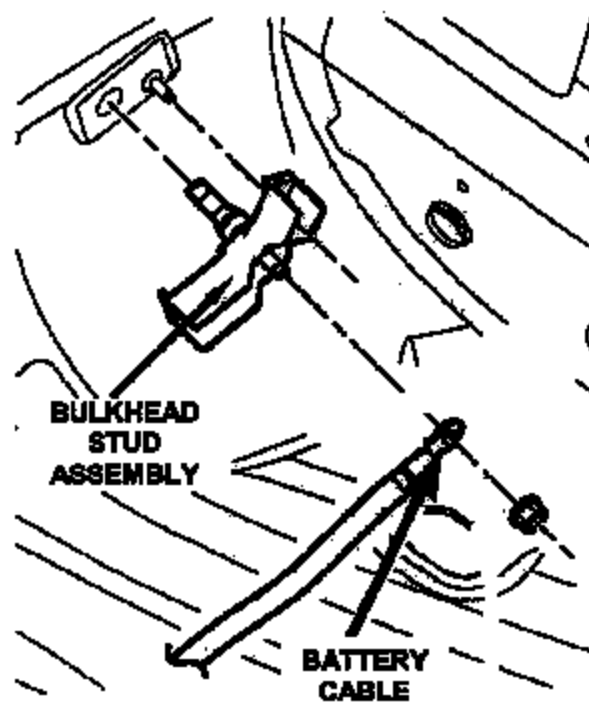
Figure 2

9. Inspect the battery cable bulkhead stud for signs of arcing and/or cross-threading (Figure 2). If the bulkhead stud is damaged, continue with **Section B – Replace Battery Cable Bulkhead Stud.**

10. Tighten the battery cable-to-bulkhead stud fastener to 80 in-lbs (9 N·m) (Figure 2).
11. Return the kick-up panel silencer pad to its original position.
12. Install the carpet and padding and install the carpet push pin.
13. Install the front door sill trim/kick panel (Figure 1).
14. Install the passenger side floor mat.
15. Close the front passenger door.
16. Raise the vehicle on an appropriate hoist.
17. Remove the six (6) passenger side underbody splash shield push pins (Figure 3).
18. Remove the underbody splash shield (Figure 3).
19. Inspect the battery cable bulkhead stud for signs of arcing and/or cross-threading (Figure 4). If the bulkhead stud is damaged, continue with **Section B – Replace Battery Cable Bulkhead Stud**.

6. Remove the retaining nut for the bulkhead stud assembly and then remove and discard the bulkhead stud assembly (Figure 2).
7. Install a new bulkhead stud assembly (P/N 05059113AC).

8. Install the bulkhead stud assembly retaining nut (Figure 2), tighten the nut to 80 in-lbs (9 N·m).
9. Install the battery cable onto the bulkhead stud (Figure 2). Install a new battery cable nut (P/N 06101809) and tighten to 80 in-lbs (9 N·m).
