**DEFECT INFORMATION REPORT FOR DAIMLERCHRYSLER RECALL D30**

## **Safety Recall D30**

# **Shoulder Belt Adjuster Turning Loop Bolts**

2005 (LX) Chrysler 300 and Dodge Magnum

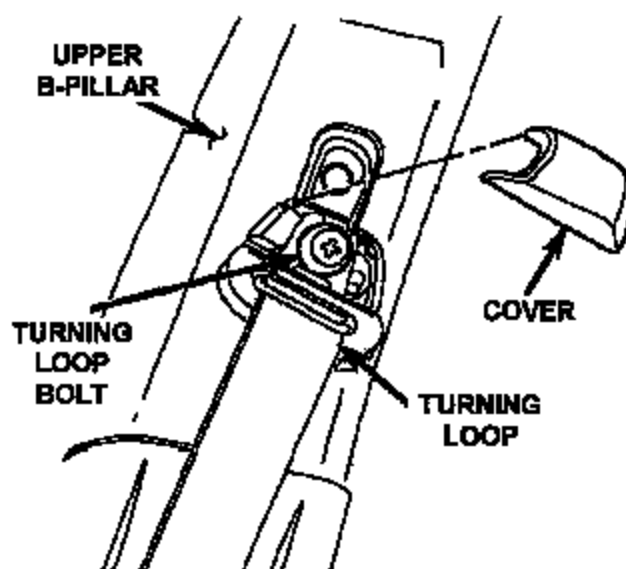
Figure 1 – Passenger Side Shown

The front shoulder belt adjuster turning loop bolts on about 12,000 of the above vehicles may not have been properly tightened. This could cause shoulder belt separation in certain crash conditions, which can increase the risk of injury to front seat occupants.

1. Using a trim stick placed between the turning loop cover and the release button, pry the top of the driver's side turning loop bolt cover open and then remove the cover (Figure 1).
2. Tighten the turning loop bolt to 30 ft-lbs (40 N·m).
3. Install the turning loop bolt cover by aligning catches on the bottom of the cover with the turning loop bracket and then snapping the cover over the top of the bracket. Ensure that the cover is fully installed.

**NOTE:** There should be no gap between the turning loop cover and the turning loop. Pinch the turning loop and cover with your finger and thumb to fully seat the cover.

**NOTE:** If the turning loop cover was damaged during removal, replace it with a new cover (P/N 5HF07BD1AC).
