DEFECT INFORMATION REPORT FOR DAIMLERCHRYSLER RECALL D34

Safety Recall B34 – Valve Cover Stud

2004 (DR) Dodge Ram Pick-up Trucks

SAFETY RECALL – VALVE COVER STUD

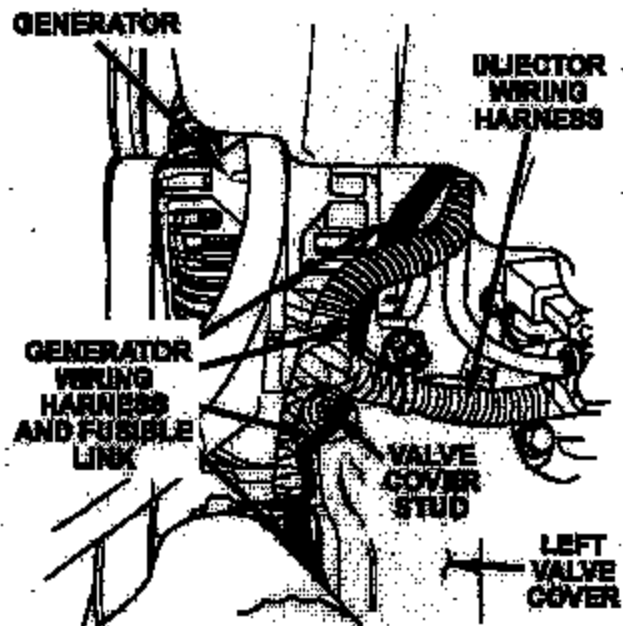
Figure 1

The alternator wiring harness may short circuit due to contact with a valve cover stud. A short circuit in the alternator harness could result in an under hood fire.

1. Open the hood.
2. Inspect the generator wiring harness/fusible link where it passes the valve cover stud located on the front left corner of the engine (Figure 1). If the wiring insulation is damaged from contact with the stud, wrap it with high quality electrical tape.
3. Install the stand off portion of the provided tie strap over the stud on the left front corner of the valve cover (Figure 2).
4. Pull the generator wiring harness forward and position it above the injector wiring harness. Secure the generator harness/fusible link to the injector harness with the provided tie strap (Figure 2).
