SUBJECT: SAFETY RECALL NOTIFICATION

**SAFETY
RECALL**

Sr04-13

DATE : SEPTEMBER 2004	SECTION : 16
SUBJECT : INSPECTION OF RADIUS ROD SUPPORT PINS

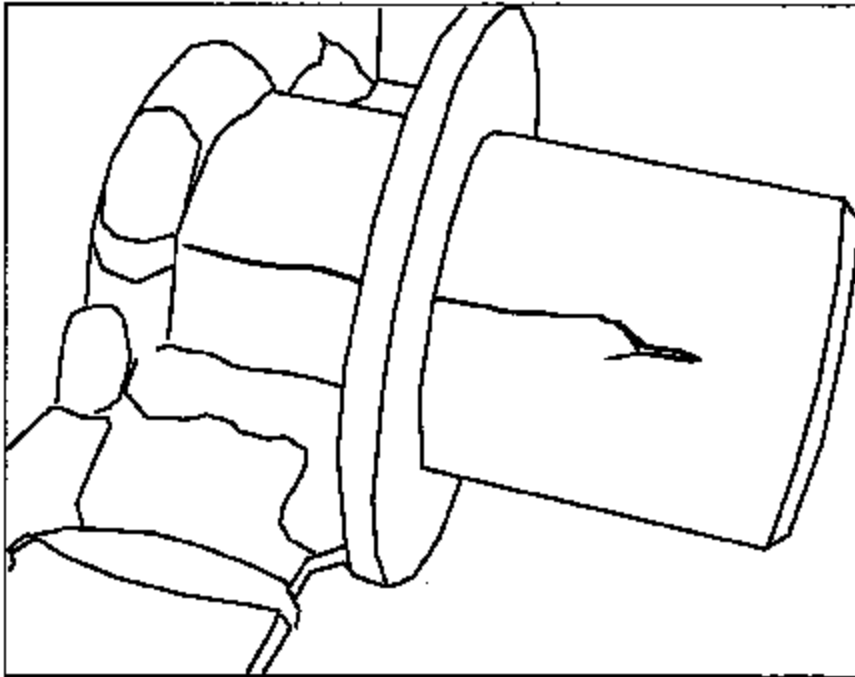
1. Dismount each radius rod by flattening the tabs of locking plate and by unscrewing the two bolts directly fastened into radius rod pivot (if needed, refer to maintenance manual). Thoroughly clean the parts contact surfaces by removing all trace of grease or rust preventive product.
2. Check support pin surface for cracks (Refer to example in figure 1).

FIGURE 1: EXAMPLE OF CRACK

3. If a defective support pin is detected, it must be replaced (Refer to figures 2, 3 and 4).
