04V-437  
(4 pages)

**Subject: Safety Recall Notification on Cab Hook Indicator Lamp Malfunction; Model Years:**  
1986-2004;  
**Models: FK415, FK417, FK455, FK457, FK617, FM555, FM557, FM617, FM657**

# Defect and Noncompliance Information Report

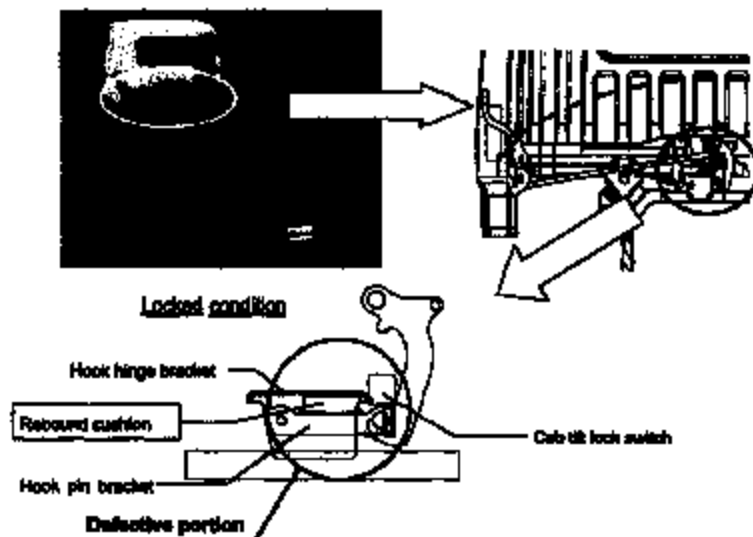
On affected vehicles, the rebound cushion may stick to the hook hinge bracket, due to improper rubber composition of the cushion. This condition could result in the hook pin bracket remaining in the up (cab closed) position when the cab latch is unlocked. With the hook pin bracket in the up position, the cab tilt lock switch remains closed, improperly indicating that the cab latch is locked. In the worst case, if the cab latch is unlocked for any reason, the instrument panel cab lock indicator will not notify the driver that the cab tilt lock mechanism is in the unlocked position.

After deliberate study of failed sample parts, MFTBC determined that the cause of failure was improper composition of the rubber material used to manufacture the rebound cushion. This may cause the cushion to stick to the hook hinge bracket, resulting in the cab tilt lock switch remaining closed.

Replace the rebound cushion with a modified component. Adjust the cable tilt lock switch and bottom bracket at the rear cab mount. MFTA will initiate a safety recall campaign to correct all potentially affected vehicles by replacement of the part and adjustments mentioned above.
