MITSUBISHI FUSO
TRUCK OF AMERICA, Inc.

04V-477
(4 pages)

Subject: Safety Recall Notification on the Front Hub Bearing; Model Years: 2000-2005;
Models: FM617, FM657, FM61F, FM64F, FM65F

Defect and Noncompliance Information Report

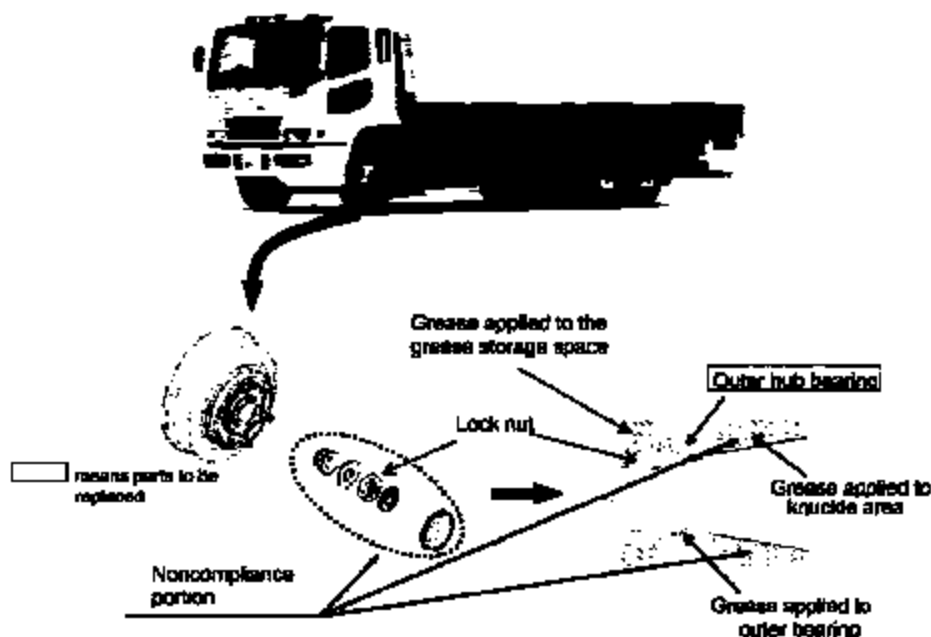
On affected vehicles using an F060T or F070T front axle, the front wheel hub outer bearing lock nut may have been improperly tightened during initial assembly, and an insufficient amount of grease may have been applied to the outer bearing. These conditions could result in the outer bearing generating excessive heat and/or breaking, causing the vehicle to become disabled. In the worst case, the excessive heat could cause a fire.

After deliberate study of failed sample parts, MFTBC determined that the cause of failure was improper tightening of the front wheel hub outer bearing lock nut during initial assembly, and an insufficient amount of grease application to the outer bearing. These conditions could result in the outer bearing generating excessive heat and/or breaking, causing the vehicle to become disabled. In the worst case, the excessive heat could cause a fire.

Remove the front wheel hub. Inspect the inner and outer front wheel hub bearings. Replace any bearing with signs of damage. Reuse any bearing that has no signs of damage. Properly lubricate the front hub and properly torque the front wheel hub outer bearing lock nut upon reassembly.
