MITSUBISHI FUSO
TRUCK OF AMERICA, Inc.

*04V-478
(4 pages)*

**Subject: Safety Recall Notification on the Front Hub Bearing; Model Years: 2003-2005;
Models: FH210, FH211, FK617, FK61F**

Defect and Noncompliance Information Report

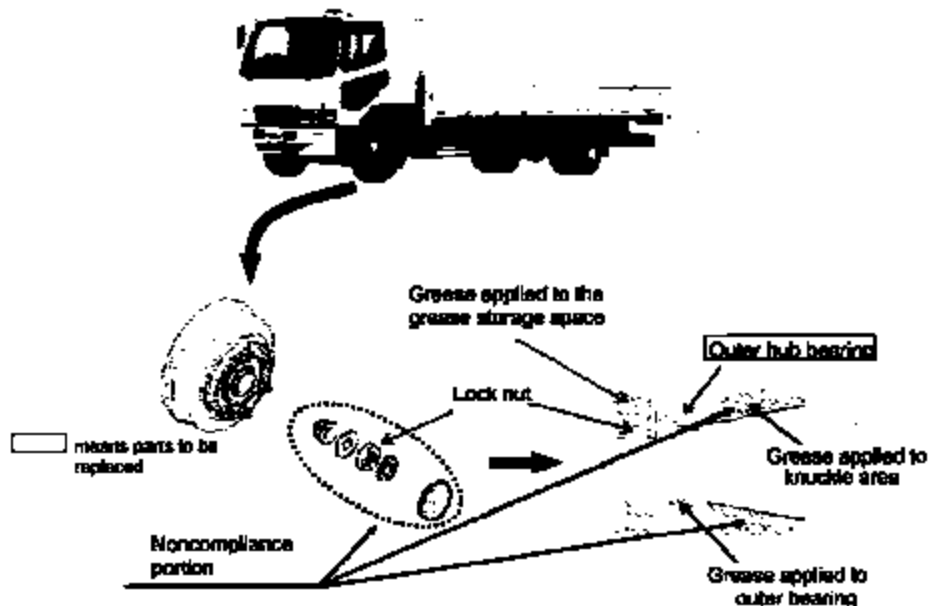
On affected vehicles using an F040T front axle, the front wheel hub outer bearing lock nut may have been improperly tightened during initial assembly, and an insufficient amount of grease may have been applied to the outer bearing. These conditions could result in the outer bearing generating excessive heat and/or breaking, causing the vehicle to become disabled. In the worst case, the excessive heat could cause a fire.

After deliberate study of failed sample parts, MFTBC determined that the cause of failure was improper tightening of the front wheel hub outer bearing lock nut during initial assembly, and an insufficient amount of grease application to the outer bearing. These conditions could result in the outer bearing generating excessive heat and/or breaking, causing the vehicle to become disabled. In the worst case, the excessive heat could cause a fire.

Remove the front wheel hub. Inspect the inner and outer front wheel hub bearings. Replace any bearing with signs of damage. Reuse any bearing that has no signs of damage. Properly lubricate the front hub and wheel bearings. Properly torque the front wheel hub outer bearing lock nut upon reassembly.
