# HONDA

04V-564  
(4 pages)

**Identification of potentially affected vehicles:**

**Defect description:**

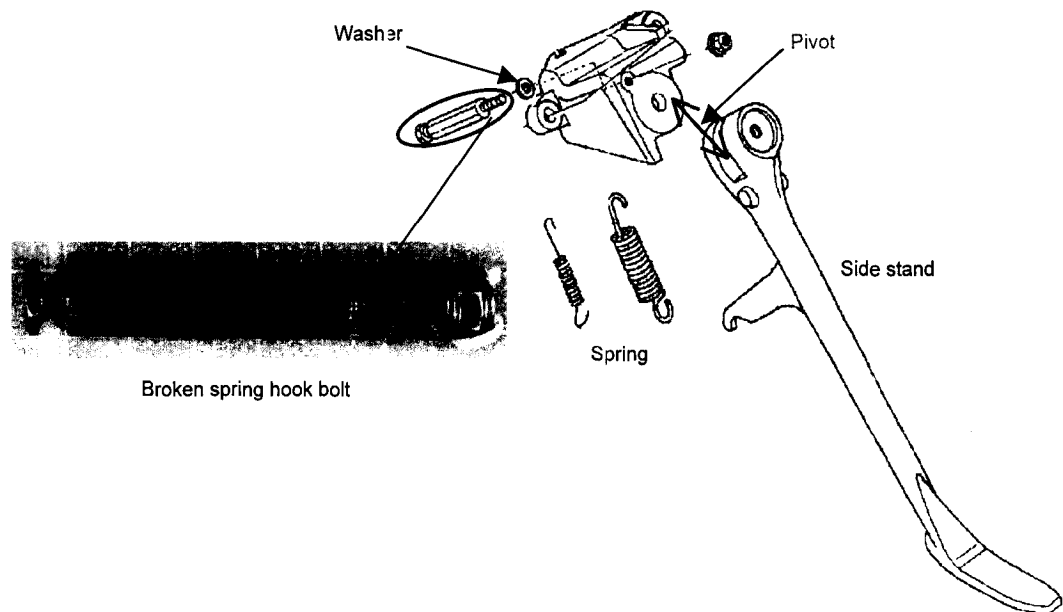
The washer for the side stand spring bolt does not have sufficient hardness and may deform, which could cause the bolt to flex and eventually break during side stand operation. In limited circumstances, a retracted side stand could drop while riding, possibly activating the side stand ignition cut-off system. If the ignition is cut, the engine will stall without warning, which could cause a crash.

The side stand is held in the down or the retracted position with a spring and spring hook bolt. The washer installed on the spring hook bolt does not have sufficient hardness and may deform, which could lead to flexing of the bolt. Stresses from side stand operation could eventually cause the bolt to break during side stand operation and, generally, the side stand will no longer remain in a retracted position, which is obvious to the operator. However, if the side stand pivot is corroded, the corrosion may prevent the side stand from falling back down after being retracted. In this case, riding on rough roads could cause a retracted side stand to drop while riding. These motorcycle side stands are equipped with an ignition cut-off system. If the side stand drops while riding, there is a possibility the engine could stall without warning and cause a crash.

The owners of all affected vehicles will be notified by mail and asked to take their vehicle to an authorized Honda dealer. The dealer will install an improved washer and a new spring bolt and nut, free of charge.
