**MITSUBISHI FUSO**  
TRUCK OF AMERICA, Inc.

04V-570  
(5 pages)

**Subject: Safety Recall Notification on the Fuel Injection Pipe Clamps;  
Model Years: 2001-2004; Models: FE640, FH210  
MFTA Safety Recall – R3125410 Fuel Injection Pipe Clamps**

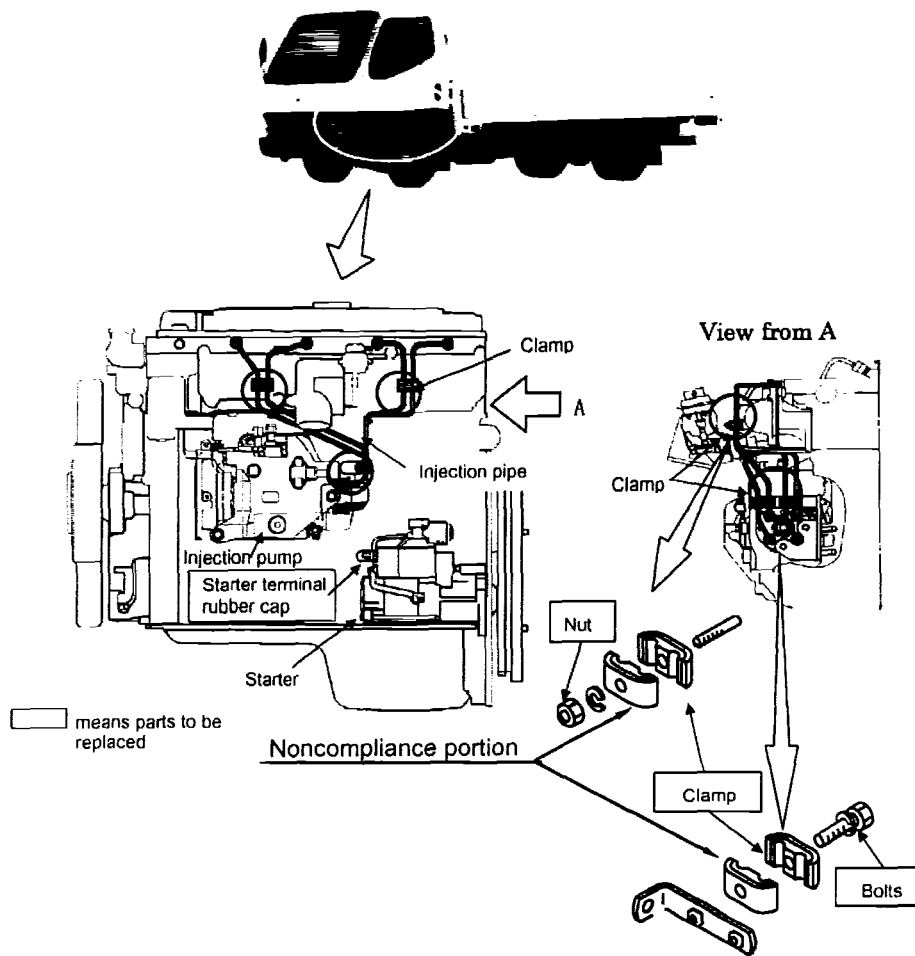
On affected vehicles, the rubber portion of the fuel injection pipe clamps could deteriorate. Normal vehicle operation could cause the deteriorated clamp to loosen and drop. If this condition occurs in the area of the fuel injection pump, the engine starter could short circuit if the clamp drops onto the starter terminal. This could prevent the engine from starting. In the worst case, excessive heat from the short circuit could cause a fire.

After deliberate study of failed sample parts, MFTBC determined that the cause of failure was deterioration of the rubber portion of the fuel injection pipe clamps. These conditions could result in the engine starter short circuiting if the clamp drops onto the starter terminal, preventing the engine from starting. In the worst case, excessive heat from the short circuit could cause a fire.

Remove each clamp and inspect for rubber deterioration. Replace the clamp if the rubber deterioration is evident. Replace the attaching hardware and apply adhesive to prevent the bolts/nuts from loosening. Inspect for a rubber cap on the starter motor S terminal and install a cap if one is not present, to prevent a short circuit. Install a new label cautioning against dropping clamps/bolts during future fuel injection pump and/or fuel line repair work.
