04V-609  
(13 pages)

**SUBJECT: Campaign #93 – Workhorse™ Fuel Line**

## INSTRUCTIONS TO PERFORM CAMPAIGN #93

### Inspection of Fuel Line on 20,700 lb. GVWR or greater Workhorse Chassis

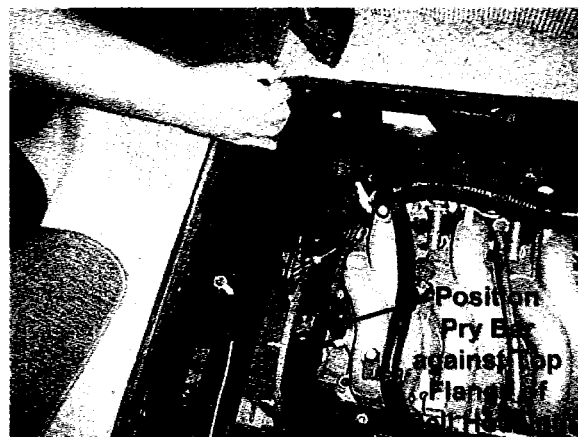
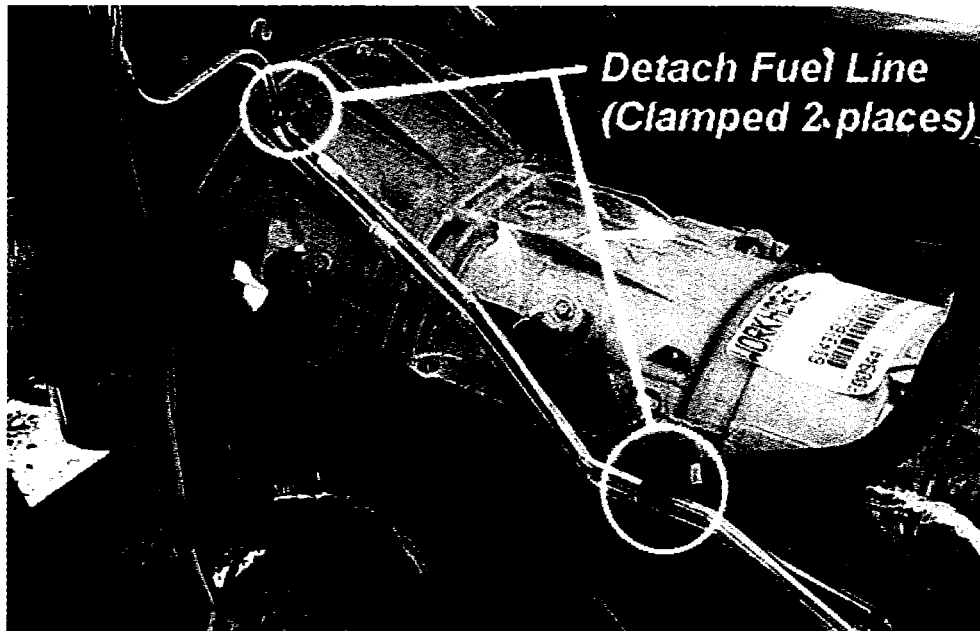
#### Step 2 – Pry Wiring Support Channel Away From Fuel Line

Photo shows top view of transmission on bare chassis for clarity of locations

- If the channel is closer than  $\frac{1}{2}$ " from the fuel line, place a pry bar against the top flange of the transmission bell housing and pry the channel away from the fuel line as shown in the photos to provide  $\frac{1}{2}$ " minimum clearance.
