UPDATE -- Safety Recall C45 - Floor Shifter Ignition/Park Interlock

Involved Vehicles: 1993-1997 (LH) Chrysler Concorde, LHS and
300M; Dodge Intrepid and Eagle Vision

Safety Recall C45 **Floor Shifter Ignition/Park Interlock**

This revision corrects the Load Limiting Push Rod part number application for 1993 – 1997 LH vehicles equipped with a Cobra shifter handle.

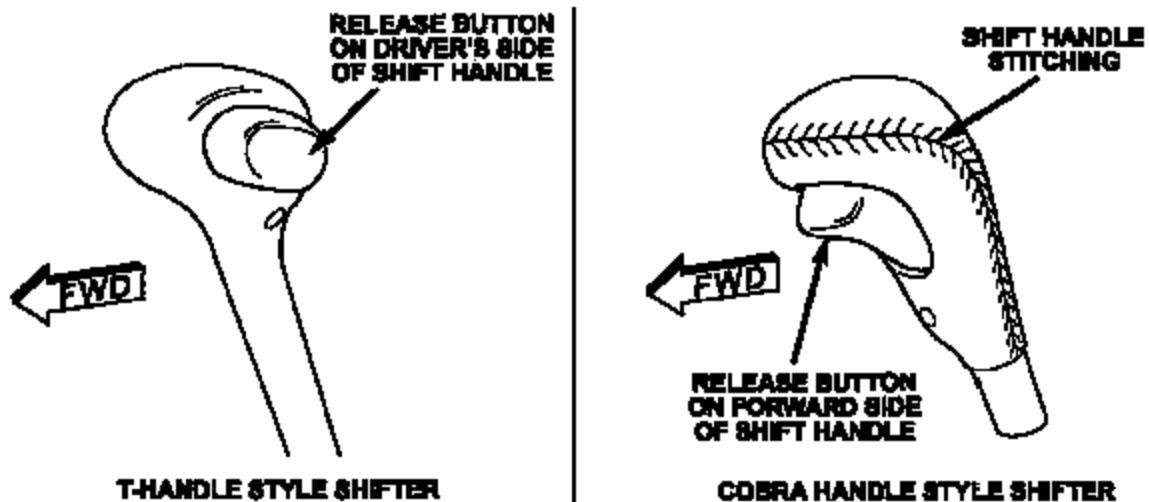
Figure 1

1,2,3	1996 - 1999 1993 - 1997	JA/JX LH	Cobra Handle	CBWSC451	Load Limiting Push Rod (Long Rod)	1
4,5	1998 - 1999	LH	Cobra Handle	CBWSC452	Load Limiting Push Rod (Short Rod)	2
6	1995 - 1997 1993 - 1997	JA LH	T-Handle	CBXTC453	Load Limiting Push Rod (Ball End)	3

. 1993 through 1997 LH vehicles EQUIPPED WITH A COBRA SHIFTER HANDLE require the long load limiting push rod, P/N CBWSC451 (NOT CBWSC452 as shown on Page 3).

. 1993 through 1997 LH vehicles EQUIPPED WITH A T-HANDLE SHIFTER require the short load limiting push rod, P/N CBXTC453 (as shown on Page 3).

. 1998 and 1999 LH vehicles EQUIPPED WITH A COBRA SHIFTER HANDLE require load limiting push rod with the ball end, P/N CBWSC452 (as shown on Page 3).

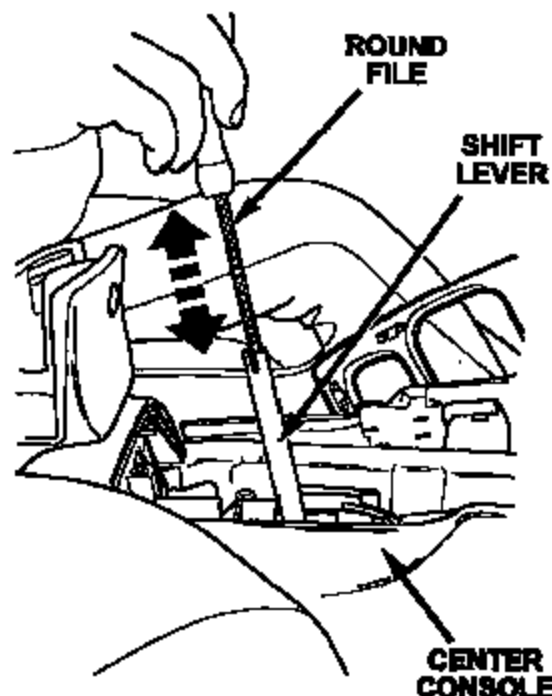
Figure 5

CAUTION: Failure to remove all metal burrs from inside the shift lever may make installation of the new push rod extremely difficult.

13. Verify that the new load limiting push rod and the original push rod are the same length.
14. Discard the old push rod and preload spring.
15. For vehicles that had the dimple drilled out, use a small round file to remove any remaining metal burrs from the inside of the shift lever at the hole drilled in Step 9 (Figure 5).
