Subject: 2001 to Early 2004 Model Year Toyota Highlander Child Protection Lock System

SUBJECT: **ADVANCED NOTIFICATION** – SPECIAL SERVICE CAMPAIGN (SSC) – 40B  
(2001 TO EARLY 2004 MODEL YEAR TOYOTA HIGHLANDER CHILD PROTECTION  
LOCK SYSTEM)

**TECHNICAL INSTRUCTIONS**  
**FOR**  
**SPECIAL SERVICE CAMPAIGN 40B**  
**2001 - 2004 MY TOYOTA HIGHLANDER**  
**CHILD PROTECTION LOCK SYSTEM**

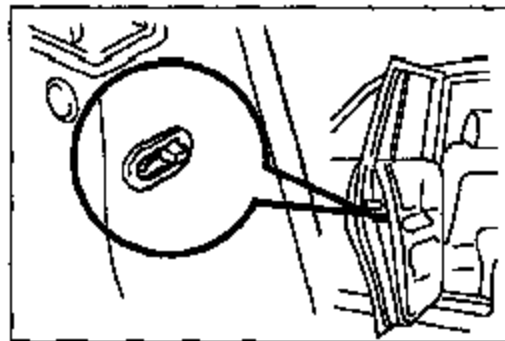
- The 2001 to early 2004 Model Year Highlander vehicles have a CPL system in both of the rear side doors. When an operator of the vehicle closes the door very hard with the CPL lever being in the lock position, there is a possibility that the lock lever may contact the body panel, causing the CPL lever to move into the unlock position. This condition could allow the door to be opened with the inside door handle while the operator believes that the CPL was activated.
