**Re: 49 CFR Part 573; Recall of Mercedes-Benz S and CL-Class**

### Voluntary Recall Campaign MY 2000 - 2001 S and CL-Class Blower Motor Fuse Holder

Campaign No. 2004070010

SUBJECT: **MODELS 215/220**  
**MODEL YEARS 2000 THROUGH 2001**  
**INSTALLATION OF BLOWER MOTOR WIRING HARNESS**

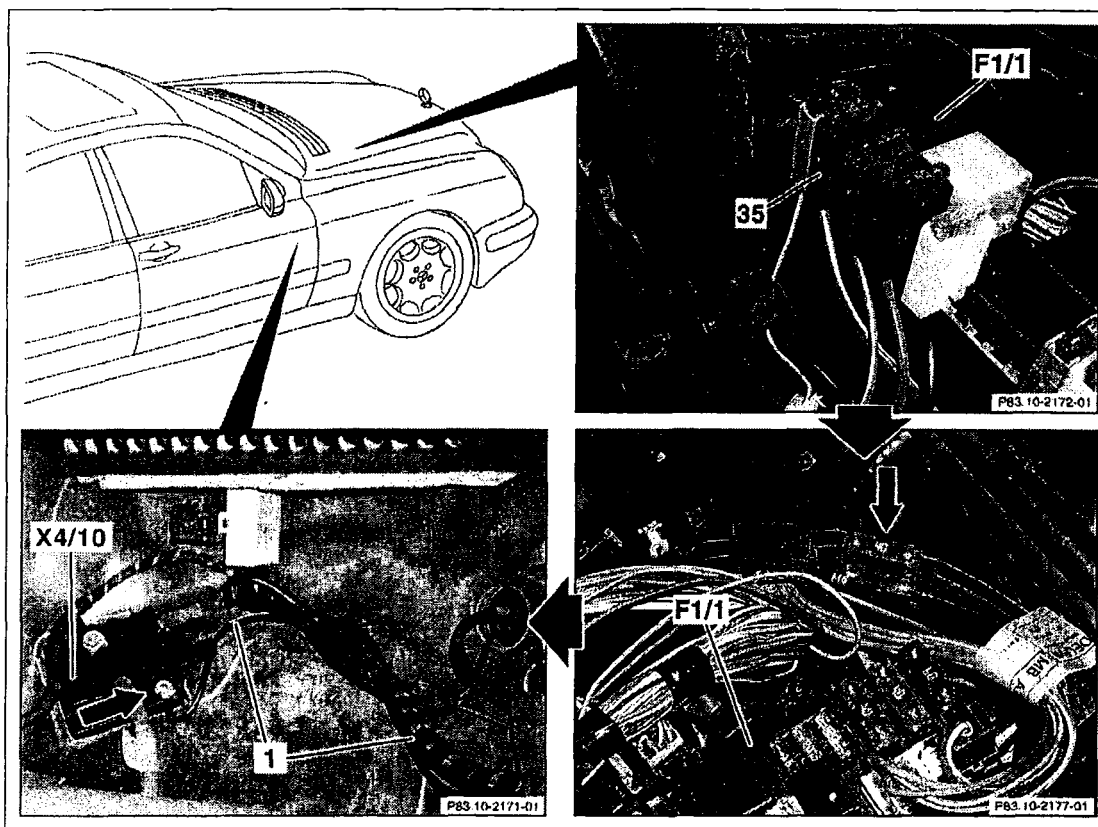
Figure 1

X4/10 Terminal block and fuse box, terminal 30  
 F1/1 Right fuse box
