Re: 49 CFR Part 573; Recall of Mercedes-Benz S and CL-Class

Campaign No. 2004070010, October 2004
Revised November 2005

SUBJECT: **MODELS 215/220, MODEL YEARS 2000 THROUGH 2001
INSTALLATION OF BLOWER MOTOR WIRING HARNESS**

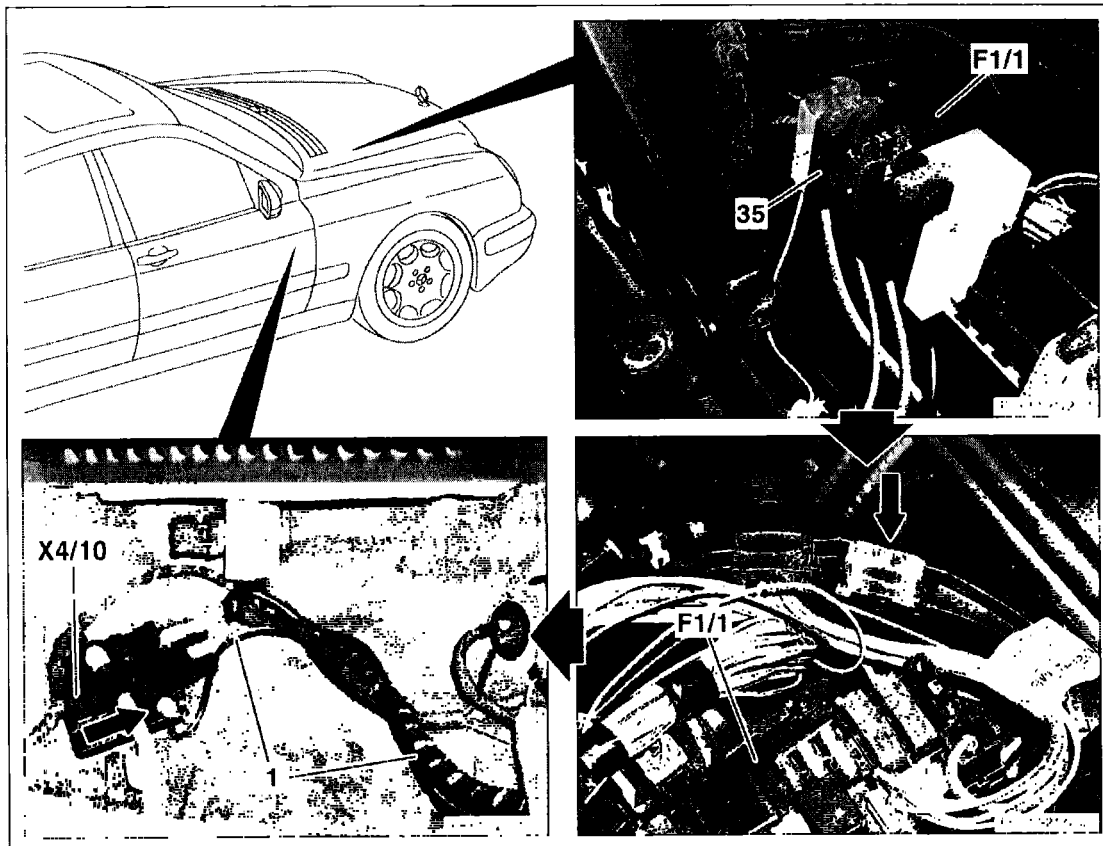
**Figure 1**

X4/10 Terminal block and fuse box, terminal 30
 F1/1 Right fuse box
