**Triumph Motorcycles Notice : Service Bulletin 325 - Updated status to Recall****Notice Information**

**Please Post****TO:** All Triumph America Dealers**ATTN:** Service Manager / Technicians**SUBJECT:** Safety Recall – Starter Motor / Oil Cooler Pipe – Service Bulletin 325

**Bonneville America and Speedmaster  
Affected VIN range 139158 - 176552**

**Subject** ..... Starter Motor Cable/Oil Cooler Pipe

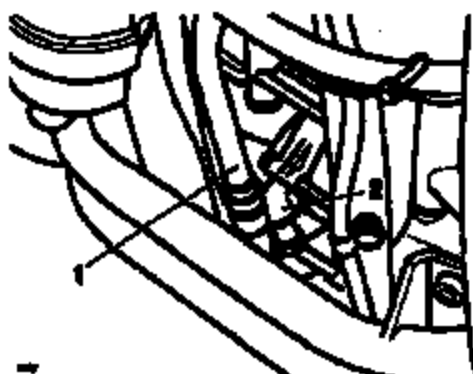
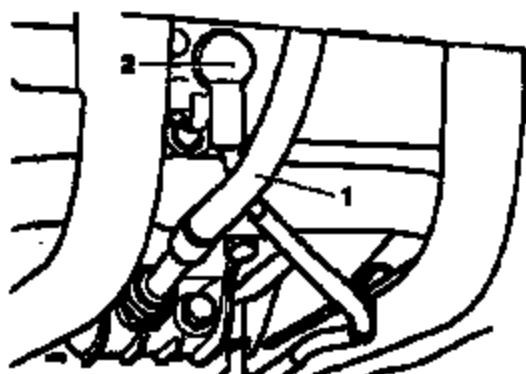
1. Examine the power supply cable to the starter motor for signs of contact with the oil cooler return pipe. If contact is apparent, or if the space between the two items is less than 10 mm, the starter cable and/or oil cooler pipe must be repositioned and any insulation damage rectified.

1. Oil cooler return pipe
2. Starter motor power supply cable

2. If the gap is found to be at least 10 mm, no further action is necessary. If the gap is less than 10 mm, make adjustments as follows:
