July 1, 2004
Ref. No.: 04V-274

RE: Part 573.6(c)(9) – Subaru Legacy Sedan & Outback Sedan Side Curtain Airbag Recall
WWR-02

We have assigned campaign code WWR-02 to the Side Curtain Airbag Recall.

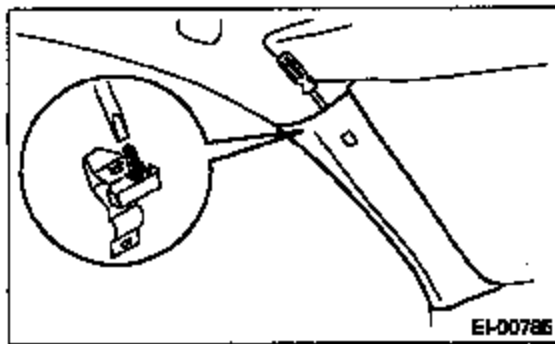
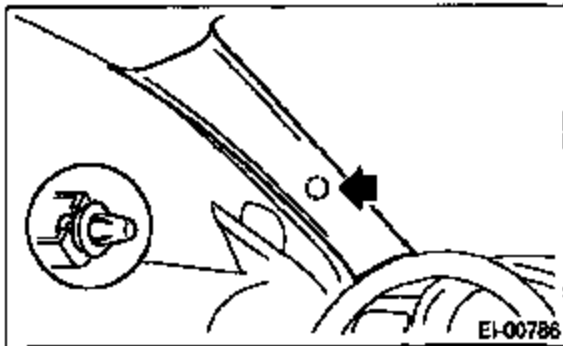
4. Remove the A-Pillar upper trim covers. Start by pushing the metal tab with a flat blade screwdriver or similar tool to release the top portion. Next, gently pull on the trim to disengage the lower clip.

Note: If the metal clip is damaged during removal, the A-Pillar trim must be replaced.

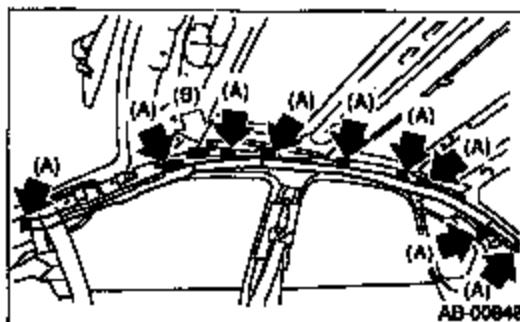
20. Remove both Side Curtain Air Bags -- (9 bolts each side – Sunroof Model); (8 bolts each side – Non Sunroof Model). Remove the bolts (A) and clip (B), and then remove the Side Curtain Air Bag module.

- Start with the front end of the Side Curtain Air Bag and move towards the rear.
- Be careful not to disturb the routing of the Sun Roof Drain tubes (if equipped).
- Be careful when removing bolts, that the metal brackets which are part of the Side Curtain Air Bag Assembly do not damage seat covers or other interior

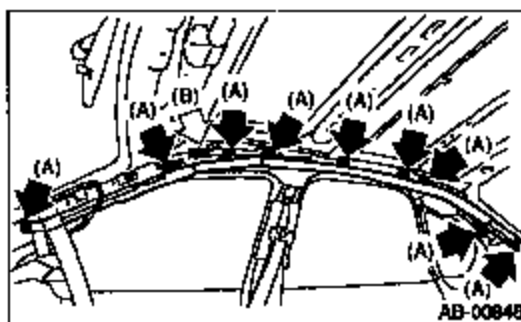
20. Remove both Side Curtain Air Bags – (9 bolts each side – Sunroof Model); (8 bolts each side – Non Sunroof Model). Remove the bolts (A) and clip (B), and then remove the Side Curtain Air Bag module.

- Start with the front end of the Side Curtain Air Bag and move towards the rear.
- Be careful not to disturb the routing of the Sun Roof Drain tubes (if equipped).
- Be careful when removing bolts, that the metal brackets which are part of the

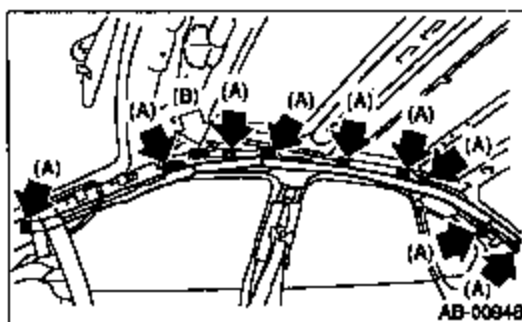
20. Remove both Side Curtain Air Bags – (9 bolts each side – Sunroof Model); (8 bolts each side – Non Sunroof Model). Remove the bolts (A) and clip (B), and then remove the Side Curtain Air Bag module.

- Start with the front end of the Side Curtain Air Bag and move towards the rear.
- Be careful not to disturb the routing of the Sun Roof Drain tubes (if equipped).
- Be careful when removing bolts, that the metal brackets which are part of the
