**Re: 49 CFR Part 573; Recall of Mercedes-Benz E and SL-Class**

**Subject: Voluntary Recall Campaign MY 2003 – 2005 E and 2003 – 2004 SL-Class  
Sensotronic Brake Control (SBC) System. Additional Technical and Parts  
Information**

**Re: STAR Diagnosis Compact II – SBC Recall – COM  
Port 1 Disabled**

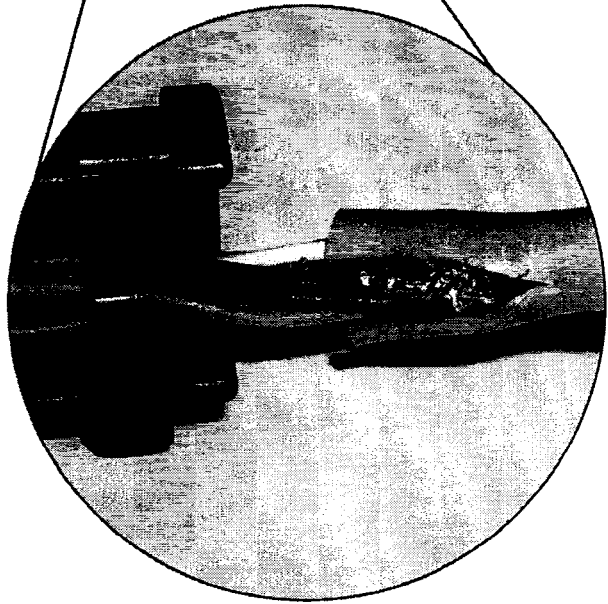
Inspect the SBC module box, and verify that either the red or green LEDs are illuminated. If they are not illuminated, please inspect the SBC module box wiring harness for a damaged wire (review attached image). If damaged, repair the module box. Review the attached document "SBC Module Box Harness. jpg."
