**SUBJECT:** Safety Recall 04S17 – Supplement #2: Revised Claiming Instructions and Parts Ordering Update

**REF:** Safety Recall 04S17: All 1999 through 2001 Model Year Taurus & Sable Vehicles Installation of Front Coil Spring Protective Shields for Vehicles Operated in Corrosion States

## 1999 – 2001 MODEL YEAR TAURUS AND SABLE VEHICLES — FRONT COIL SPRING PROTECTIVE SHIELD INSTALLATION

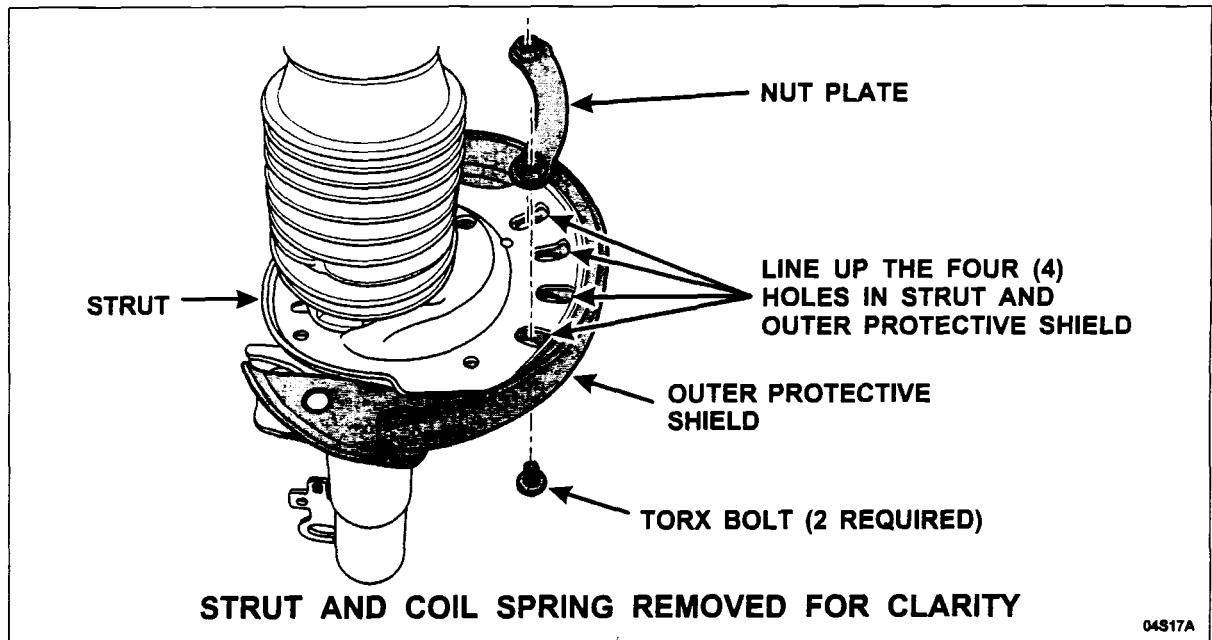
FIGURE 1

3. Position the outer protective shield over the strut assembly. Place the nut plate above the strut, line up the holes in the strut and the outer protective shield, and install the Torx bolts from below. **DO NOT** tighten the bolts to specification at this time. See Figure 1.

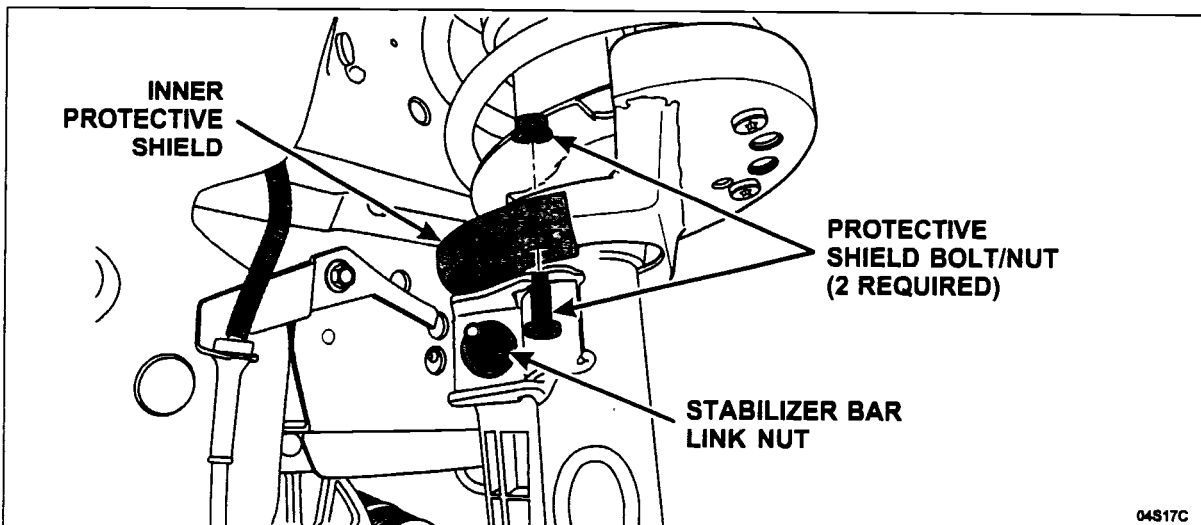
FIGURE 3

4. NOTE: When installing the stabilizer bar link nut, use the hex holding feature to keep the stabilizer bar link ball joint from turning.
  - a) Position the inner protective shield lower mounting tab behind the stabilizer bar link mounting bracket.
  - b) Before installing the stabilizer bar link, place the supplied washer over the stabilizer bar link stud. See Figure 2.
  - c) Reposition the stabilizer bar link and install *new* retainer nut. DO NOT tighten the nut at this time. See Figure 3.
5. Install the two (2) bolts and the two (2) nuts securing the inner and outer protective shields together. DO NOT tighten the nuts to specification at this time. See Figure 3.

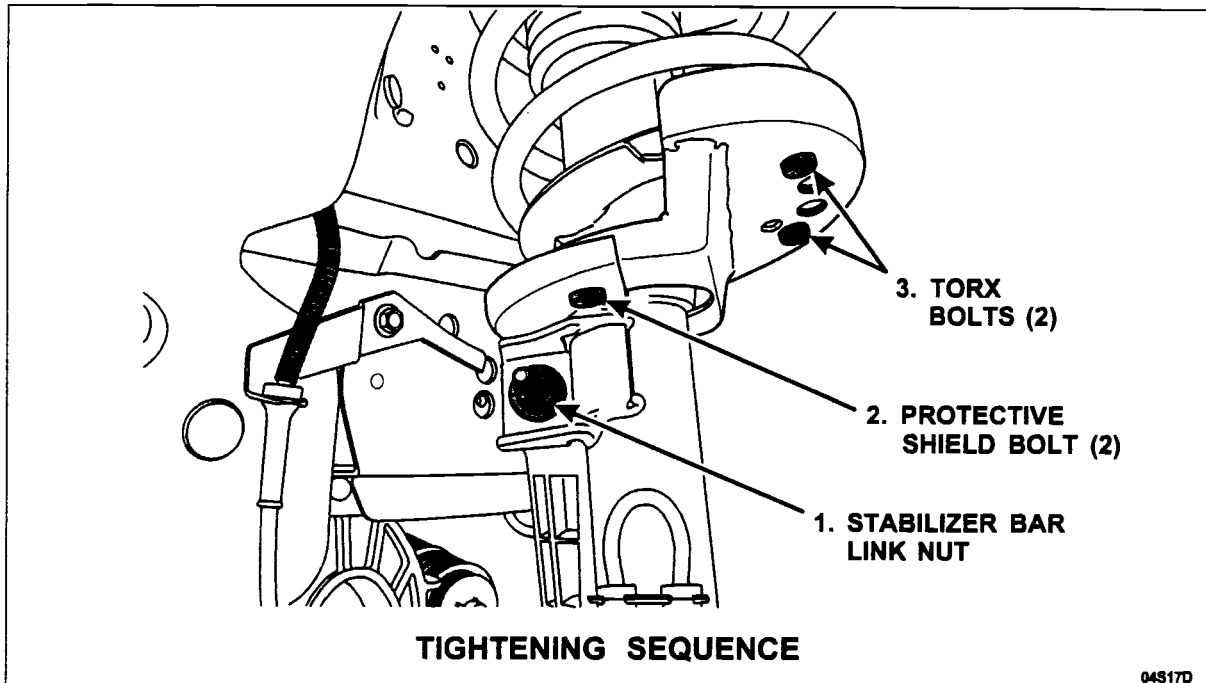
**FIGURE 4**

6. Tighten the fasteners in the following sequence (see Figure 4):
  1. Stabilizer bar link nuts – 90 Nm (66 lb-ft)
  2. Outer-to-inner protective shield bolts – 27 Nm (20 lb-ft)
  3. Torx bolts-to-nut plate – 27 Nm (20 lb-ft)
