TOYOTA CUSTOMER SERVICES

Volume: XI
Number: TC04-020
Date: 11/15/2004
 Action
 Retain
 Information

SUBJECT: SPECIAL SERVICE CAMPAIGN (SSC) – 40K
(2000 MODEL YEAR TOYOTA CELICA AND ECHO MASTER CYLINDER INSPECTION)

TECHNICAL INSTRUCTIONS
FOR
SPECIAL SERVICE CAMPAIGN 40K
2000 CELICA
MASTER CYLINDER AND BRAKE BOOSTER INSPECTION

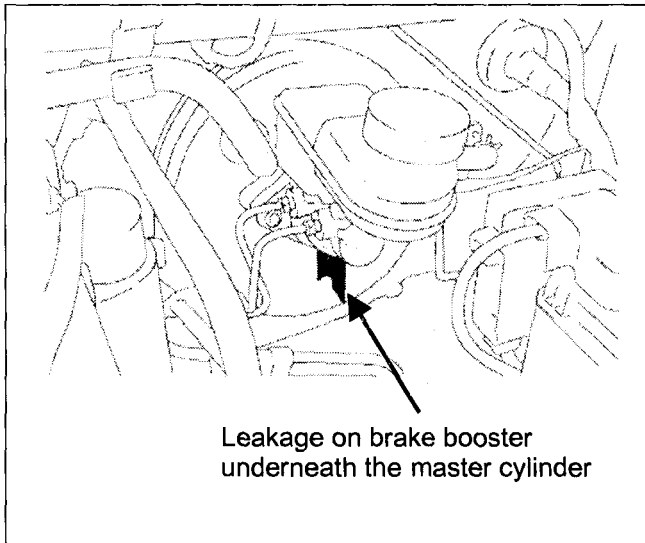
1. INSPECT BRAKE MASTER CYLINDER EXTERNALLY FOR LEAKAGE

- (a) Check (visually and by feel) for fluid leakage from the master cylinder in the area shown.

Ensure that any signs of brake fluid leakage is not a result of overfill/spillage from a previous repair.

If the master cylinder is leaking, it must be replaced along with the brake booster. Refer to the appropriate repair manual for replacement procedures and to page 3 for parts information. (Remember to keep the replaced master cylinder/brake booster assembly under the terms of the Warranty Parts Recovery policy)

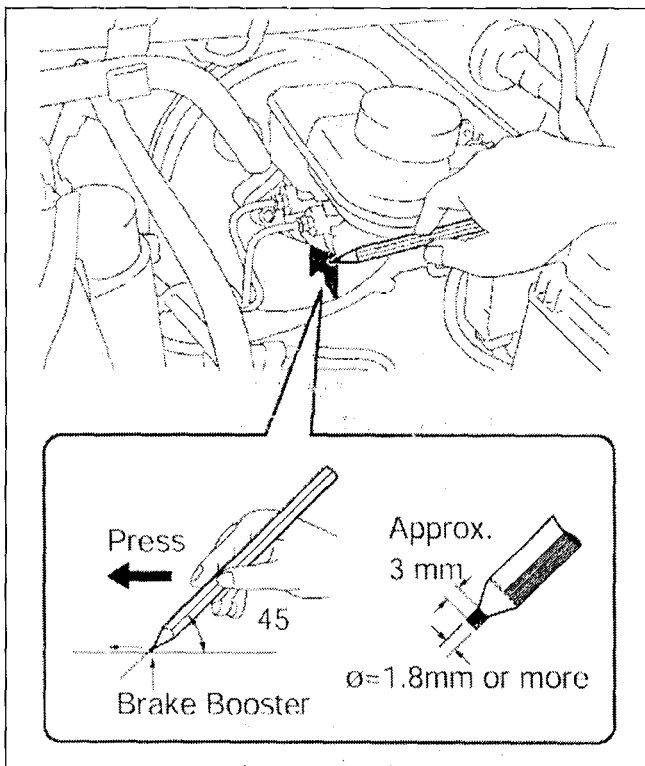
- (b) Using a sharpened pencil, as shown, check that the paint from the brake booster does not come off.

The pencil is used as a non-abrasive tool to determine if the paint on the booster has been damaged due to leaking brake fluid.

If the master cylinder is leaking, it must be replaced along with the brake booster. Refer to the appropriate repair manual for replacement procedures and to page 3 for parts information. (Remember to keep the replaced master cylinder/brake booster assembly under the terms of the Warranty Parts Recovery policy)

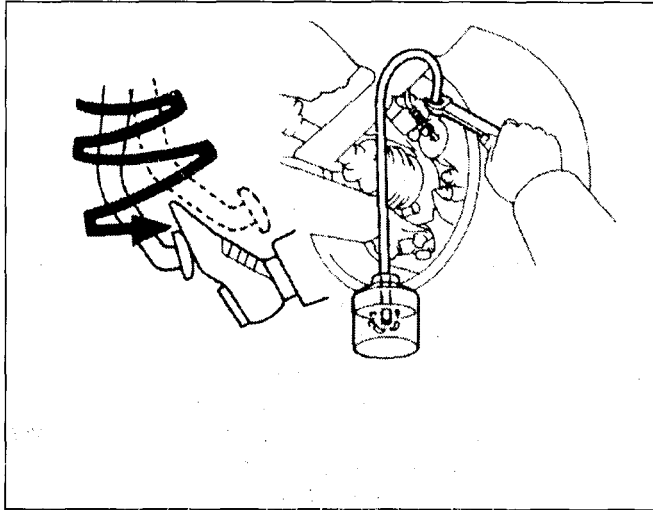
2. INSPECT FOR AIR BY MANUALLY BLEEDING THE BRAKE SYSTEM.
(Do not use a pressure or vacuum type brake bleeder)

- (a) Fill the brake master cylinder reservoir.
- (b) Bleed the brake system in the following sequence to determine if any air is in the master cylinder.
 - 1. Right Rear
 - 2. Left Rear
 - 3. Right Front
 - 4. Left Front

If any air is found, the master cylinder and brake booster must be replaced.

However, ensure that the any air found in the brake system is from the master cylinder. Due to the distance of the master cylinder, immediately visible air is not from the master cylinder. (Remember to keep the replaced master cylinder/brake booster assembly under the terms of the Warranty Parts Recovery policy)

Refer to the appropriate repair manual for replacement procedures and to page 3 for parts information. (Remember to keep the replaced master cylinder/brake booster assembly under the terms of the Warranty Parts Recovery policy)

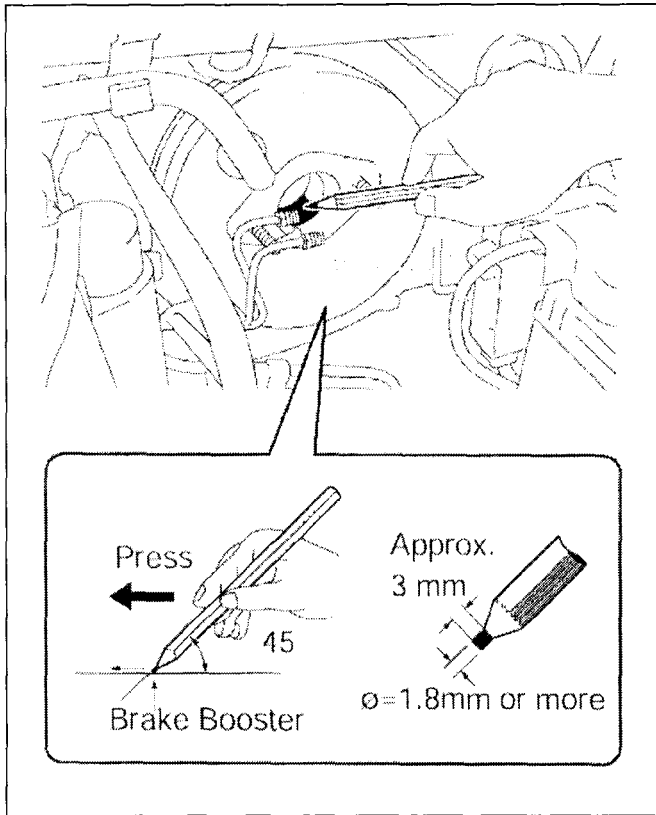
- (j) Check for signs of brake fluid leakage inside the booster. Use a pencil as shown. Check that the paint does not come off the brake booster.

The pencil is used as a non-abrasive tool to determine if the paint on the booster has been damaged due to leaking brake fluid.

If the master cylinder is leaking, it must be replaced along with the brake booster. Refer to the appropriate repair manual for replacement procedures and to page 3 for parts information. (Remember to keep the replaced master cylinder/brake booster assembly under the terms of the Warranty Parts Return Policy)

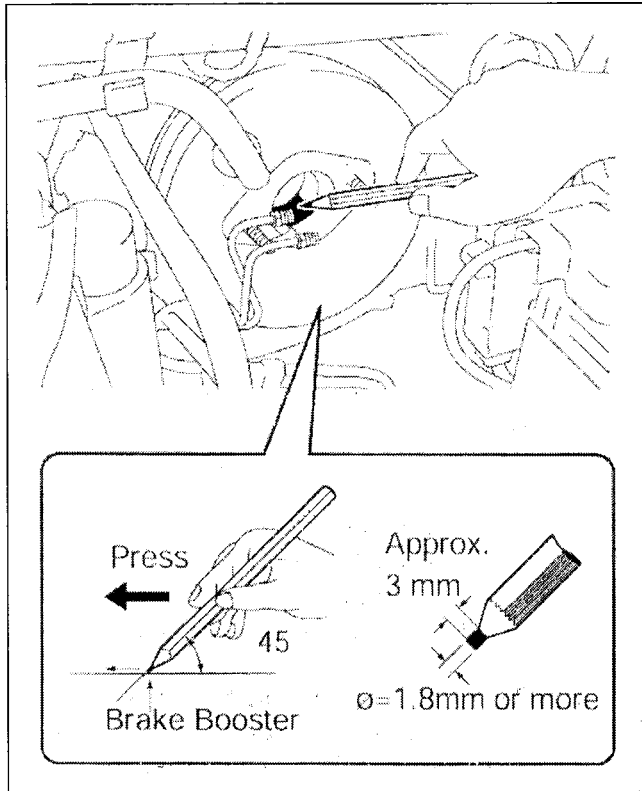
- (f) Check for signs of brake fluid leakage inside the booster. Use a pencil as shown. Check that the paint does not come off the brake booster.

If the master cylinder is leaking, it must be replaced along with the brake booster. Refer to the appropriate repair manual for replacement procedures and to page 3 for parts information.
