# TOYOTA CUSTOMER SERVICES

Volume: XI  
Number: TC04-020  
Date: 11/15/2004  
 Action  
 Retain  
 Information

SUBJECT: SPECIAL SERVICE CAMPAIGN (SSC) – 40K  
(2000 MODEL YEAR TOYOTA CELICA AND ECHO MASTER CYLINDER INSPECTION)

**TECHNICAL INSTRUCTIONS**  
**FOR**  
**SPECIAL SERVICE CAMPAIGN 40K**  
**2000 CELICA**  
**MASTER CYLINDER AND BRAKE BOOSTER INSPECTION**

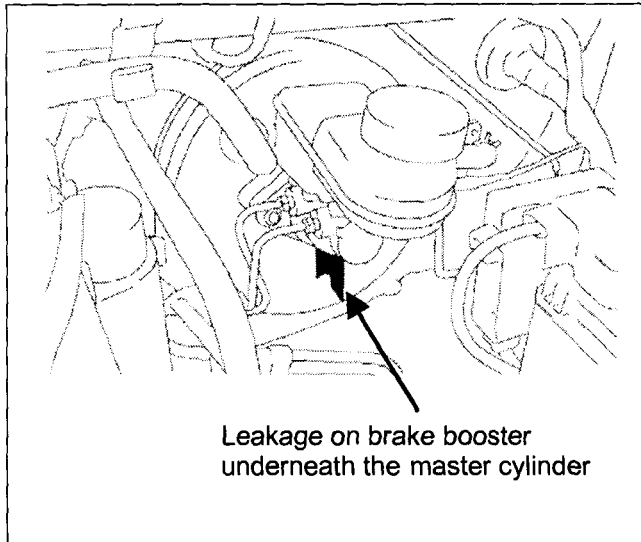
**1. INSPECT BRAKE MASTER CYLINDER EXTERNALLY FOR LEAKAGE**

- (a) Check (visually and by feel) for fluid leakage from the master cylinder in the area shown.

**Ensure that any signs of brake fluid leakage is not a result of overfill/spillage from a previous repair.**

If the master cylinder is leaking, it must be replaced along with the brake booster. Refer to the appropriate repair manual for replacement procedures and to page 3 for parts information. (Remember to keep the replaced master cylinder/brake booster assembly under the terms of the Warranty Parts Recovery policy)

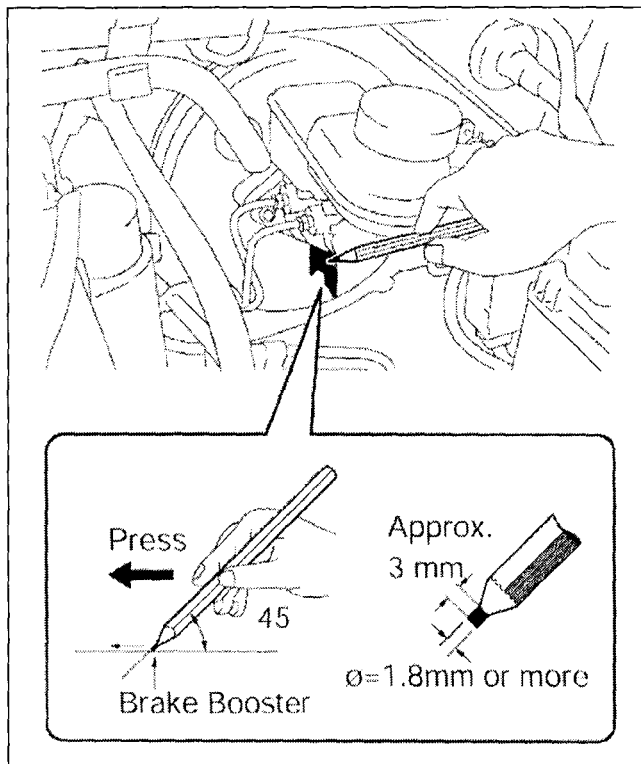
- (b) Using a sharpened pencil, as shown, check that the paint from the brake booster does not come off.

**The pencil is used as a non-abrasive tool to determine if the paint on the booster has been damaged due to leaking brake fluid.**

If the master cylinder is leaking, it must be replaced along with the brake booster. Refer to the appropriate repair manual for replacement procedures and to page 3 for parts information. (Remember to keep the replaced master cylinder/brake booster assembly under the terms of the Warranty Parts Recovery policy)

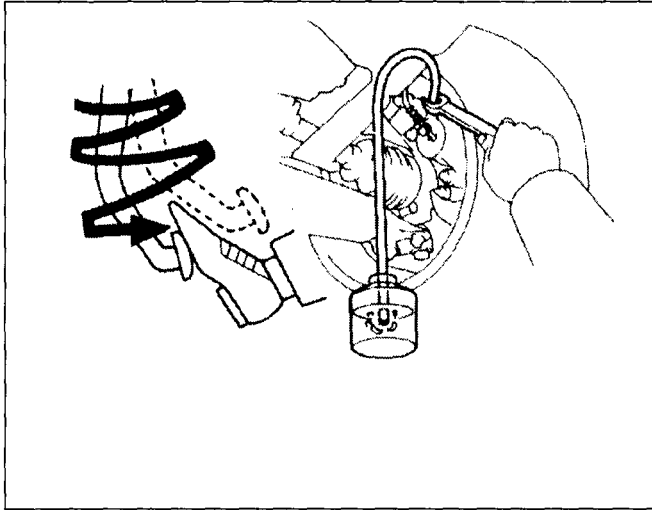
**2. INSPECT FOR AIR BY MANUALLY BLEEDING THE BRAKE SYSTEM.**  
(Do not use a pressure or vacuum type brake bleeder)

- (a) Fill the brake master cylinder reservoir.
- (b) Bleed the brake system in the following sequence to determine if any air is in the master cylinder.
  - 1. Right Rear
  - 2. Left Rear
  - 3. Right Front
  - 4. Left Front

If any air is found, the master cylinder and brake booster must be replaced.

***However, ensure that the any air found in the brake system is from the master cylinder. Due to the distance of the master cylinder, immediately visible air is not from the master cylinder. (Remember to keep the replaced master cylinder/brake booster assembly under the terms of the Warranty Parts Recovery policy)***

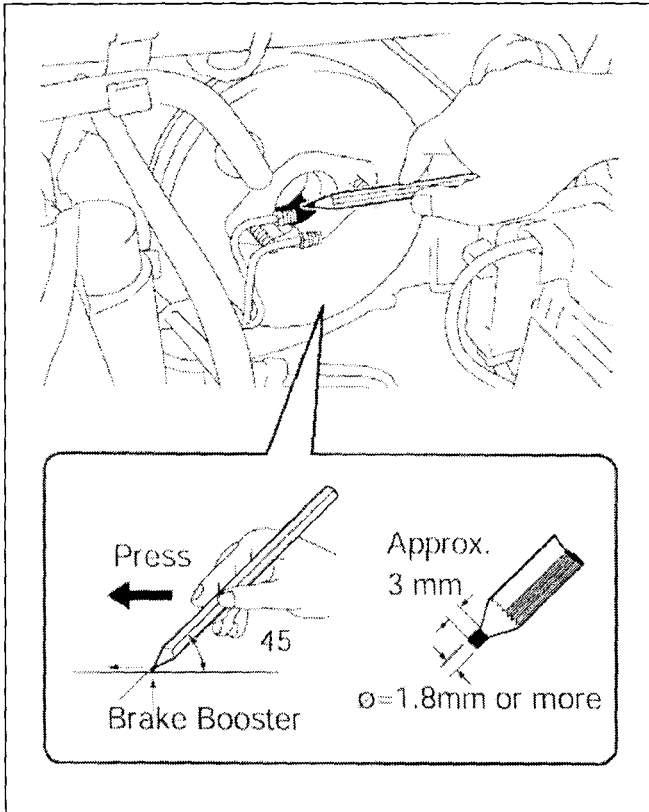
- (j) Check for signs of brake fluid leakage inside the booster. Use a pencil as shown. Check that the paint does not come off the brake booster.

The pencil is used as a non-abrasive tool to determine if the paint on the booster has been damaged due to leaking brake fluid.

If the master cylinder is leaking, it must be replaced along with the brake booster. Refer to the appropriate repair manual for replacement procedures and to page 3 for parts information. (Remember to keep the replaced master cylinder/brake booster assembly under the terms of the Warranty Parts Return Policy)

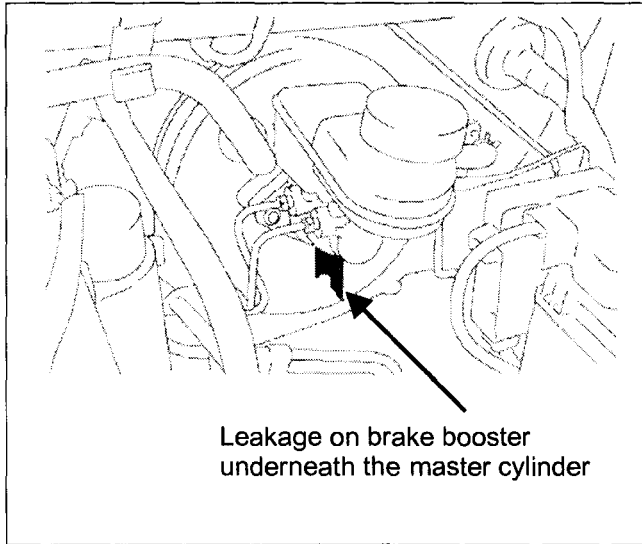
**1. INSPECT BRAKE MASTER CYLINDER EXTERNALLY FOR LEAKAGE**

- (a) Check (visually and by feel) for fluid leakage from the master cylinder in the area shown.

**Ensure that any signs of brake fluid leakage is not a result of overfill/spillage from a previous repair.**

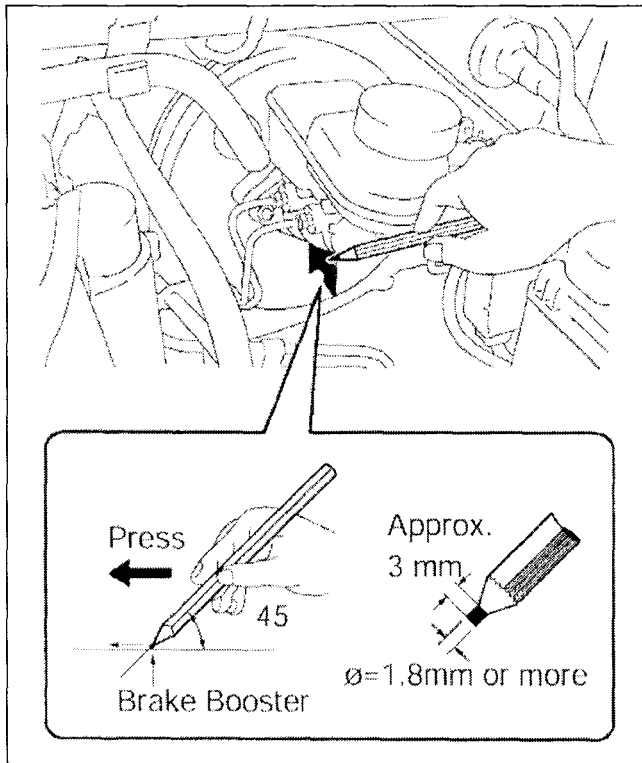
- (b) Using a sharpened pencil, as shown, check that the paint from the brake booster does not come off.

**The pencil is used as a non-abrasive tool to determine if the paint on the booster has been damaged due to leaking brake fluid.**

If the master cylinder is leaking, it must be replaced along with the brake booster. Refer to the appropriate repair manual for replacement procedures and to page 3 for parts information. (**Remember to keep the replaced master cylinder/brake booster assembly under the terms of the Warranty Parts Recovery policy**)

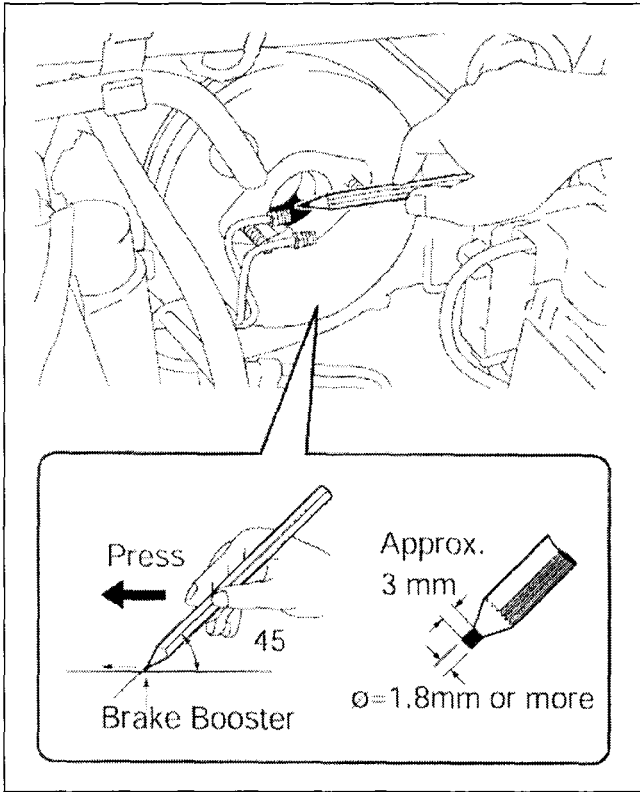
- (f) Check for signs of brake fluid leakage inside the booster. Use a pencil as shown. Check that the paint does not come off the brake booster.

If the master cylinder is leaking, it must be replaced along with the brake booster. Refer to the appropriate repair manual for replacement procedures and to page 3 for parts information.
