TOYOTA CUSTOMER SERVICES

TMS-NTC-04220

Subject: 2004 Model Year Prius Brake Light Switch SSC 40L

TECHNICAL INSTRUCTIONS
FOR
SPECIAL SERVICE CAMPAIGN 40L
2004 PRIUS
BRAKE LIGHT SWITCH
REPLACEMENT

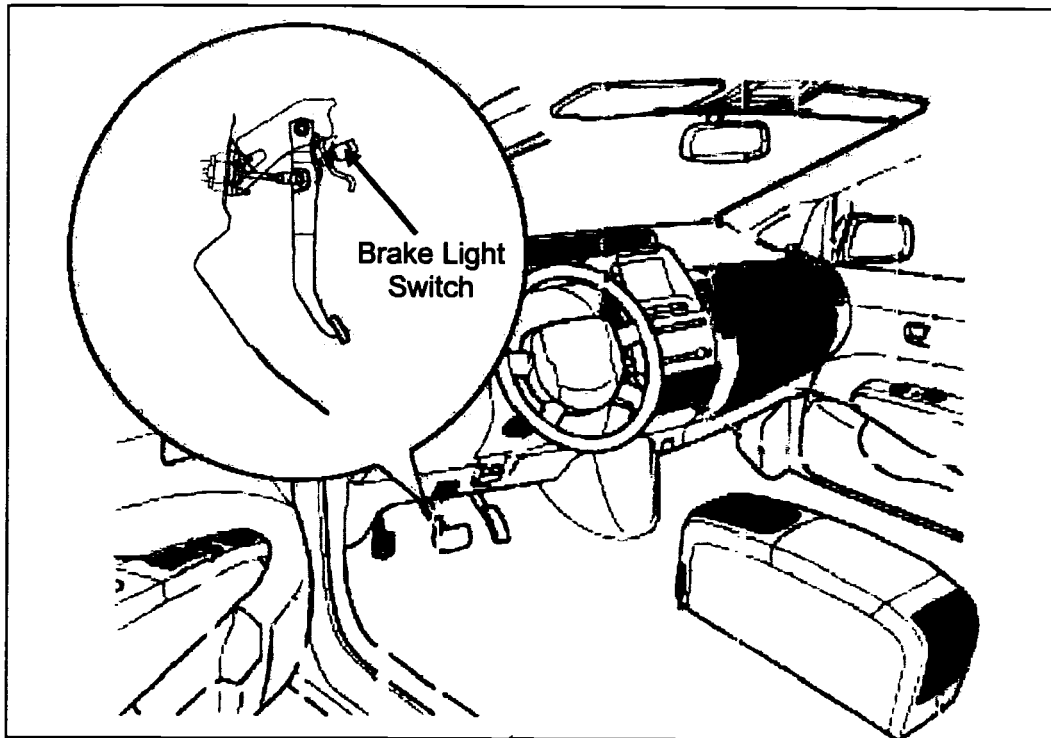
- On certain 2004 Model Year Toyota Prius vehicles, a silicon oxide build-up occurs on the contacts inside the brake light switch which can make it inoperable. If the switch is inoperable, the brake lights will not illuminate. In addition, there is a possibility that the ABS warning light may illuminate and/or the vehicle may not start.

- An SSC to replace the brake light switch will be launched in early December, 2004. Owner notifications will commence in mid-December, 2004.
- The attached Dealer Daily message will be sent to all dealers informing them of the issue and SSC launch timing.
- As required by Federal Regulation, dealers are not to deliver any vehicle acquired in their inventory, which is involved in a safety recall, until the necessary inspections/replacements have been performed.
- Dealers with affected dealer stock vehicles will be contacted by Quality Compliance.

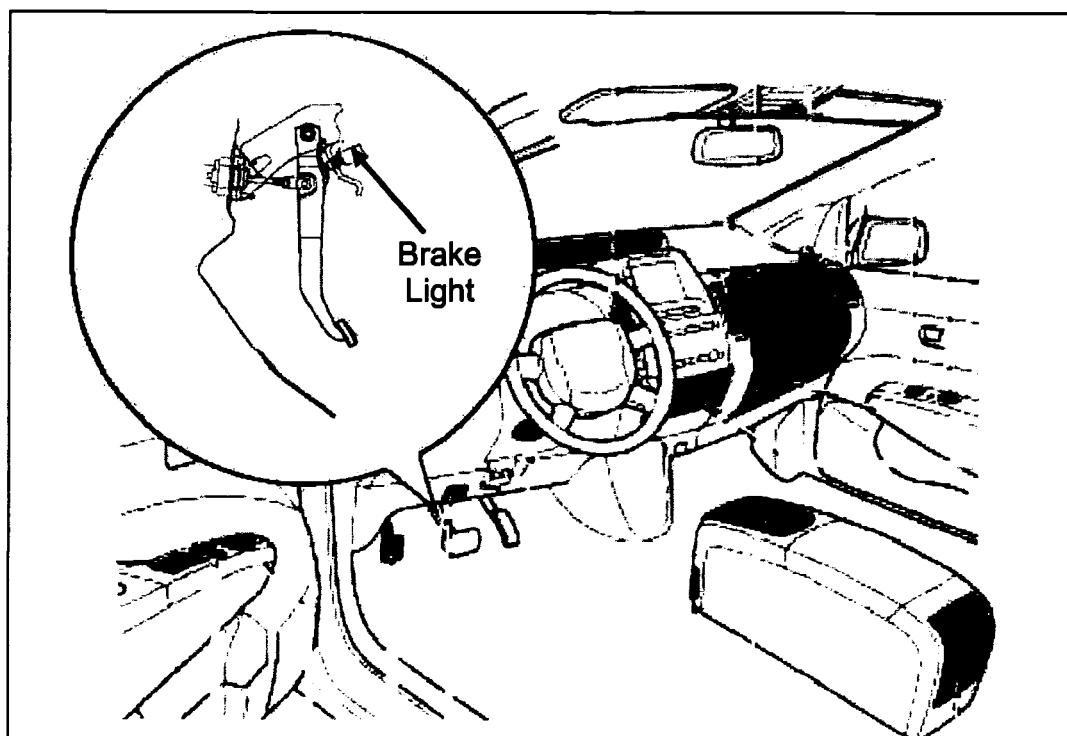
On certain 2004 model year Lexus RX 330 vehicles, a silicon oxide build-up occurs on the contacts inside the brake light switch which can make it inoperable. If the switch is inoperable, the brake lights will not illuminate. In addition, there is a possibility that the ABS warning light may illuminate and/or the vehicle may not shift out of the "P" (park) position.

An SSC to replace the brake light switch will be launched in early December 2004. Owner notification will begin in mid-December 2004. The attached Dealer Daily message will be posted to all dealers informing them of the issue and SSC launch timing. **As required by Federal Regulation, dealers are not to deliver any vehicle acquired in their inventory, which is involved in a safety recall, until the necessary inspections/repairs have been performed. Dealers with affected dealer stock vehicles will be contacted by Lexus Service and Parts Operations.** If your staff should receive any contacts from owners experiencing issues with the brake light switch, please direct the owner to their local Lexus dealer for diagnosis and/or replacement. A Q&A has been attached for your reference.
