TOYOTA CUSTOMER SERVICES

November 23, 2004
TMS-NTC-04224

Subject: Certain 2000 and 2001 Model Year Celica Daytime Running Lights (DRL)

Certain 2000 and 2001 Model Year Toyota Celica Daytime Running Lights (DRL)

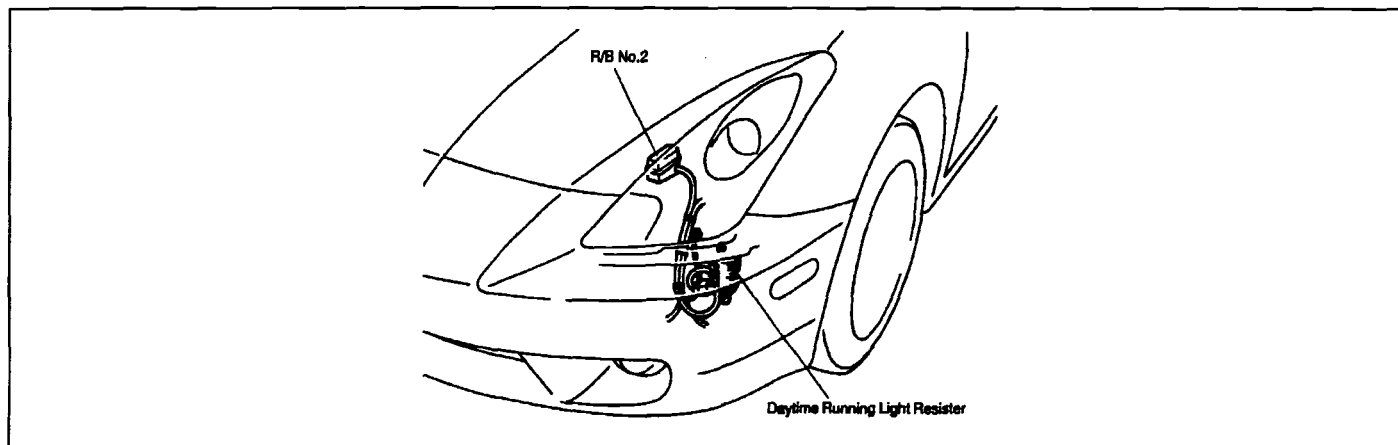
- Due to a design error, the DRL on certain 2000 and 2001 model year Celica vehicles operates at high illumination during vehicle operation. At this high illumination level, the Celica does not meet certain luminous intensity requirements.

- An SSC to install a resistor pack for the DRL system will be launched in early 2005.
- The attached Dealer Daily message will be sent to all dealers informing them of the issue.
- If your staff should receive any contacts from owners experiencing issues with the DRL system, please direct the owner to their local Toyota dealer for diagnosis and/or replacement.
- A Q&A has been attached for your reference.
