TO: All Mazda Dealership General Managers, Service Managers, and Parts Managers
DATE: July 2012
SUBJECT: 2002-2004 Tribute Accelerator Cable Safety Recall 2704L – **UPDATE**

On certain 2002-2004 Tribute vehicles equipped with 3.0L engines, the accelerator cable may prevent the throttle from returning to the idle position, possibly resulting in elevated engine speeds while driving. An unexpected increase in engine idle speed may increase stopping distance and may result in a vehicle crash without warning.

2002 - 2004 TRIBUTE ACCELERATOR CABLE [RECALL 2704L]

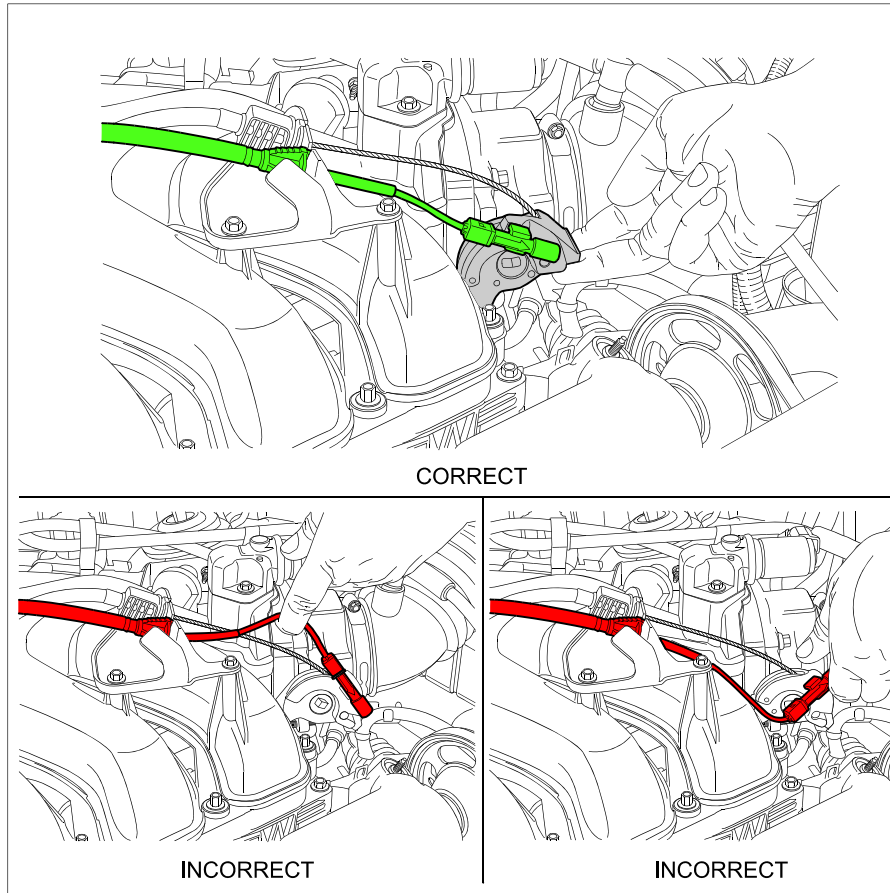
CAUTION: Damage to the speed control cable may result if the throttle body cam is rotated by lifting up on the speed control cable or the speed control cable connector end. When disconnecting the accelerator cable from the throttle body, rotate the throttle body cam only by lifting up on the cam itself. See Figure below.
