TOYOTA CUSTOMER SERVICES

Volume: XI
Number: TC04-022
Date: 12/06/2004
 Action
 Retain
 Information

SUBJECT: SPECIAL SERVICE CAMPAIGN (SSC) – 40M
(2004 THROUGH EARLY 2005 MODEL YEAR TOYOTA CAMRY RIGHT FRONT
POWER SEAT, SEAT BELT BUCKLE STATUS SWITCH REPLACEMENT)

2004 through early 2005 CAMRY
RIGHT FRONT POWER SEAT, BELT BUCKLE
STATUS SWITCH REPLACEMENT

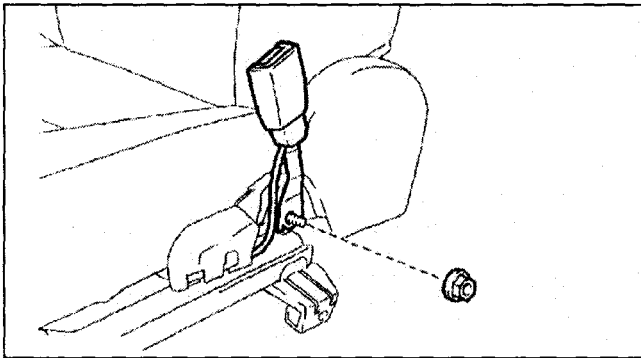
The yaw sensor is mounted to the floor under the right front seat and could be damaged during seat removal and installation.

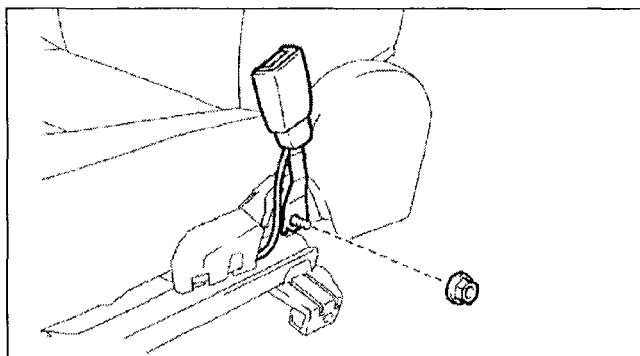
The yaw sensor is mounted to the floor under the right front seat and could be damaged during seat removal and installation.
