**IC CORPORATION**  
751 SOUTH HARKRIDER, CONWAY, AR 72032  
Phone: (501) 505-2190 Fax: (501) 505-2185  
email: bob.douglas@ic-corp.com  
DEFECTS INVESTIGATION

Subject: **Safety Recall 04305 NHTSA #04V-498**

IC CORPORATION RECALL # 04305  
NHTSA RECALL # 04V- 498

### **30-Inch Child Restraint Seat Cushion Retention**

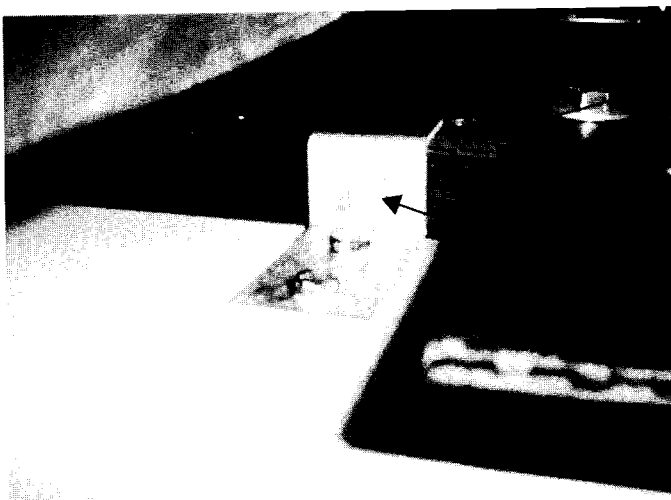
The 30-inch child restraint seat cushion retention may not retain the seat in all circumstances. In the event of a sudden stop, the seat cushion may tip forward and may become unattached causing the passenger to slide off the seat and/or be trapped by the seat cushion. This action could possibly result in personal injury or death.

Rectangular support is located in rear portion of seat cushion frame.

Reinforcement on aisle side of seat frame.

Under side of seat cushion.

1. Make sure that the cushion is in place and snug against the sidewall of the bus.
2. Using the metal Z-shaped clip, hold in place against the rectangular rear longitudinal bar and the board on the bottom side of the seat cushion. Leave about 1-inch between edge of clip and seat frame reinforcement plate.

11. Return seat to the proper position, which requires the seat cushion to be tight against the wall of the bus.
12. Using two (2) 1/4-inch bolts with 1/4-inch lock washers, secure the z-shaped clip to the board using the T-nuts just installed. These bolts must be inserted into the nut insert that was just installed.

Z-shaped clip installed approximately 1-inch from reinforcement plate.
