Amendment to
04V-127

Re: Four Winds International Corporation
Recall No.: 04V-127

EXHIBIT "A"

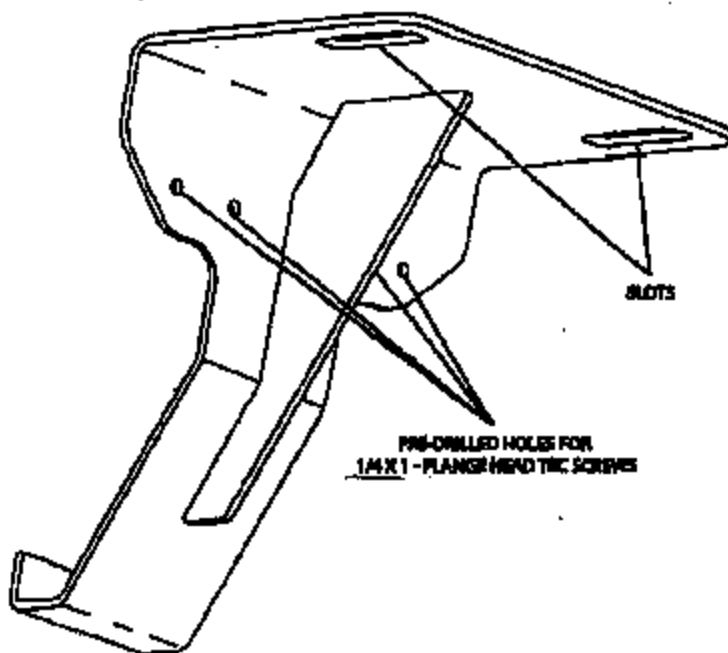
DIAGRAM 1-1

The seat pedestal braces are located behind the front tires within the wheel wells and anchor the seat pedestals to the chassis frame.

Identify the brace, and inspect, insuring that there are 4 (four) $\frac{1}{4}$ X 1 - Flange Head Tec Screws securing the brace to the motor home chassis frame. If there are less than 4 (four) screws, proceed to secure the brace using $\frac{1}{4}$ X 1 Flange Head Tec Screws (refer to diagram 1-1). If upon inspection a seat pedestal brace is not present refer to diagram 1- 2 of this installation guide.

Using the $\frac{1}{2}$ X 1 Flange Head Tec Screws, fasten the brace to the front truss (refer to diagram 1-1).

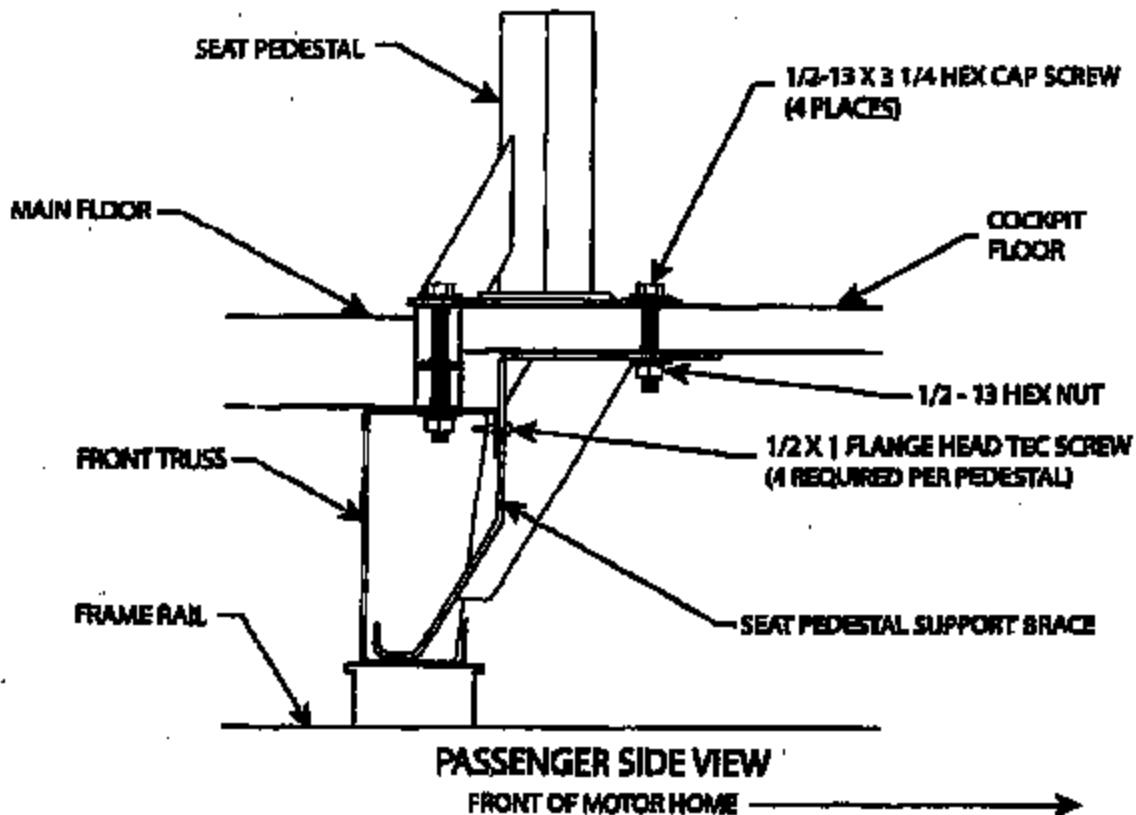
DIAGRAM 1-2

Upon inspection, if a seat pedestal brace is not present, installation of the brace is required immediately.

To proceed with installation, remove the seat pedestal's front $\frac{1}{2}$ -13 Hex Nuts from the $\frac{1}{2}$ -13 Hex Cap Screws, as well as the $\frac{1}{2}$ Lock Washers and the $\frac{1}{2}$ Flat Washers, which secure the seat pedestal to the doghouse frame.

Place the brace slots over the Hex Cap Screws. Replace the Flat Washer, followed by the Lock Washer and then the Hex Nut. Hand tighten the Hex Nut. Insure the back of the brace is flush with the front truss of the chassis frame.

Torque the hex screw and nut to 65 lb.ft. Repeat procedure for the opposite seat pedestal.
