Transport Canada Recall # 04-214 (NHTSA Recall # 04V-380)

This letter is a Motor Vehicle Safety Act, Section 10, Article report that Fleetwood Enterprises Inc., is voluntarily initiating a recall campaign for conventional and fifth wheel travel trailers.

## IMPORTANT RECALL INFORMATION #40521

#### Recall Service Bulletin

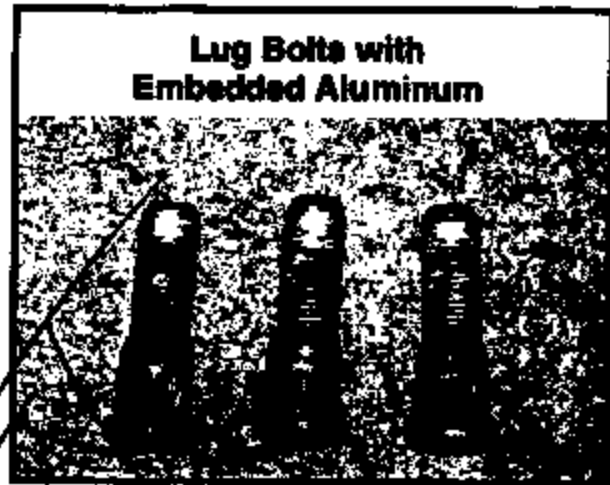
Figure 5

9. Inspect the lug studs on the hub. Lug stud threads should be smooth and clean. If any of the lug studs show signs of wear, or any of the threads are embedded with aluminum, **ALL** the lug studs on that hub will need to be replaced. See Figure 5. **Note:** All new lug studs must also have new lug nuts installed. If there is no damage to the lug studs, proceed directly to Step 25.

15. Use a 1/2 ton arbor press or greater to remove the damaged lug studs from the hub. **Warning:** Do not remove damaged lug studs with a hammer. The hub could be damaged and debris may lodge in the bearing assembly.

18. Install new lug studs using the press. Line up the splines on the new lug stud with the grooves in the hub from the old lug stud to ease pressing in place. **Warning:** Do not install lug studs with a hammer or pull the lug studs into their seated location by tightening down a nut. Damage can occur.

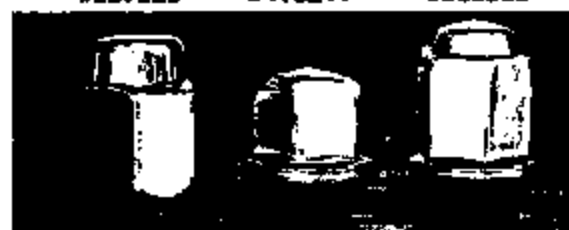
Figure 12

28. Inspect lug nuts for damage or wear. Examples include: threads embedded with metal, loose metal particles, damaged tapers, etc. All damaged lug nuts will need replacement with new lug nuts. All new lug studs must have new lug nuts installed. Note: Hold all parts for 60 days or until a return request is issued by Fleetwood.
