AMERICAN SUZUKI MOTOR CORPORATION

04F-062
04V-357

The following information is submitted in accordance with the reporting regulations in Title 49 of the Code of Federal Regulations, Part 579, Subpart B - Reporting of Safety Recalls and Other Safety Campaigns in Foreign Countries.

Affected vehicles are certain 2002-2003 model year Daewoo/GMDAT Evanda passenger cars produced in Korea from October 19, 2001 through January 20, 2003.

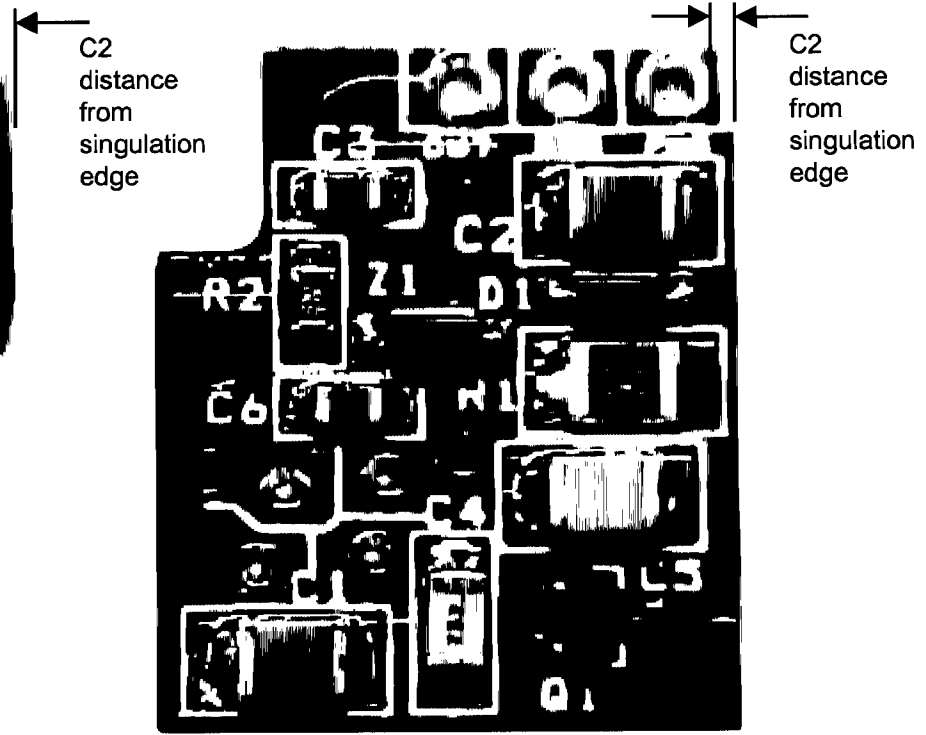
Suspect PCB
(AB Automotive)

A capacitor in the PC board of the camshaft sensor can crack, which can result in melting of the camshaft sensor. Melting of the sensor would likely produce smoke and a smell, and would cause illumination of the malfunction indicator lamp (MIL). This could also lead to melting of a front portion of the camshaft cover and a part of the wiring harness near the camshaft sensor.

The reason of voluntary recall is a possible crack in C2 capacitor on the suspect PCB (Printed Circuit Board) of cam sensor. The crack might be resulted from the stress of PCB cutting process in PCB maker's manufacturing process (AB automotive)

GMDAT has decided to initiate a safety-related recall campaign to correct the defect in subject vehicles. Camshaft sensors in affected vehicles will be replaced and an additional in-line 5A fuse will be installed.
