TO: ALL VOLVO RETAILERS - US & CANADA
RE: RECALL CAMPAIGN 133

<h1 style="text-align: center;">VOLVO</h1> <h2 style="text-align: center;">Service Manager Bulletin</h2>				TITLE:		GROUP:	NO:
				Recall Campaign 133 Ball Joint SEMS Nut S60, V70, S80 Mdl. Yr: 2004		81	133
						ISSUING DEPARTMENT:	
				Warranty			
CARMARKET:		North America					
REFERENCE BULLETINS:		DATE:					
PB61-133 SB61-0013		YEAR 2004	MONTH 02	DAY 02			
Service Personnel: read and initial.		Page 1 of 3

Ball joint nuts in front control arms

Ball joint nuts in front control arms, replacing

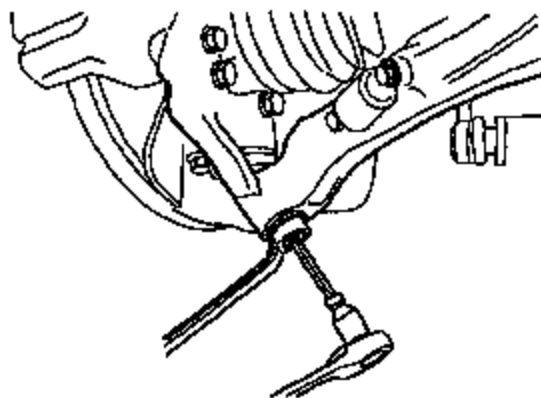
06102428

Replacing the ball joint nut

Note! Replace on both sides.

Remove the front wheels.

Caution! The ball joint pinion must not rotate. Use a Torx wrench as a counter hold so that the rubber boot is not damaged.

Remove the nut on the control arm.

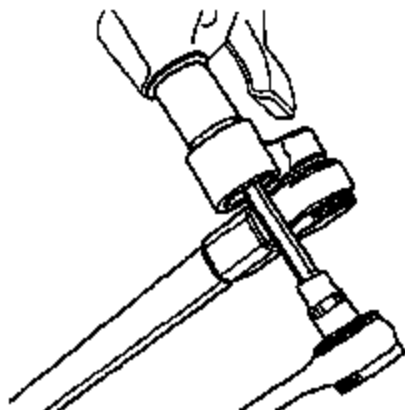
06102429

Torque tightening

Install a new nut.

Caution! The ball joint pinion must not rotate. Use special tool 961 2827 (torx 40 long version) as a counterhold to prevent damaging the rubber boot.

Tighten the joint. Tighten to 80 Nm. Using the torx 40 as the counterhold.

Then continue with angle-tightening. See step 3.

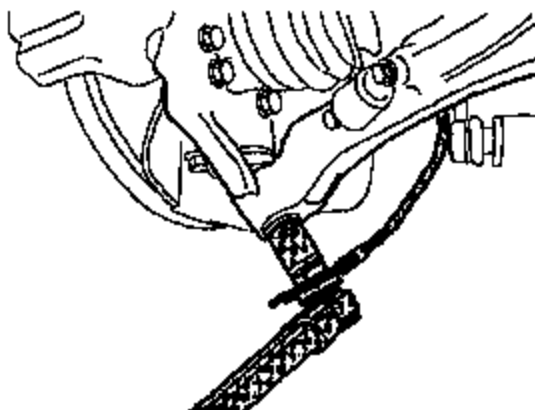
J361024-01

Installing the ball joint nut, angle-tightening

Angle-tighten 35°. Use angle gauge 961 2060.

Note! A counterhold is not required when angle tightening if the joint has been tightened to 50 Nm. Because the friction between the ball joint and control arm is greater than between the ball joint nut and threads.

Install the wheels.

Tighten to 140 Nm.
