# Foretravel

## SERVICE BULLETIN

**Subject: NHTSA Recall-Window Wiper Technology 04 Spindle Shaft**

**Subject: NHTSA Recall-Villa Seat Belt Bolt Replacement**

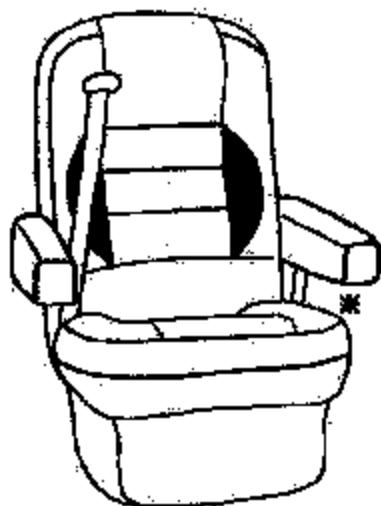
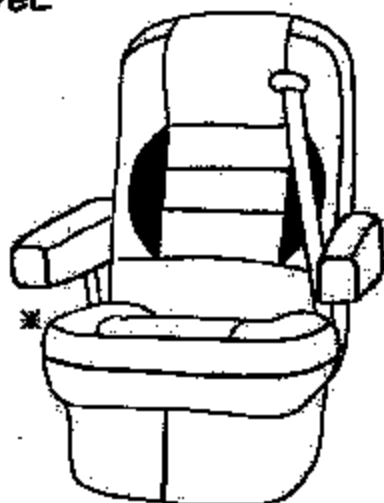
\* BELT BUCKLE \*

Villa International of Anaheim, California has initiated a NHTSA Recall on the driver and passenger seats on 60, 2004 year model U270, U295 and U320 (**Unit # Range 6234-6295**) Foretravel motor homes due to possible failure of the seat belt buckle bolt used to attach the buckle to the frame.

1. LOCATE BELT BUCKLE, I.E. RIGHT SIDE OF THE VEHICLE, SEE ABOVE FIGURES. BELT BUCKLE LOCATION INDICATED BY AN ASTERISK (\*).
2. TAKE OUT THE CAP AND LOOSEN EXISTING BOLT TO REMOVE BELT BUCKLE, SEE FIG. 1.
3. INSERT 7/8 ID x 3/8 OD x 3/4 SPACER INTO 1" DIA. TUBE; SEE FIG. 2.
4. RE-INSTALL BELT BUCKLE, WITH 3/8 USS FLAT WASHER ZINC & 3/8-16 x 2 GRADE 5 HEX BOLT. SEE FIG. 2.
5. TIGHTEN BOLT TO 30 FT. LBS. PUT CAP BACK ON.

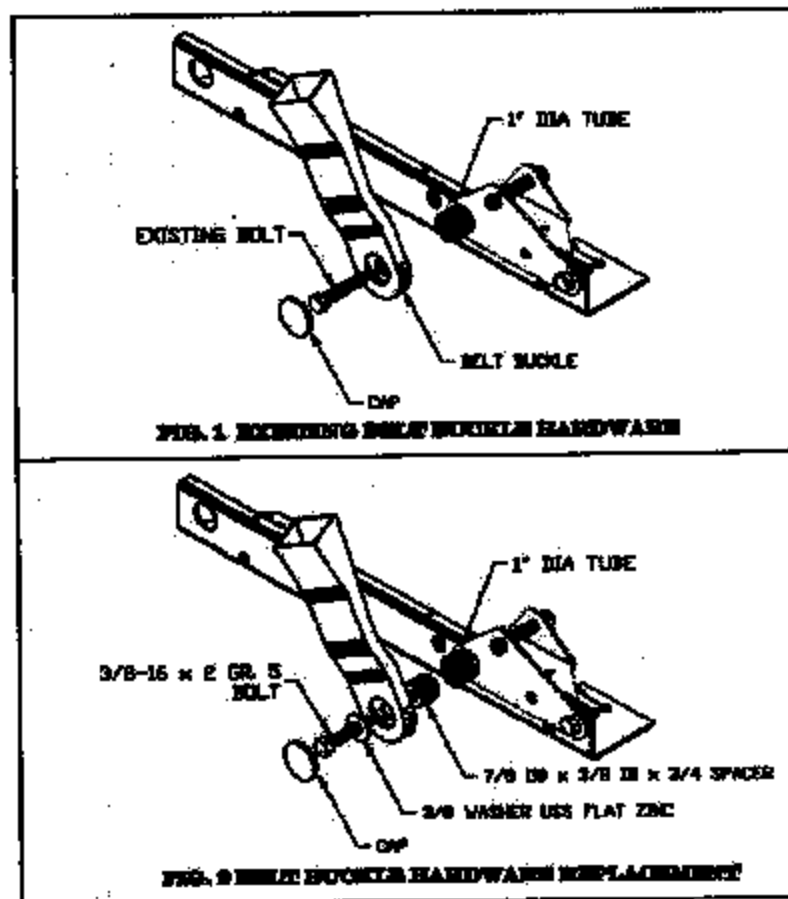
The recall will consist of removing the seat belt buckle bolt on both the driver and passenger seats. A bushing will be placed on the grade 5 bolt used to attach the seat belt buckle to the frame.
