Recall Bulletin

File In Section: Product Recalls
Bulletin No.: 04004
Date: June 2004

F/CMVSS NONCOMPLIANCE RECALL

SUBJECT: BRAKE HYDRO-BOOST RELIEF VALVE SEAL FRACTURE

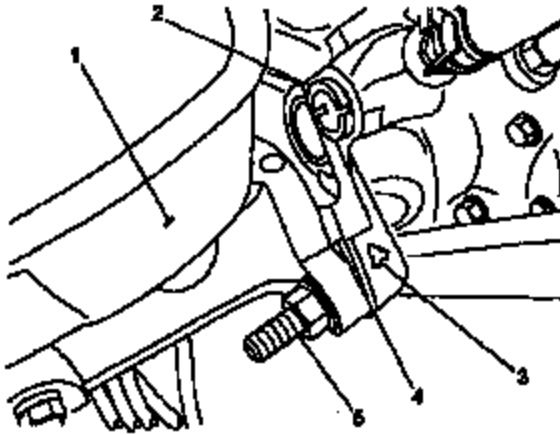
1478889

2. Locate the relief valve (2) on the hydraulic brake booster. The valve is located in the front of the brake booster directly behind the master cylinder reservoir (1).
 - o If the color of the relief valve is metallic yellow or has a brass appearance, then no further action is required.
 - o If the color of the relief valve is silver or aluminum, continue to the next step.

3. Inspect the hydraulic brake booster at the location shown (4) for a stamped number. The location (4) is the same surface that the master cylinder mounts on, just above the outboard mounting bolt and nut (5). Also inspect for a paint mark (3) near the master cylinder outboard mounting bolt (5). If a stamped number is found it will be a 1, 2, 3, or 4. If a paint mark is found, it will be yellow, pink, or white.

- o If a yellow, pink, or white paint mark IS visible, no further inspection or repairs are required. Disregard any stamped number found when a yellow, pink, or white paint mark is visible.

- o If there are NO paint marks and there IS a stamped number 2, 3, or 4 visible, no further inspection or repairs are required.
 - o If there are NO paint marks and there IS a stamped number 1 visible, then proceed to the next step.

- o If there are NO paint marks and there are NO stamped numbers visible, then proceed to the next step.

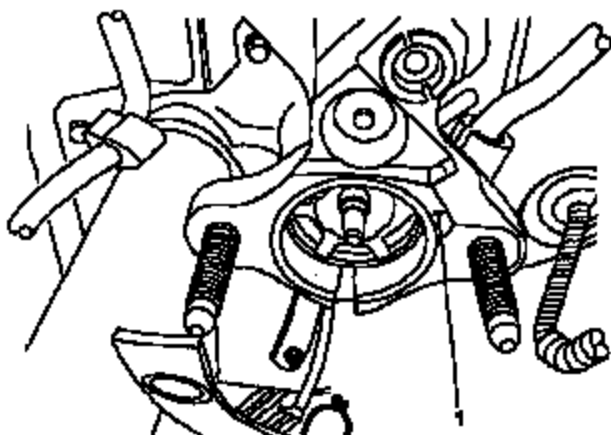
1478924

8. Inspect the machined surface that was covered by the master cylinder on the front of the hydraulic brake booster at the location (1) shown for a stamped number. The stamped number will be a number 1, 2, 3, or 4.
 - o If a stamped number 1 is visible, then the relief valve must be replaced. Proceed to the next step.
 - o If a stamped number 2, 3, or 4 is visible, then no further action is required. Proceed to Step 14 and reinstall the master cylinder.
 - o If no stamped number is visible, then no further action is required. Proceed to Step 14 and reinstall the master cylinder.
9. Cover the master cylinder with a clean shop towel in order to protect it from fluids or cleaners. Also, place a shop towel under the hydraulic brake booster to absorb any fluid that may leak out of the unit when the relief valve is removed in the next step.

7. Remove and reposition the master cylinder away from the hydraulic brake booster so that the machined surface on the front of the booster where the master cylinder was mounted is visible.

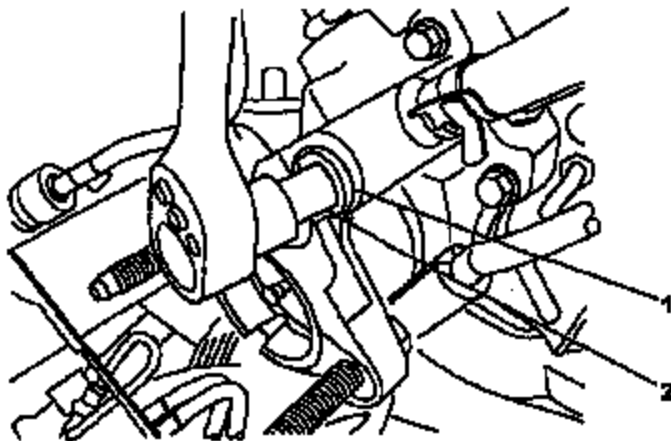
1478923

11. Inspect the two O-rings on the original valve for signs of damage. If an O-ring is missing, broken, or damaged, inspect the bore in the hydraulic brake booster for any pieces or debris using a non-metallic type tool or a clean "lint-free" towel.

10. Using the tool (2) included with the new relief valve, unscrew the original relief valve (1) from the hydraulic brake booster.

12. Insert the NEW relief valve into the bore. **Tighten**

Tighten to 17 N·m (13 lb ft).
