**Subject: 04005 - Product Safety Recall  
Windshield Wiper Operation**

# Recall Bulletin

Bulletin No.: 04005

**SUBJECT:** WINDSHIELD WIPER OPERATION

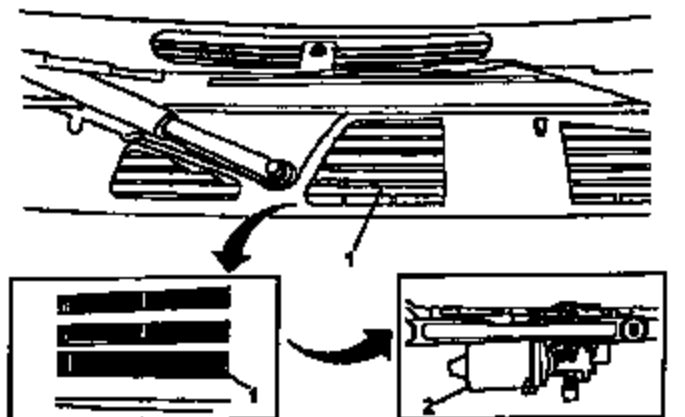
1486880

1. Using a flashlight, look down through the air inlet screen (1) at the location shown.
  - o If the color of the can (2) on the wiper motor is **SILVER**, no repairs are required on the vehicle.
  - o If the color of the can (2) on the wiper motor is **BLACK**, proceed to the section below titled, **REPAIR PROCEDURE**.

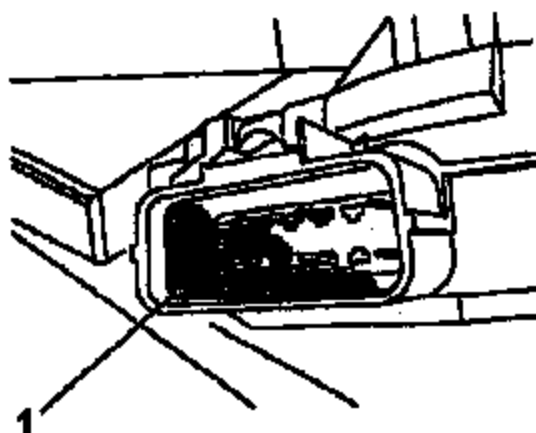
1466664

16. Inspect the inside of the electrical connector on the wiper motor for moisture or water. If no moisture or water is found, continue inspecting for evidence or signs that moisture or water was present at some earlier time. Indicators include water stains, dried dirt, etc. (1).

- o If moisture or water is found in the electrical connector, or if there is evidence that there was moisture or water present at an earlier time, the complete wiper motor module (including the motor) **MUST** be replaced. Obtain a new wiper module and proceed to Step 20. The new wiper modules already have a different style of breathable seal on the wiper cover. **DO NOT** install the breathable seal described later in this recall on new wiper modules.

- o If there is no moisture or water found in electrical connector, or if there is **NO** evidence that moisture or water was present at an earlier time, a breathable seal must be installed over the vent in the wiper motor cover. Proceed to the next step.
