Subject: 04006C - Product Safety Recall  
Electronic Column Lock System  
Service Procedure Revised

File In Section: Product Recalls  
Bulletin No.: 04006C  
Date: February 2006

**SUBJECT: ELECTRONIC COLUMN LOCK SYSTEM**

**MODELS: 1997-2004 CHEVROLET CORVETTE EQUIPPED WITH A MANUAL TRANSMISSION  
1997-2000 CHEVROLET CORVETTE EQUIPPED WITH AN AUTOMATIC TRANSMISSION  
2001-2004 CHEVROLET CORVETTE EQUIPPED WITH AN AUTOMATIC TRANSMISSION – EUROPEAN EXPORT ONLY**

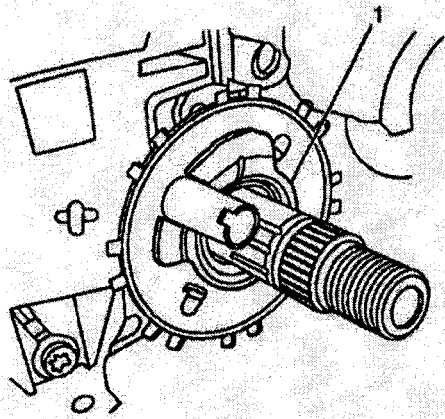
1489468

27. Using J 23653-SIR (2), remove the retaining ring and the lock plate (1) and discard both.
