Bulletin No.: 04006B

PRODUCT SAFETY RECALL

SUBJECT: ELECTRONIC COLUMN LOCK SYSTEM

**MODELS: 1997-2004 CHEVROLET CORVETTE EQUIPPED WITH A MANUAL TRANSMISSION
1997-2000 CHEVROLET CORVETTE EQUIPPED WITH AN AUTOMATIC TRANSMISSION
2001-2004 CHEVROLET CORVETTE EQUIPPED WITH AN AUTOMATIC TRANSMISSION – EUROPEAN EXPORT ONLY**

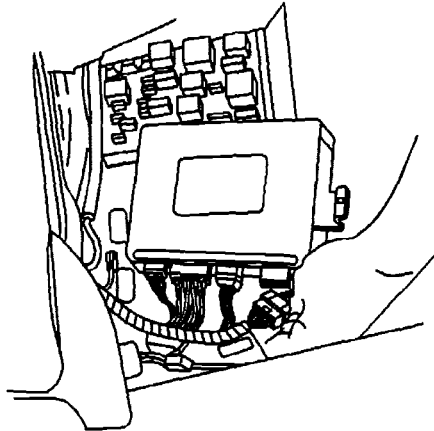
802246

16. Disconnect the green 16-way connector from the BCM. The above illustration is rotated approximately 90 degrees.
17. Using the appropriate terminal release tool, remove the purple wire and terminal from cavity A6 of the BCM connector.
