Subject: MY 2003 Isuzu Ascender -  
Windsheld Wiper Module -  
Part 573 Defect Information Report -  
Recall 04V-061 -  
Supplemental Submission

July 8, 2004  
Campaign 04V-061  
Bulletin SB04-04-S002

**ASCENDER WINDSHIELD WIPER OPERATION  
SAFETY RECALL CAMPAIGN  
04V-061**

**BULLETIN NUMBER:**  
SB04-04-S002

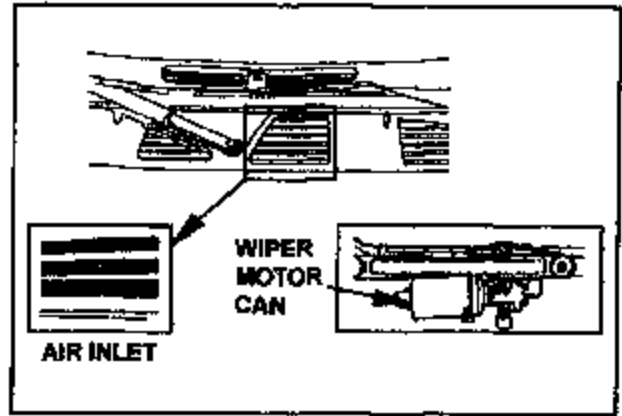
Figure 1

1. Using a flashlight, look down through the air inlet screen at the location shown (see figure 1).

- If the color of the can on the wiper motor is **SILVER** (see figure 1), no repairs are required on the vehicle, proceed to the section titled, **APPLYING THE CAMPAIGN LABEL**.
- If the color of the can on the wiper motor is **BLACK** (see figure 1), proceed to the section titled **REPAIR PROCEDURE**.

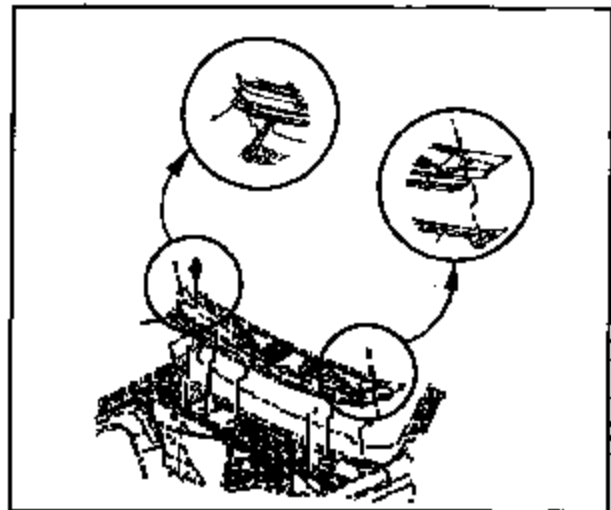
Figure 2

1. Verify that all of the functions of the wiper system (low, high, delay, etc.) operate properly.
2. Turn the key to the off position.
3. Open the hood.
4. Remove the three push-in retainers that attach the air inlet grille (leaf screen) to the plenum sheet metal (see figure 2).

10. Remove the antenna mast if applicable.
11. Remove the 10 mm hex head nut that attaches the left and right ends of the air inlet grille to the plenum sheet metal (refer to figure 2).

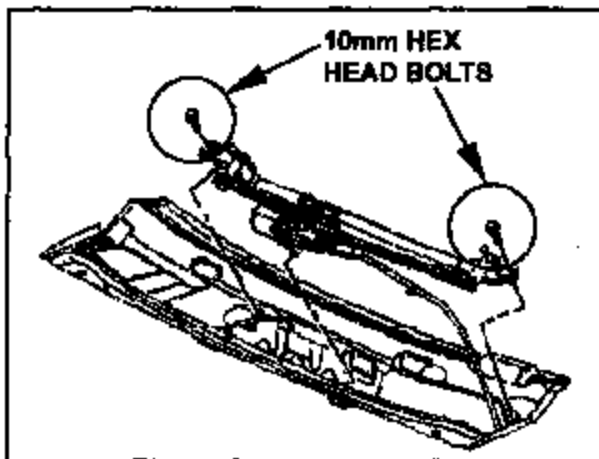
Figure 3

13. Remove the two 10 mm hex head bolts that attach the wiper module to the plenum sheet metal (see figure 3).

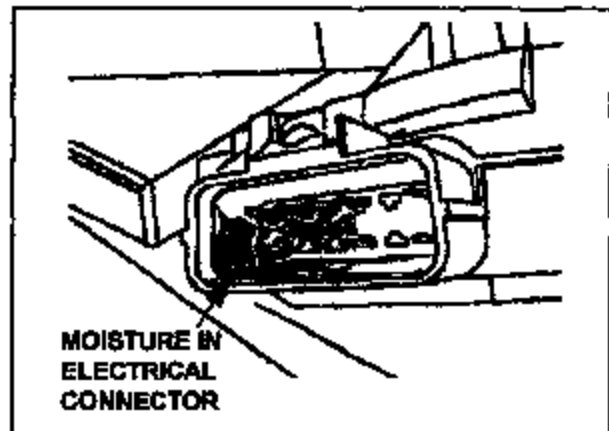
Figure 4

14. Disconnect the electrical connector.
15. Remove the wiper module and place on a suitable work surface.
16. Inspect the inside of the electrical connector on the wiper motor for moisture or water. If no moisture or water is found, continue inspecting for evidence or signs that moisture or water was present at some earlier time. Indicators include water stains, dried dirt, etc (see figure 4).

- If moisture or water is found in the electrical connector, or if there is evidence that there was moisture or water present at an earlier time, the complete wiper motor module (including the motor) **MUST** be replaced. Obtain a new wiper module and proceed to Step 20. The new wiper modules already have a different style of breathable seal on the wiper cover. **DO NOT** install the breathable seal described later in this recall on new wiper modules.

- If there is no moisture or water found in electrical connector, or if there is **NO** evidence that moisture or water was present at an earlier time, a breathable seal must be installed over the vent in the wiper motor cover. Proceed to the next step.

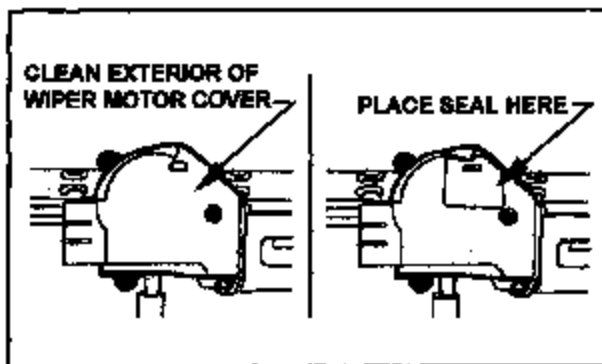
Figure 5

17. Clean the exterior surface of the wiper motor cover thoroughly. It must be free of dirt, grease, oil, and other contamination (see figure 5).

20. Remove the backing material from the seal, align it over the wiper motor cover so that it completely covers the vent and press it firmly into place as shown in the above illustration. Apply firm pressure across the entire surface of the seal and around all outside edges. Continue applying pressure a second time to the edges to assure full adhesion (refer to figure 5).
